**VOLVO XC90: TJ4039**

**Limited Technical Inspection**

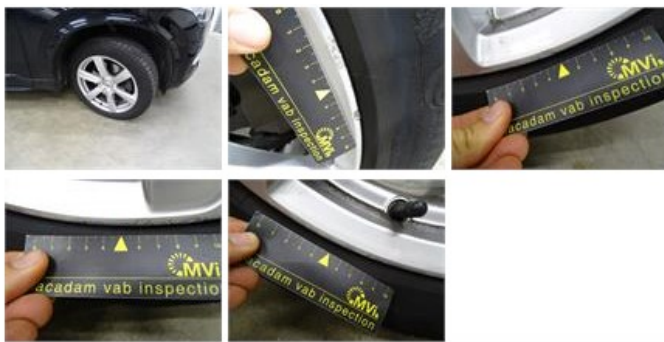
Total cost ex VAT	2453,31
Roof, Scratch(es), Acceptable	0,00
<i>No pictures to display</i>	
Alloy rim F R, Scratch(es), LI - Repair and paint (complete)	95,00

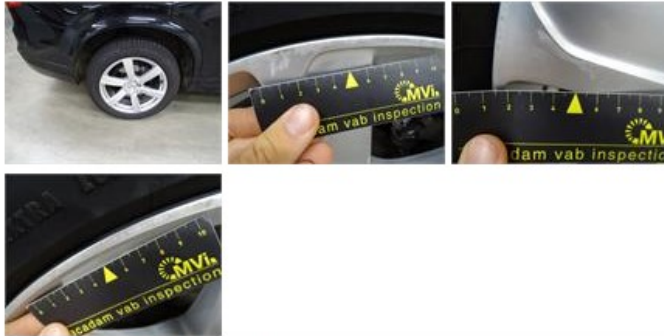
Alloy rim R R, Scratch(es), LI - Repair and paint (complete) 95,00

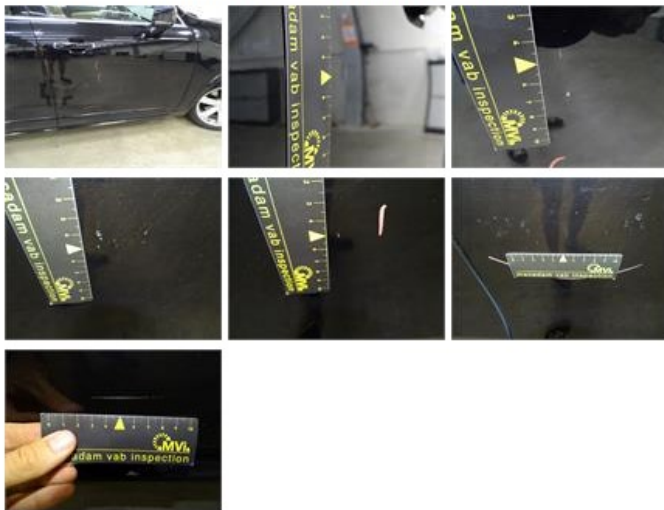
Door F R, Dent(s) and scratch(es), LI - Repair and paint (complete) 382,02

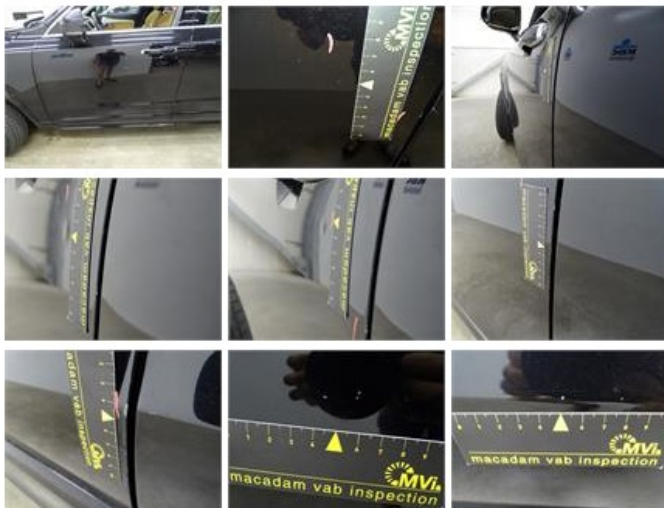
Door F L, Dent(s) and scratch(es), LI - Repair and paint (complete) 382,02

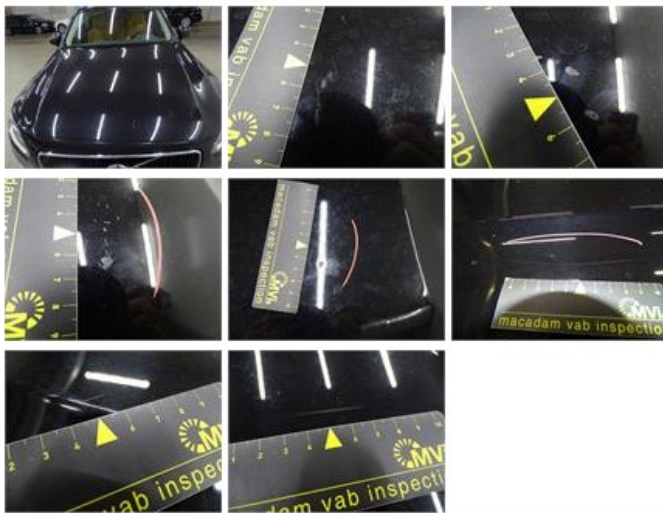
Bonnet, Dent(s) and scratch(es), LI - Repair and paint (complete)

348,09

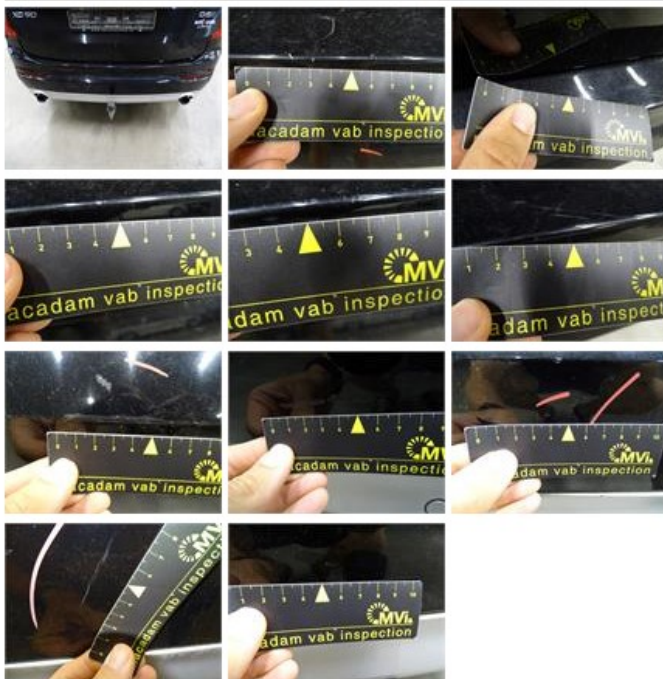
Bumper R, Scratch(es), LI - Repair and paint (complete)

254,16

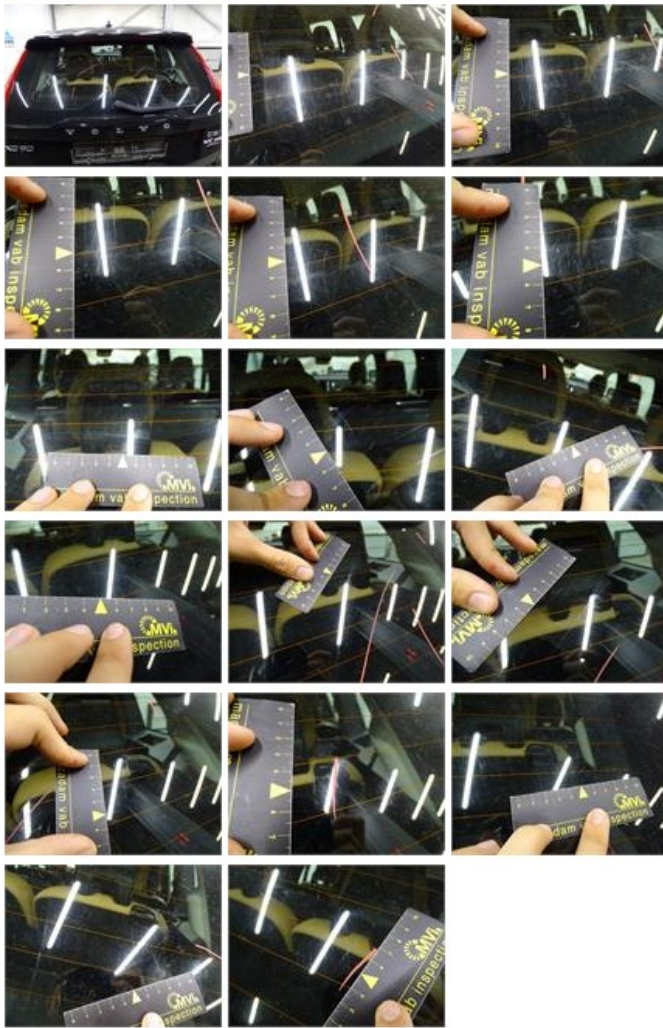
Rear window, Scratch(es), E - Replace

420,00
