VOLKSWAGEN Polo: 1GUH320

| Vinnnumber: | WVWZZZ6RZEY250656 | Versionname: | POLO BER BlueMotion DPF 89g 75PK |

Limited Technical Inspection

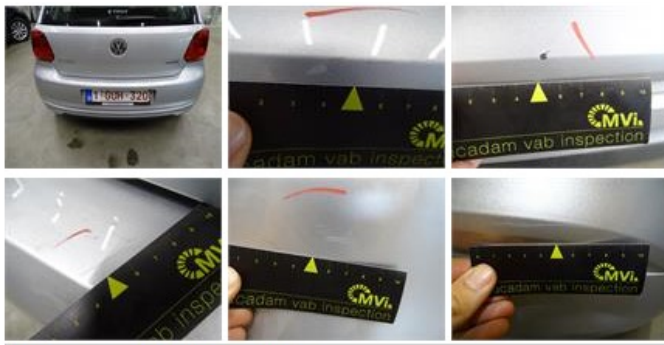
| Bumper R, Scratch(es), LI - Repair and paint (complete) | 169,44 |

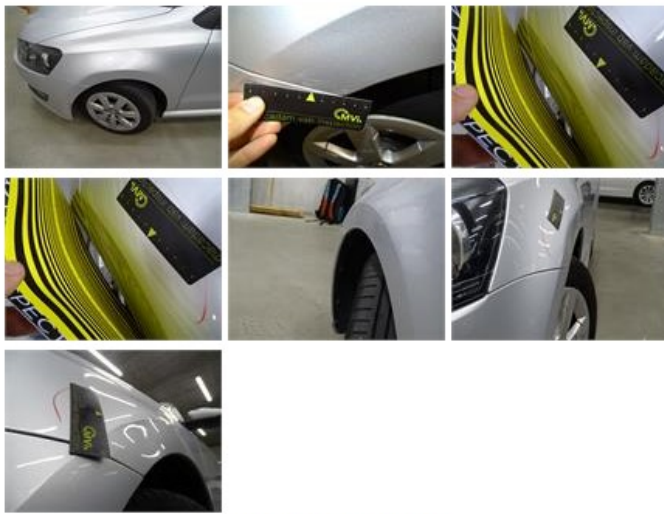
Wing F L, Dent(s) and scratch(es), LI - Repair and paint (complete)

176,14

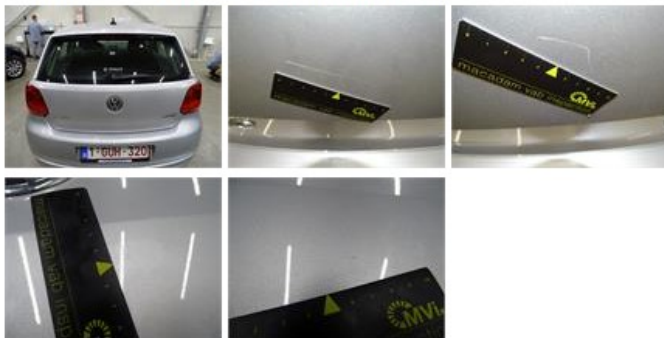
Tailgate, Scratch(es), LI - Repair and paint (complete)

241,34

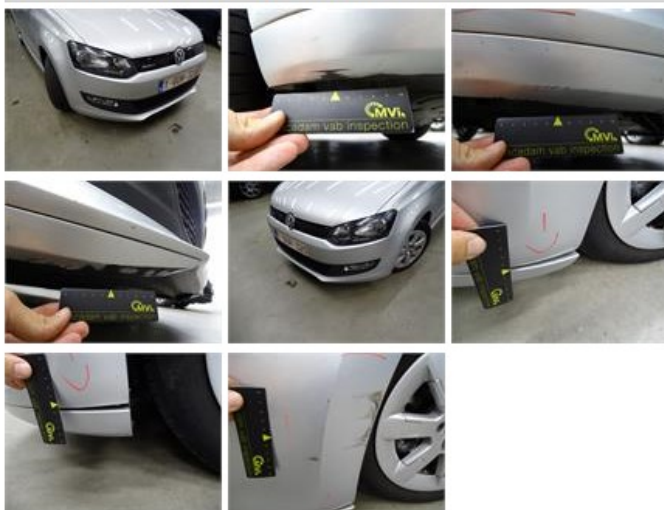
Bumper F, Scratch(es), LI - Repair and paint (complete)

169,44
