VOLKSWAGEN GOLF VII: 1KET267

Limited Technical Inspection

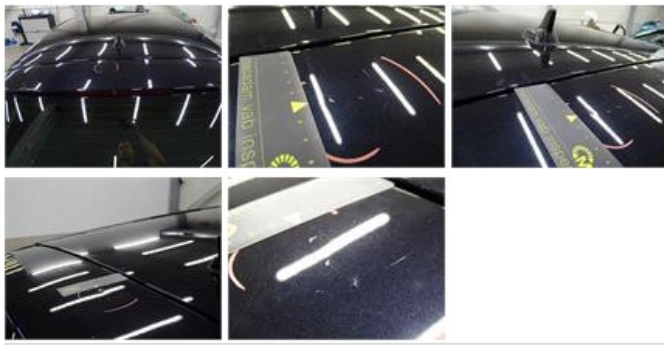
Total cost ex VAT	2405,92
Rear spoiler, Dent(s) and scratch(es), LI - Repair and paint (complete)	115,56

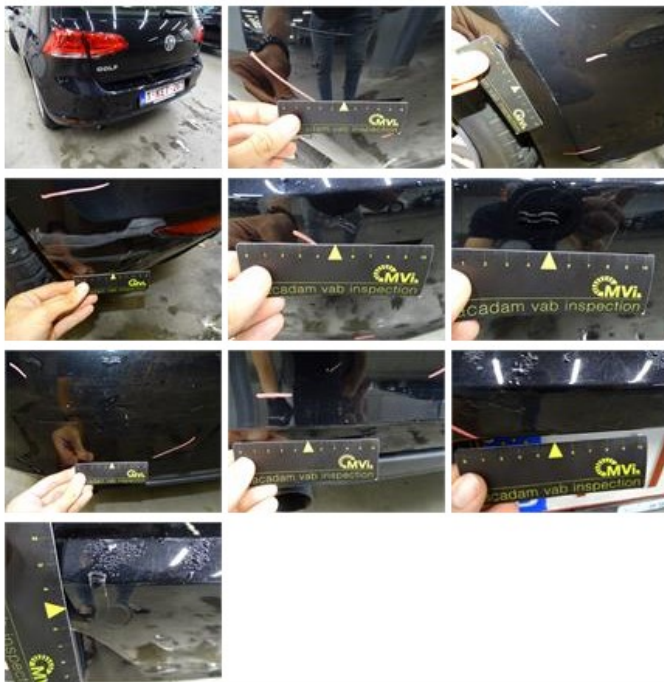
Bumper R, Scratch(es), LI - Repair and paint (complete) 211,80

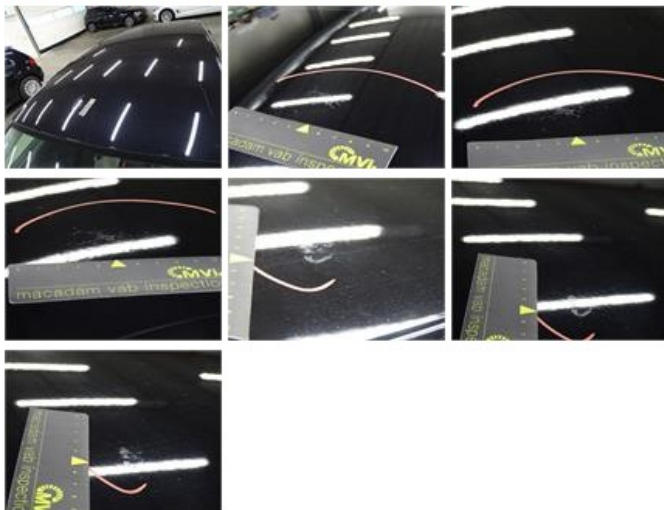
Roof, Chemical polution, LI - Repair and paint (complete) 481,50

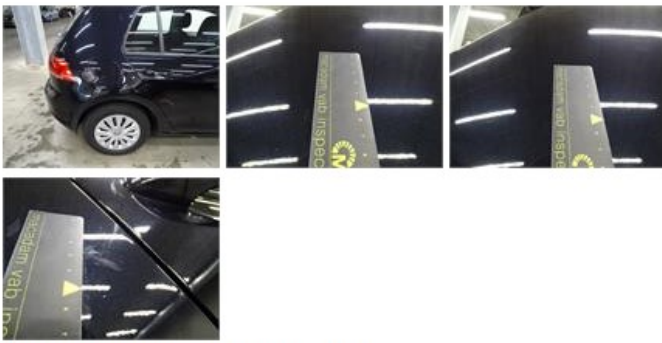
Wing R R, Bad repair, Acceptable 0,00

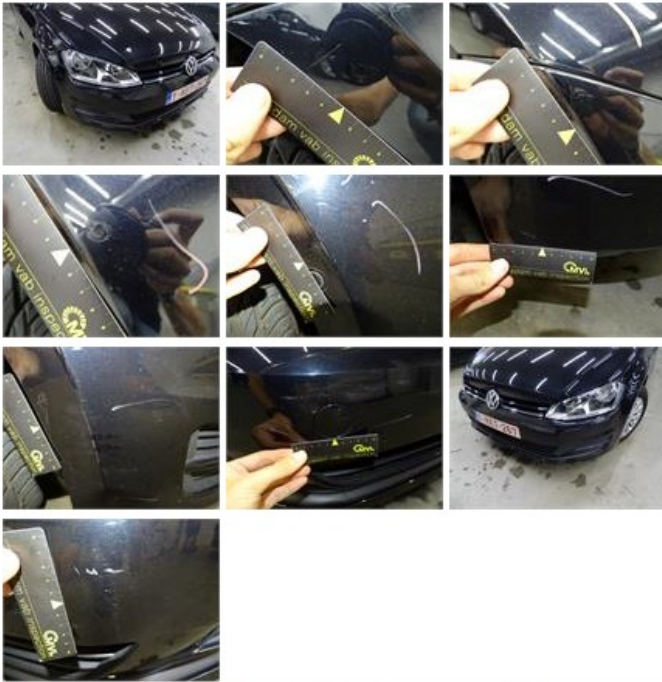
Bumper F, Scratch(es), LI - Repair and paint (complete) 211,80

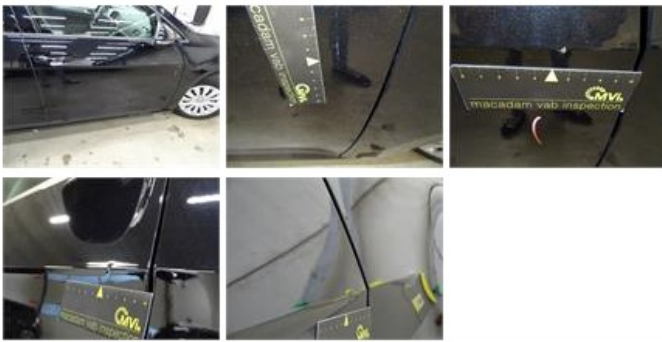
Door F R, Dent(s) and scratch(es), LI - Repair and paint (complete) 318,35

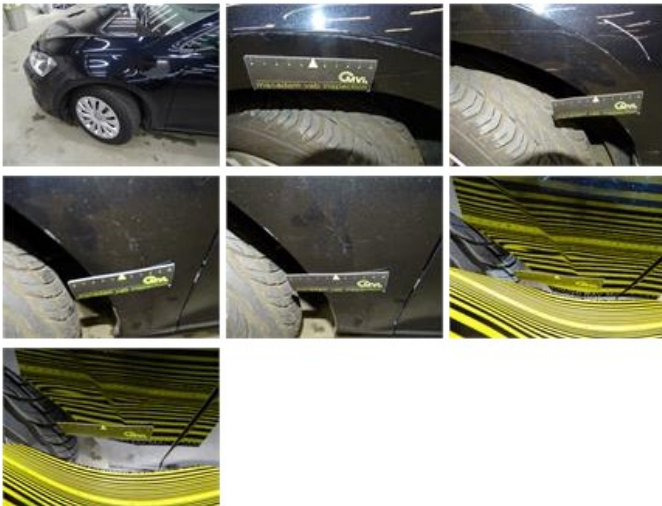
Wing F L, Dent(s) and scratch(es), LI - Repair and paint (complete) 220,18

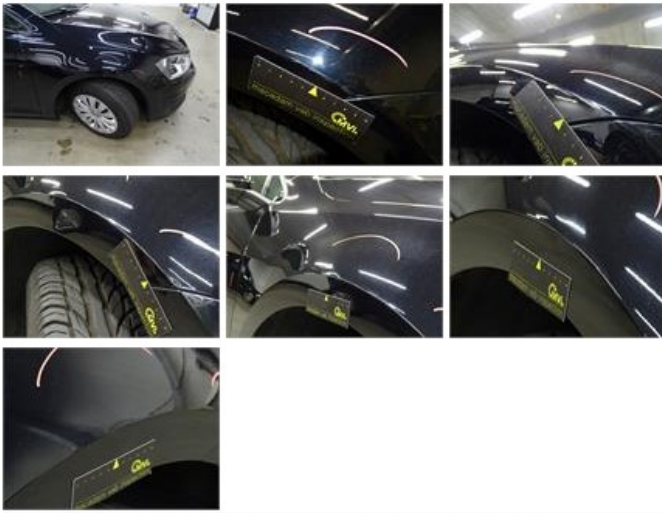
Wing F R, Dent(s) and scratch(es), LI - Repair and paint (complete)

220,18

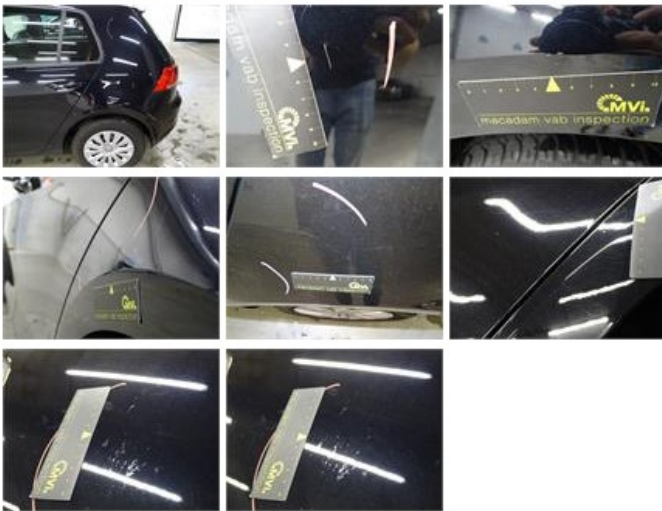
Wing R L, Dent(s) and scratch(es), LI - Repair and paint (complete)

308,20
