LU Audi a3 Sportback: NK9388

Limited Technical Inspection

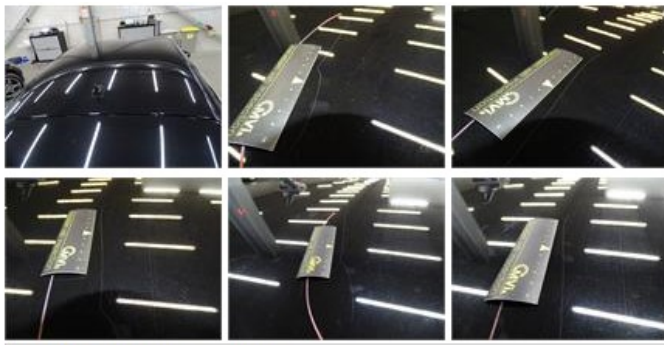
Total cost ex VAT	2326,91
Roof, Scratch(es), LI - Repair and paint (complete)	481,50

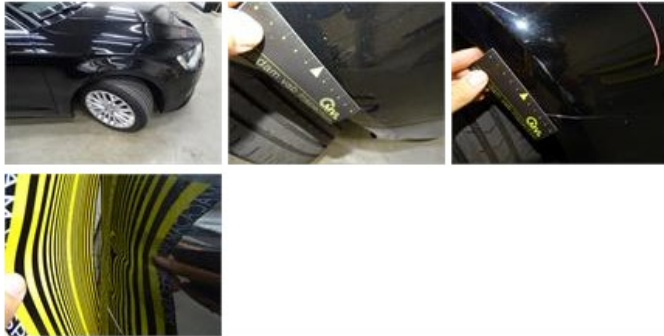
Wing F R, Dent(s) and scratch(es), LI - Repair and paint (complete) 220,18

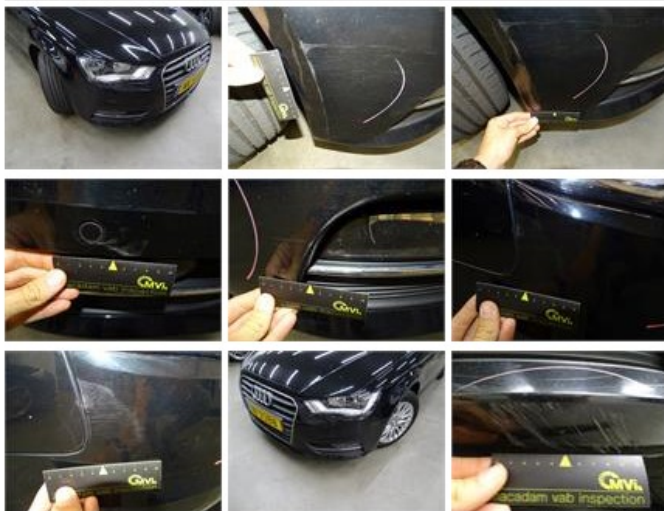
Bumper F, Scratch(es), LI - Repair and paint (complete) 211,80

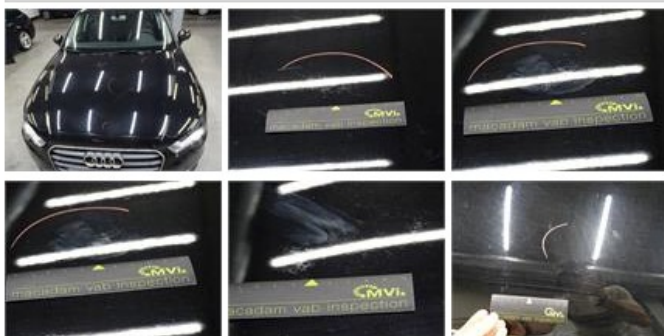
Bonnet, Chemical polution, LI - Repair and paint (complete) 290,08

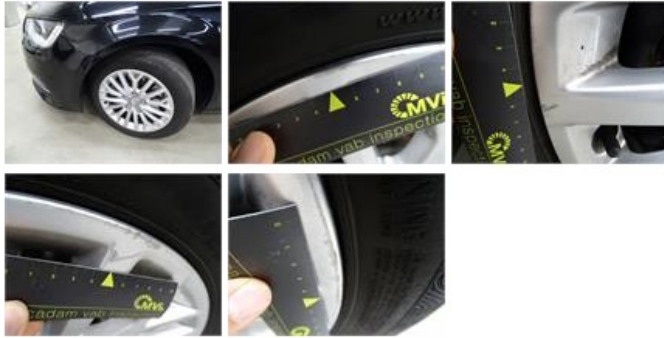
Alloy rim F L, Scratch(es), LI - Repair and paint (complete)

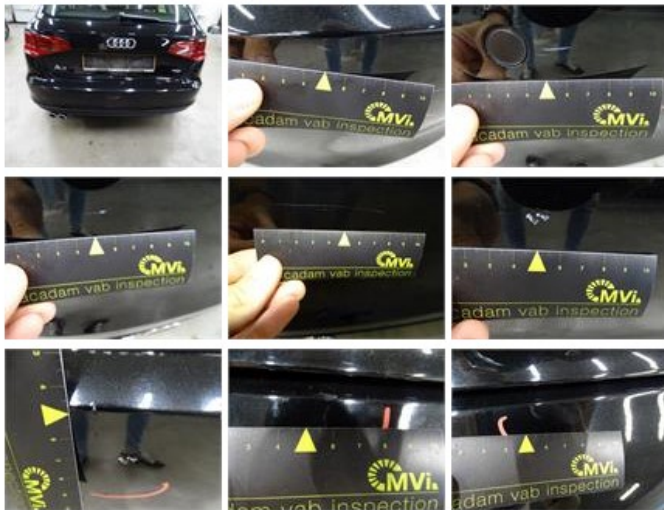
Bumper R, Scratch(es), LI - Repair and paint (complete)

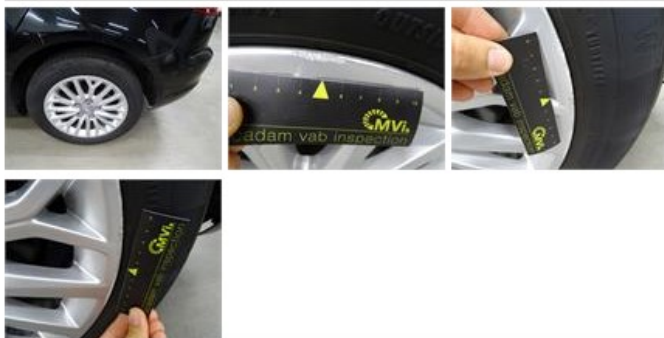
Alloy rim R L, Scratch(es), LI - Repair and paint (complete)

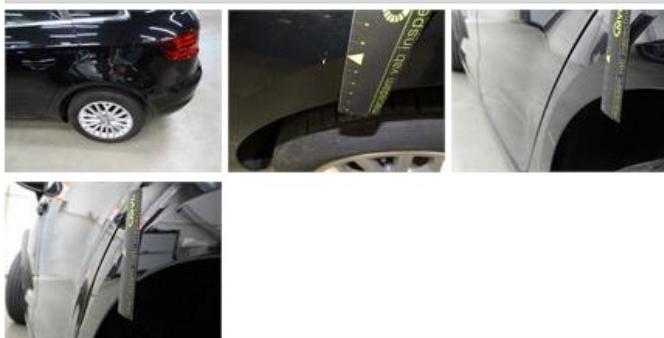
Wing R L, Dent(s) and scratch(es), LI - Repair and paint (complete)

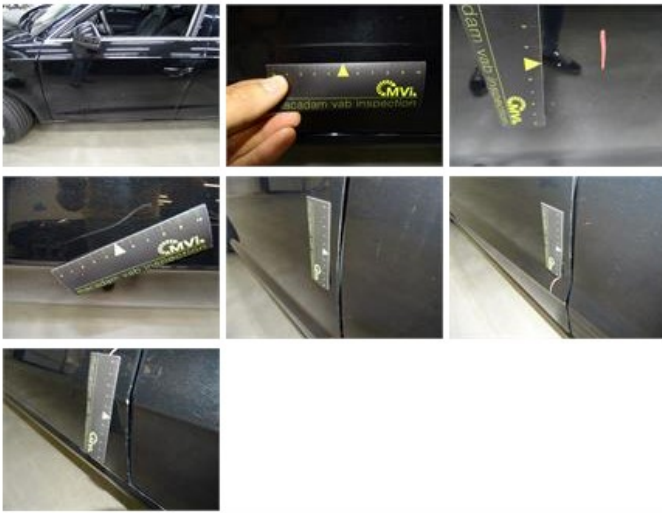
Door F L, Scratch(es), LI - Repair and paint (complete)
