SKODA Octavia: 1HLZ136

Limited Technical Inspection

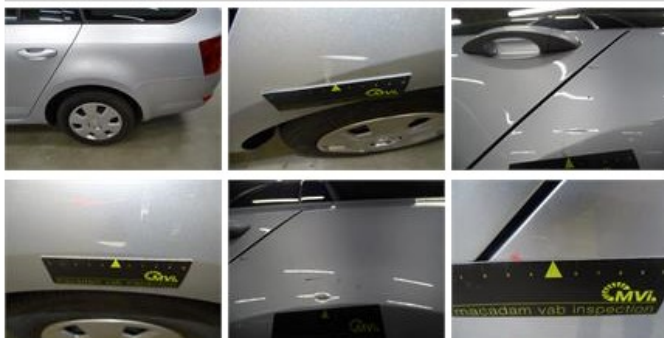
Wing R L, Dent(s) and scratch(es), LI - Repair and paint (complete)

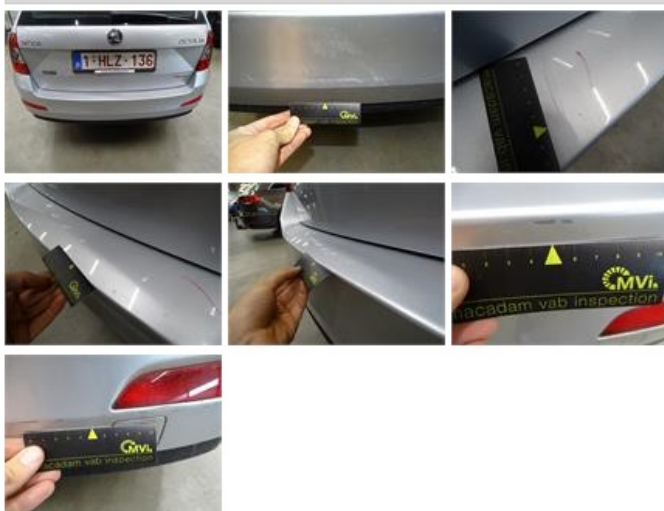
Bumper R, Dent(s) and scratch(es), LI - Repair and paint (complete)

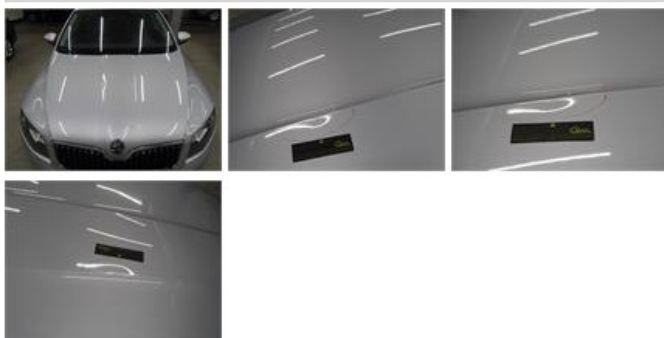
Bonnet, Dent(s), PDR - Paintless dent repair
