VOLKSWAGEN GOLF VII: 1LDK620

Limited Technical Inspection

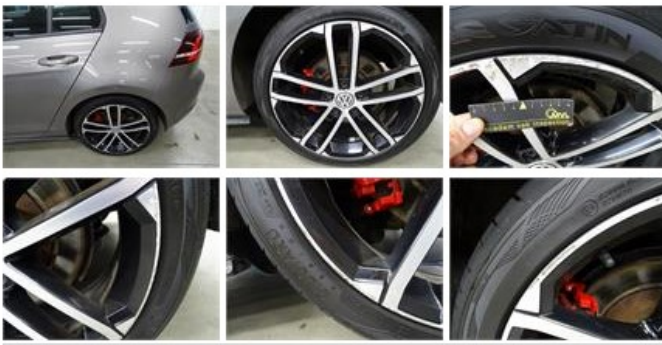
Alloy rim R L polished, Scratch(es), LI - Repair and paint (complete)	95,00
---	--------------

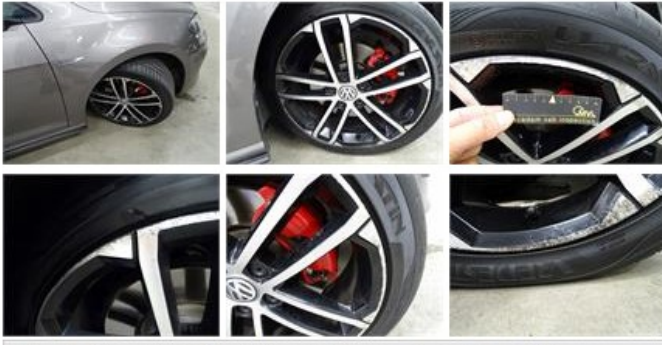
Alloy rim F R polished, Scratch(es), LI - Repair and paint (complete) 95,00

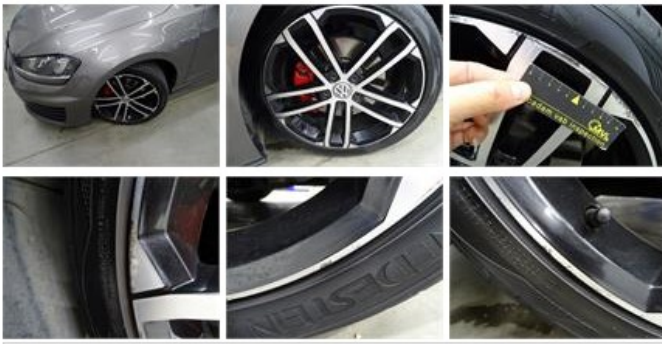
Alloy rim F L polished, Scratch(es), LI - Repair and paint (complete) 95,00

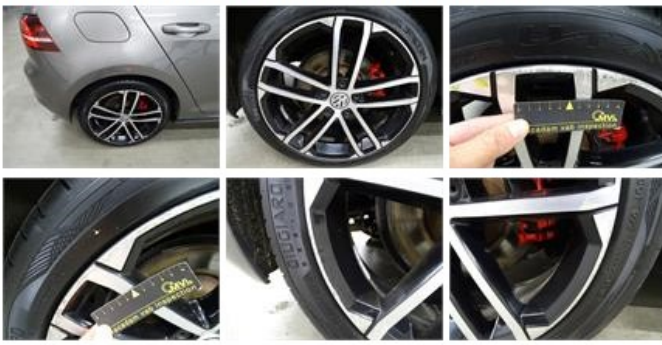
Alloy rim R R polished, Scratch(es), LI - Repair and paint (complete) 95,00
