BMW 5: AD7191			
Vinnumber:	<b>WBA5L51030D679535</b>	Versionname:	<b>5 TOURING 520dXA 184PK Aut.</b>
First Registrationdate:	<b>4/08/2014</b>	Fiscalpower:	
Expertise Mileage:	<b>139504</b>	Power Kw:	<b>140</b>
Bodytype:	<b>Break</b>	Body color:	<b>Dark Blue</b>
Gearbox:	<b>Automatic</b>	Paint type:	<b>Metalic</b>
Transmission:		Rims summer:	<b>Aluminium</b>
Fueltype:	<b>Diesel</b>	Oil level:	<b>OK</b>
Battery functioning:	<b>Yes</b>	Parking lot:	<b>2412</b>
Number of doors:	<b>5</b>		
Number of seats:	<b>5</b>		
Number head rests:	<b>5</b>		
Rims summer:	<b>Aluminium</b>		
Category:	<b>Passenger Car</b>		
Oil level:	<b>OK</b>

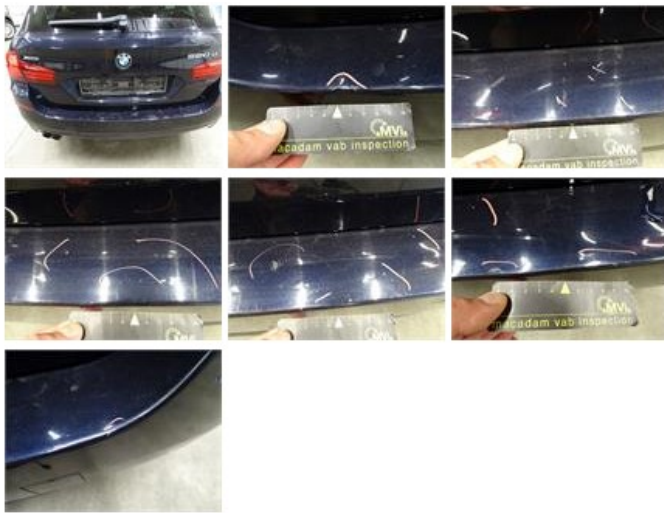
Total cost ex VAT	<b>1765,76</b>
Bumper R, Dent(s) and scratch(es), LI - Repair and paint (complete)	<b>254,16</b>

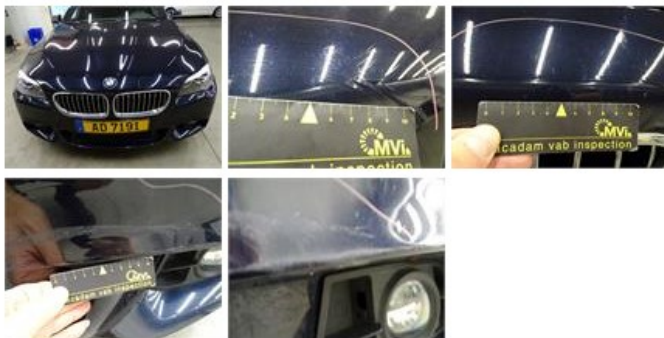
Bumper F, Dent(s) and scratch(es), LI - Repair and paint (complete) 254,16

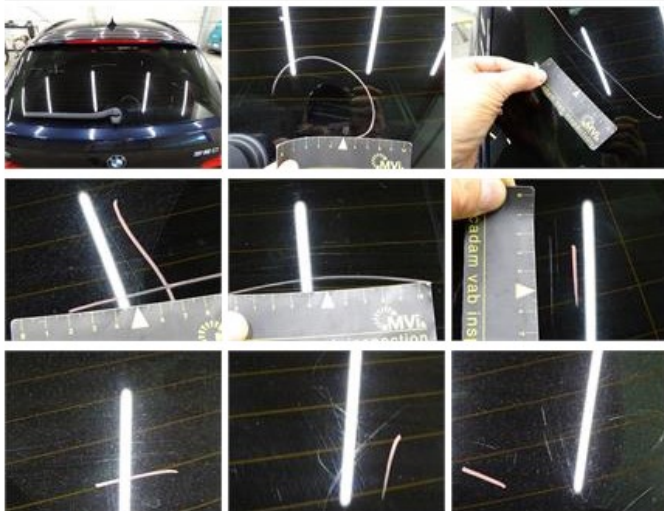
Rear window, Scratch(es), E - Replace 420,00

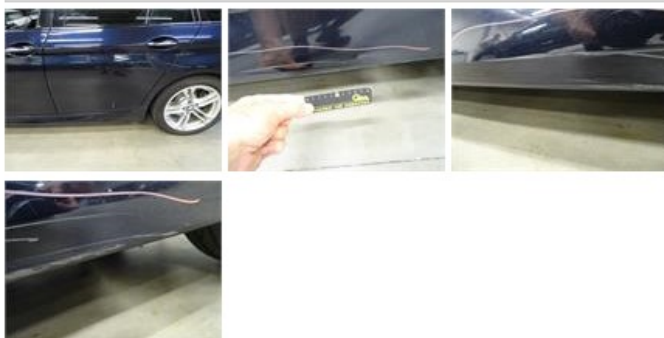
Sill outer L, Scratch(es), LI - Repair and paint (complete) 372,60
