**SKODA FABIA COMBI: 1NNU402**

**Limited Technical Inspection**

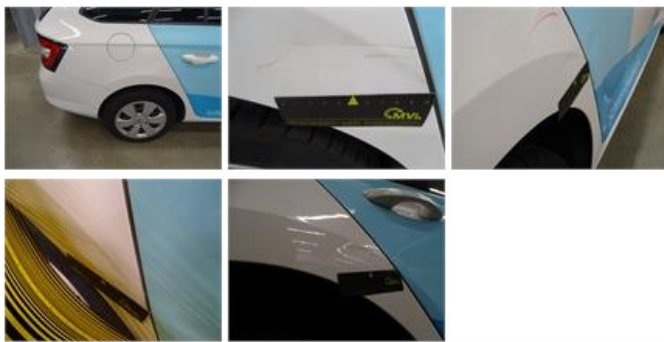
Total cost ex VAT	2464,90
Tailgate, Dent(s) and scratch(es), Acceptable	0,00
<i>No pictures to display</i>	
Rear spoiler, Dent(s), Acceptable	0,00
<i>No pictures to display</i>	
Wing R R, Dent(s) and scratch(es), LI - Repair and paint (complete)	246,56

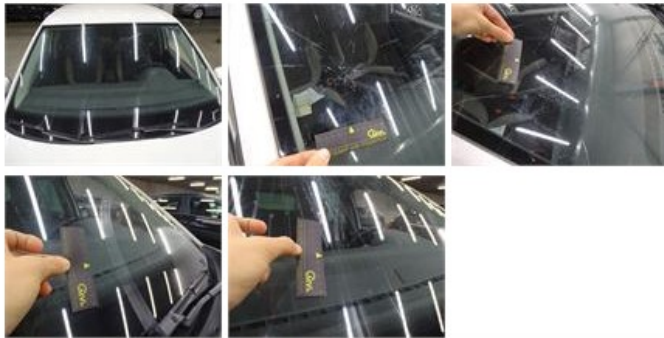
Windscreen, Crack, E - Replace

413,76

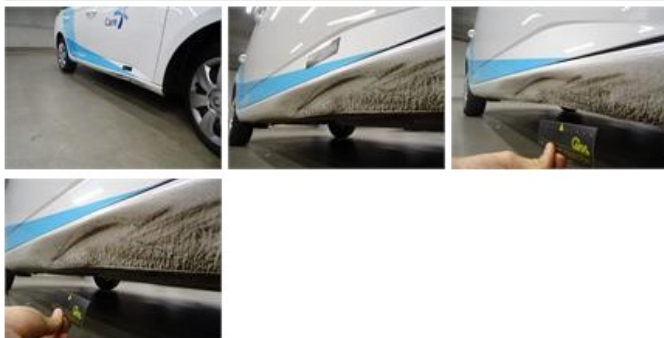
Sill outer R, Dent(s) and scratch(es), LI - Repair and paint (complete)

296,40

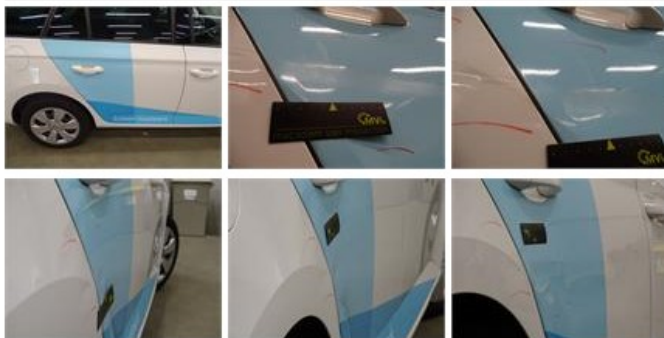
Door R R, Dent(s), LI - Repair and paint (complete)

254,68

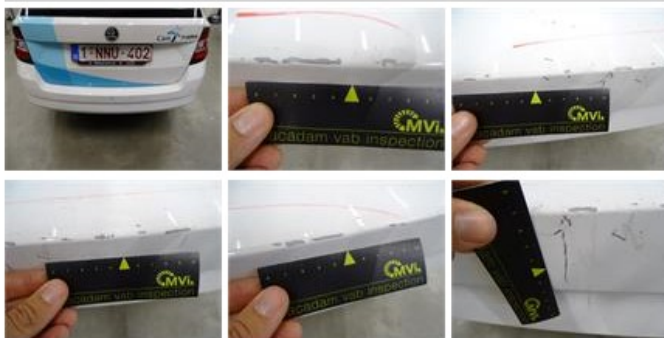
Bumper R, Scratch(es), LI - Repair and paint (complete)

169,44

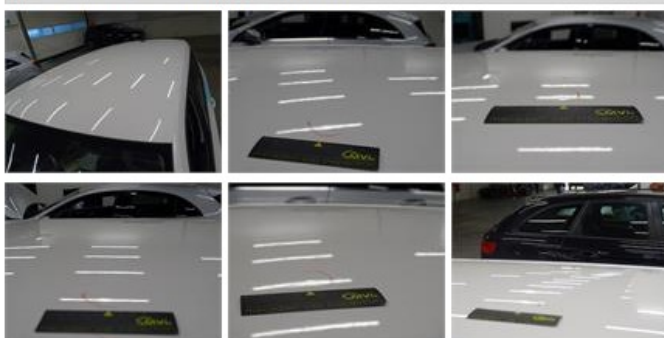
Roof, Dent(s), PDR - Paintless dent repair

201,60

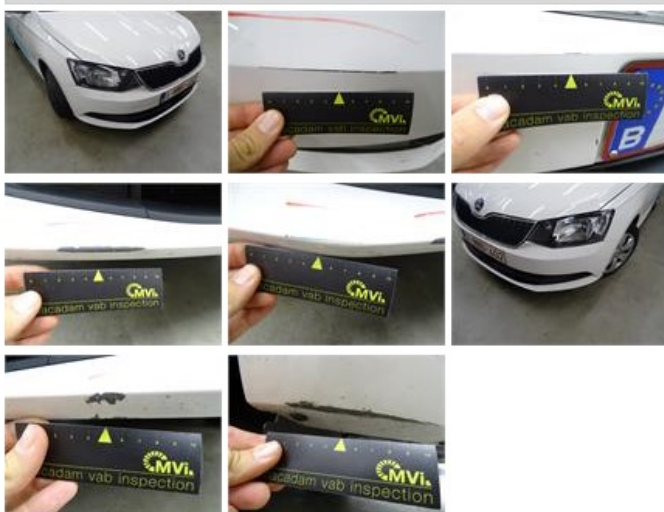
Bumper F, Scratch(es), LI - Repair and paint (complete)

169,44

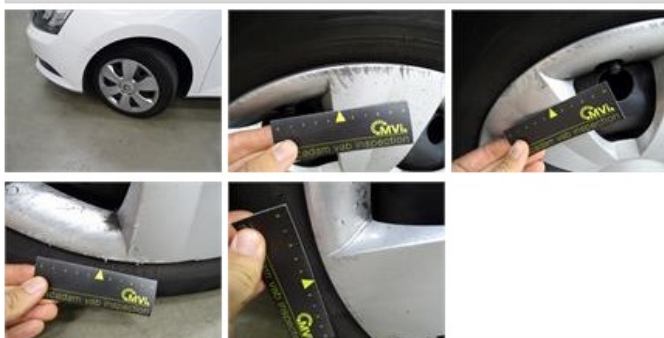
Wheel cover F L, Scratch(es), E - Replace

24,00

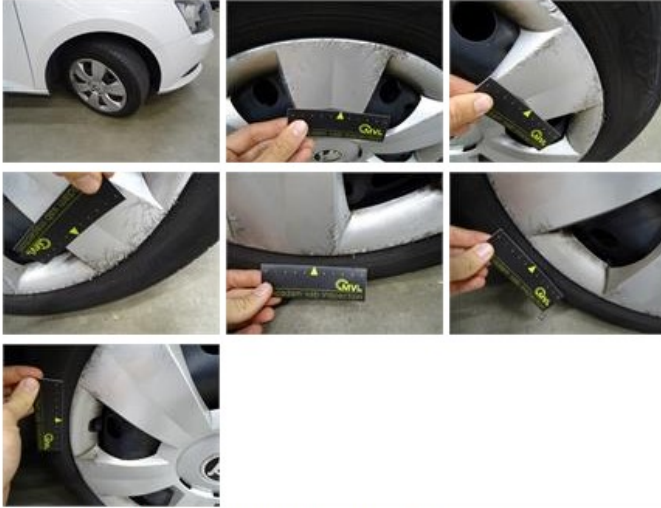
Wheel cover F R, Scratch(es), E - Replace

24,00

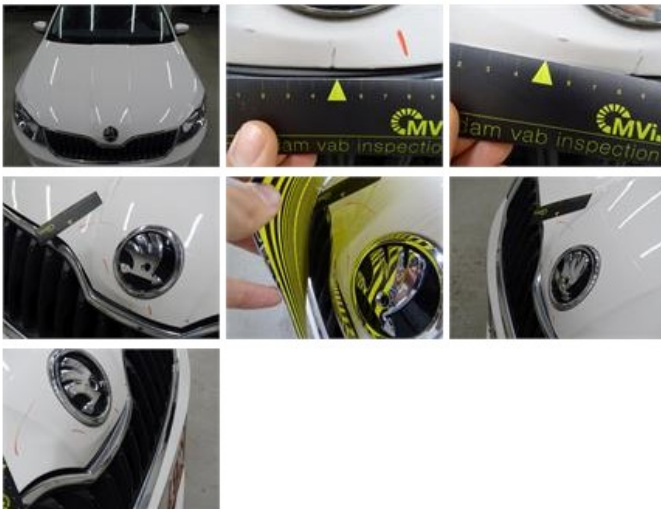
Bonnet, Dent(s) and scratch(es), LI - Repair and paint (complete)

232,06
