<b>MINI : 1PCU612</b>			
Vinnumber:	<b>WMWXN110503B51631</b>	Versionname:	<b>1.5 ONE D</b>
First Registrationdate:	<b>7/06/2016</b>	Fiscalpower:	
Expertise Mileage:	<b>110013</b>	Power Kw:	<b>70</b>
Bodytype:	<b>Hatchback</b>	Body color:	<b>Black</b>
Gearbox:	<b>MAN 6 VIT</b>	Paint type:	<b>Metallic</b>
Transmission:		Rims summer:	<b>Aluminium</b>
Fueltype:	<b>Diesel</b>	Oil level:	<b>OK</b>
Battery functioning:	<b>Yes</b>	Parking lot:	<b>1205</b>
Number of doors:	<b>3</b>		
Number of seats:	<b>5</b>		
Number head rests:	<b>5</b>		
Rims summer:	<b>Aluminium</b>		
Category:	<b>Passenger Car</b>		
Oil level:	<b>OK</b>		
Registration Certificate Car (BE):	<b>Yes</b>

<b>Limited Technical Inspection</b>			
Airco functioning	<b>OK</b>	Battery functioning	<b>Yes</b>
Tires wear profile	<b>OK</b>	Power steering	<b>Yes</b>
Idle position	<b>OK</b>	Sound engine	<b>OK</b>
Engine startingtime	<b>OK</b>	Clutch test	<b>OK</b>
Exhaust gass	<b>OK</b>	Wiper fluid level	<b>OK</b>
Handbrake	<b>OK</b>	Transmission	<b>OK</b>
		Lighting	<b>OK</b>
		Wiperblades	<b>OK</b>

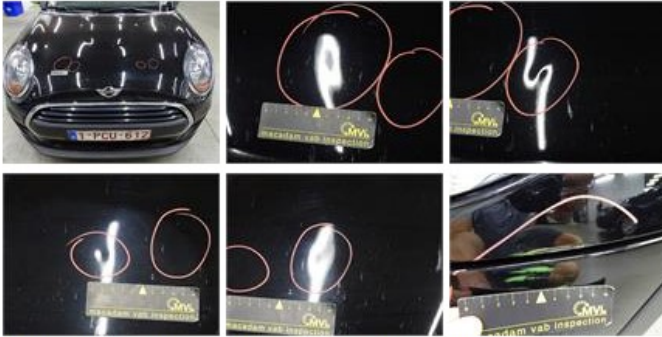
Bonnet, Dent(s) and scratch(es), LI - Repair and paint (complete) 290,08

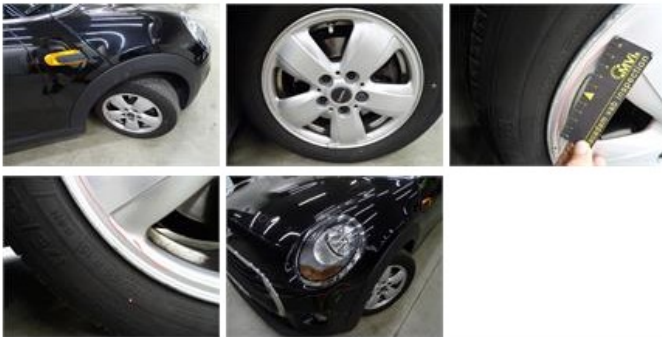
Alloy rim F R, Scratch(es), LI - Repair and paint (complete) 95,00

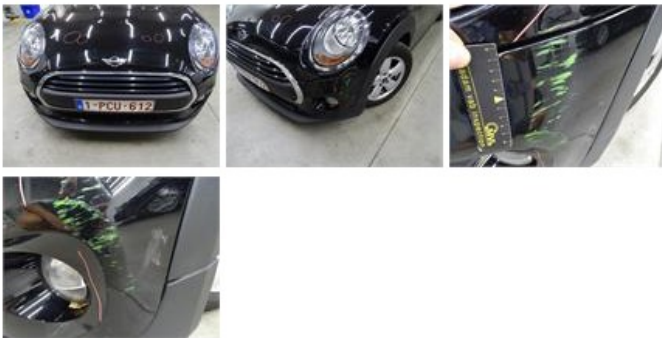
Bumper F, Scratch(es), LI - Repair and paint (complete) 211,80
