VOLVO V60: 1LTN027

Limited Technical Inspection

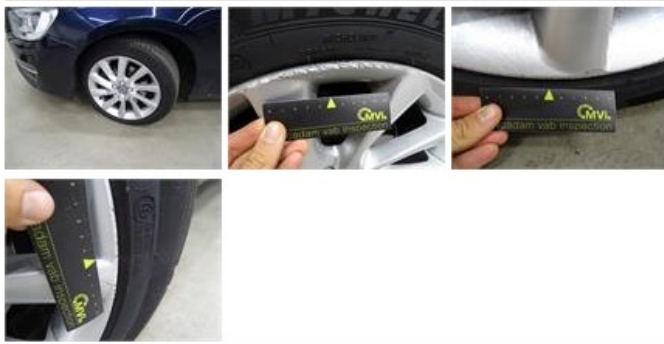
Alloy rim F L, Scratch(es), LI - Repair and paint (complete)	95,00
--	--------------

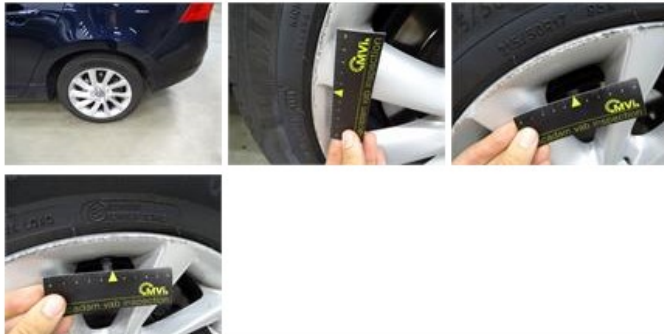
Alloy rim R L, Scratch(es), LI - Repair and paint (complete) 95,00

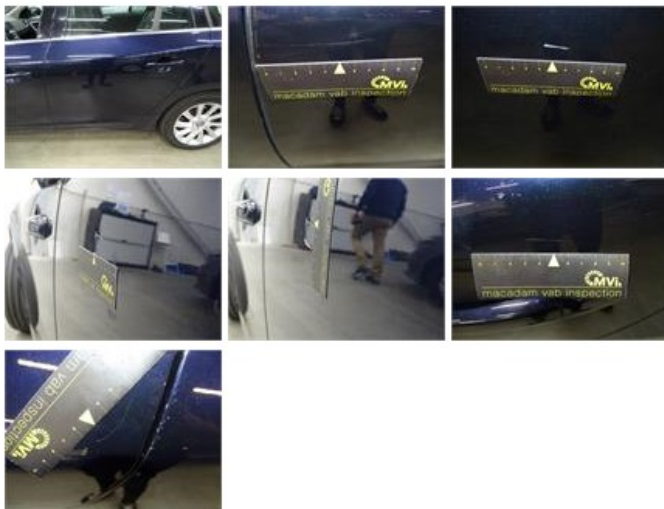
Door R L, Dent(s) and scratch(es), LI - Repair and paint (complete) 318,35

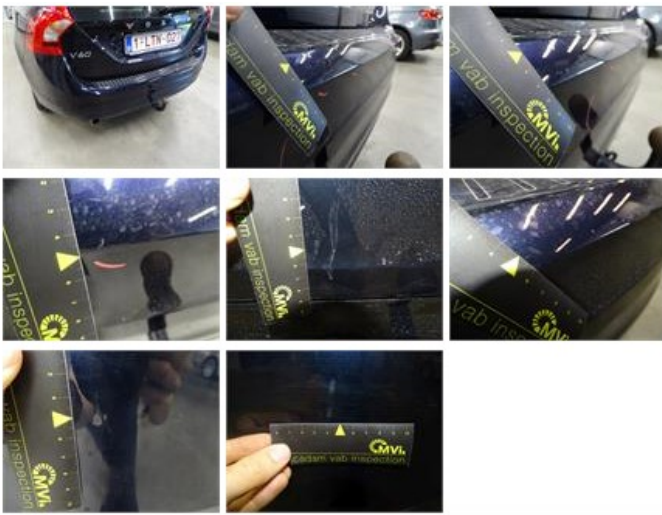
Bumper R, Dent(s) and scratch(es), LI - Repair and paint (complete) 211,80

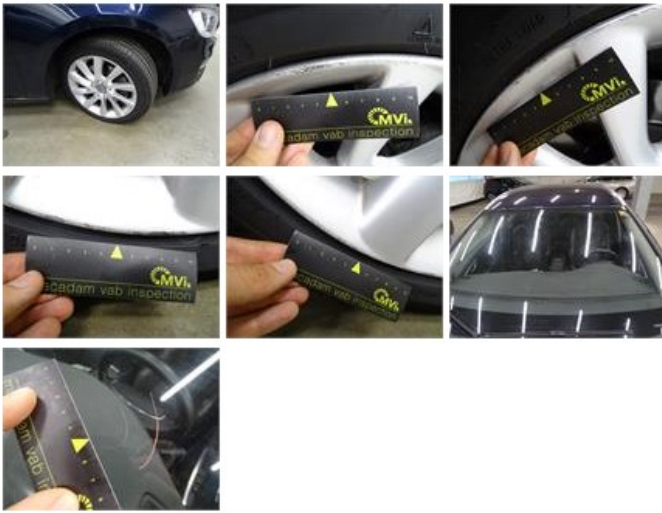
Alloy rim F R, Scratch(es), LI - Repair and paint (complete) 95,00
