VOLVO XC90: FV2310

Limited Technical Inspection

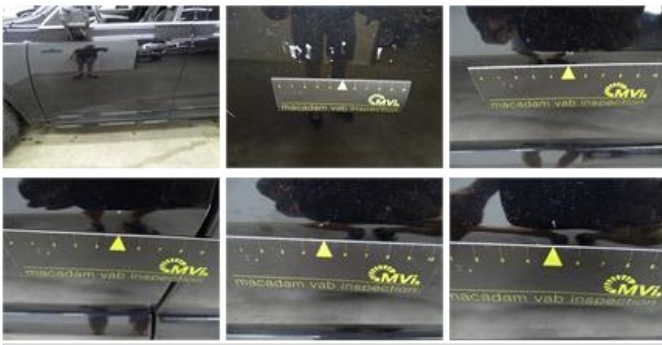
Total cost ex VAT	2599,81
Door F L, Scratch(es), LI - Repair and paint (complete)	382,02

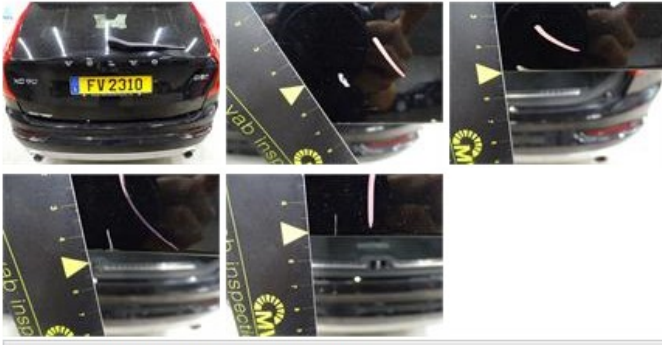
Tailgate, Scratch(es), LI - Repair and paint (complete) 362,02

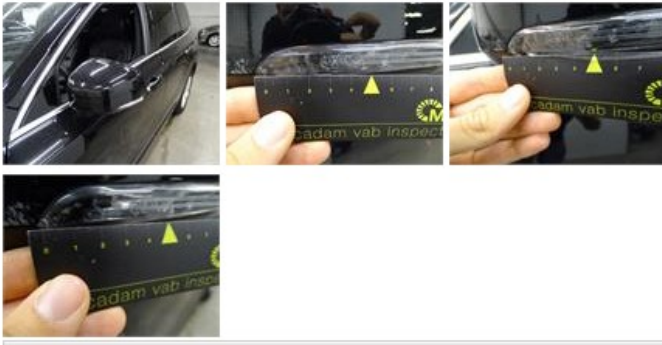
Mirror side blinker L, Scratch(es), E - Replace 31,20

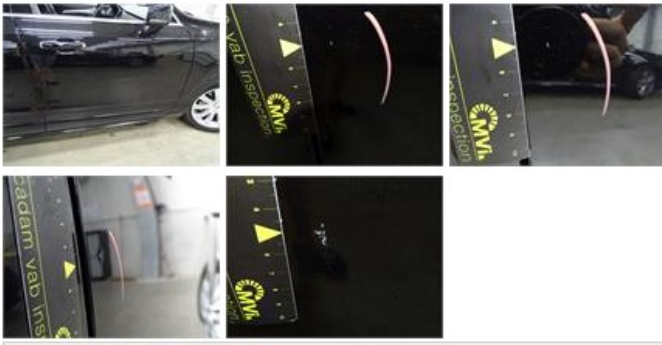
Door F R, Dent(s) and scratch(es), LI - Repair and paint (complete) 382,02

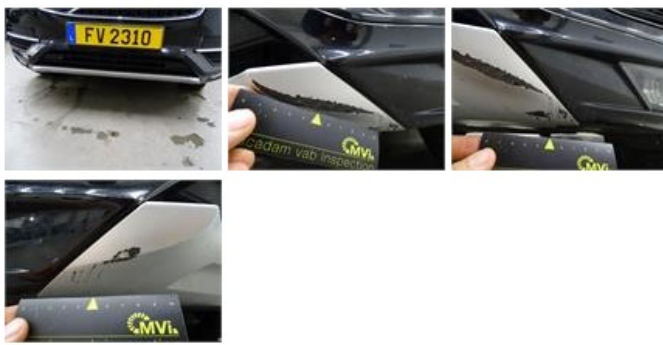
Bumper spoiler F, Scratch(es), E - Replace 48,00

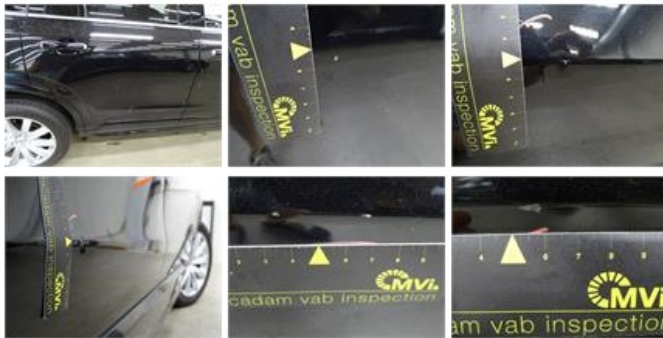
Door R R, Dent(s) and scratch(es), LI - Repair and paint (complete) 382,02

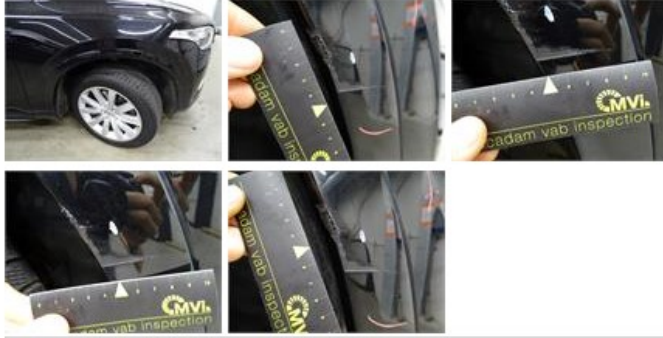
Wing moulding F R, Deformed / Strained, Le - Replace and paint 120,00

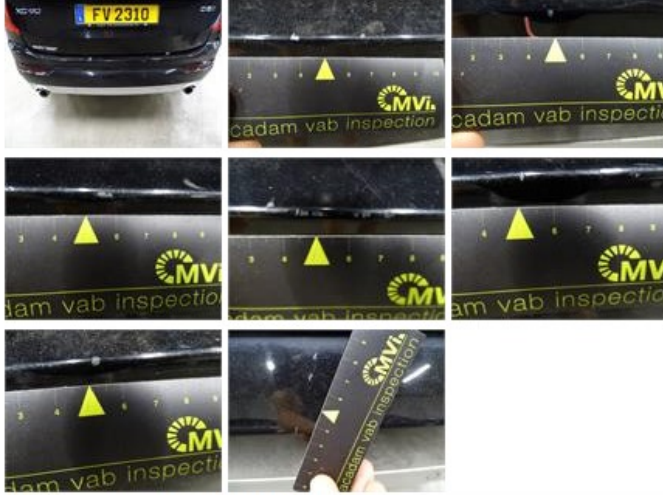
Bumper R, Scratch(es), LI - Repair and paint (complete) 254,16
