BMW 3 GRAN TURISMO: 1KTK605

| Vinnumber: | WBA3Y11050GD87114 | Versionname: | 2.0 318D (100KW) GRAN TURISMO |

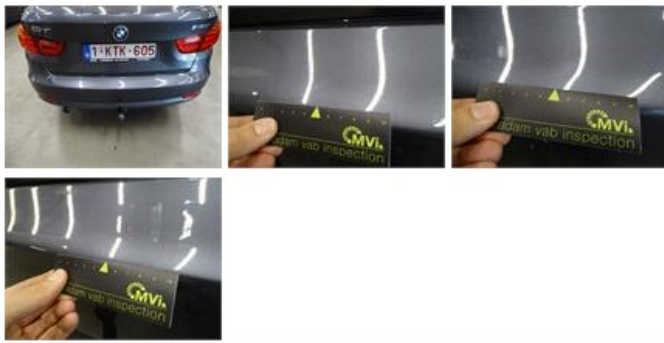
| Bumper R, Bad repair, Acceptable | 0,00 |

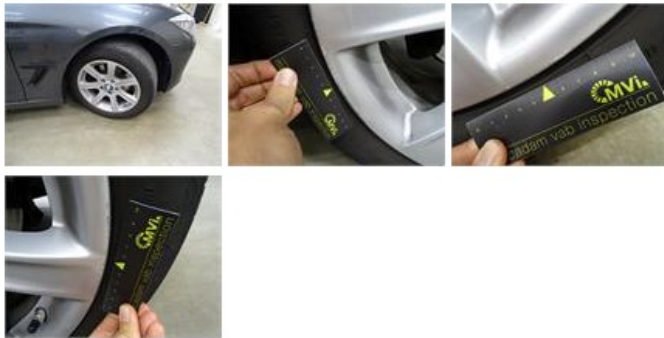
Alloy rim F R, Scratch(es), LI - Repair and paint (complete) 95,00

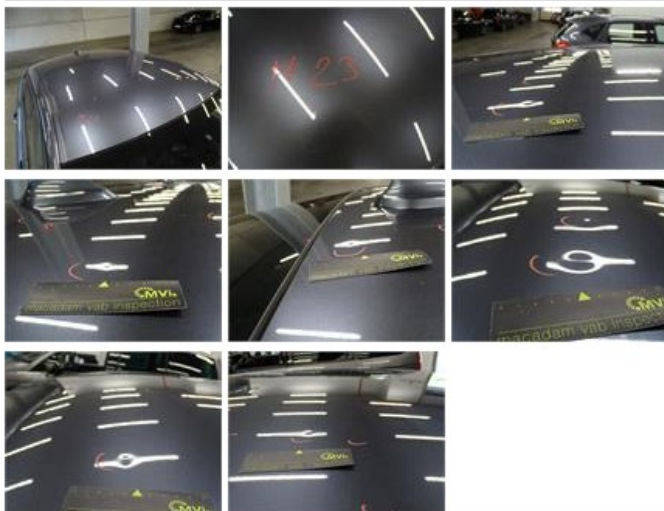
Roof, Hail damage, PDR - Hail 0,00
