BMW 3 BERLINE: 1NTY319

Limited Technical Inspection

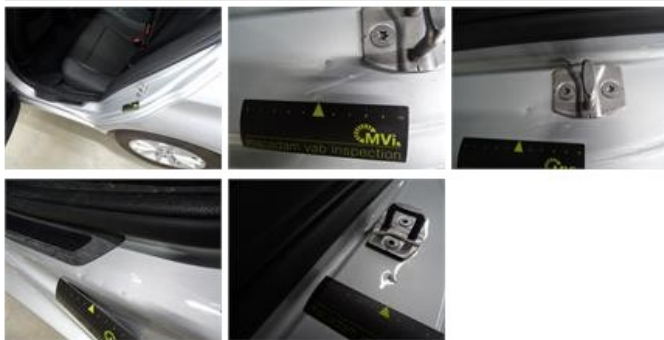
Rocker panel inner R L, Dent(s), LI - Repair and paint (complete)

115,56

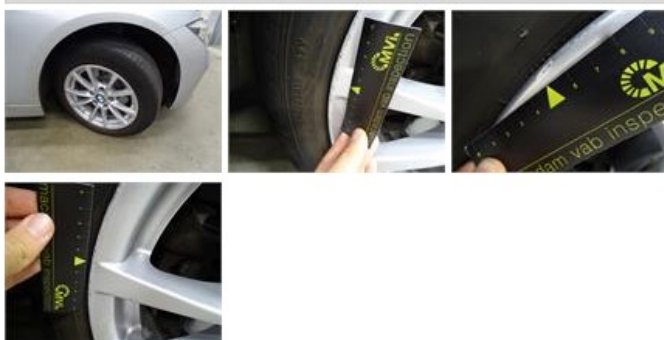
Alloy rim F R, Scratch(es), LI - Repair and paint (complete)

95,00

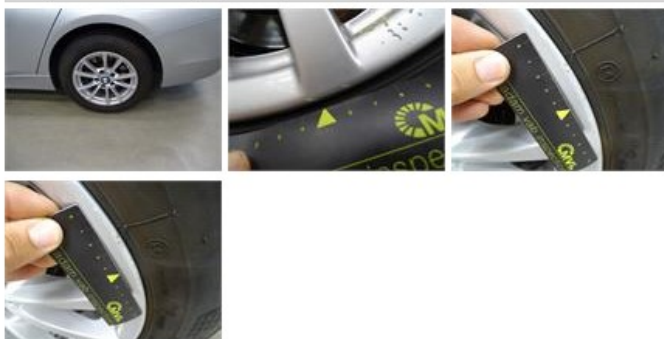
Alloy rim R L, Scratch(es), LI - Repair and paint (complete)

95,00

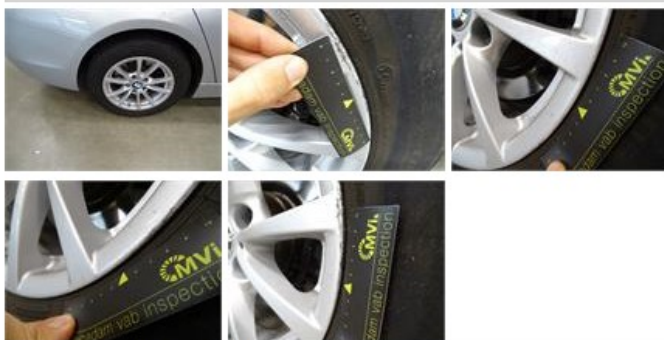
Alloy rim R R, Scratch(es), LI - Repair and paint (complete)

95,00

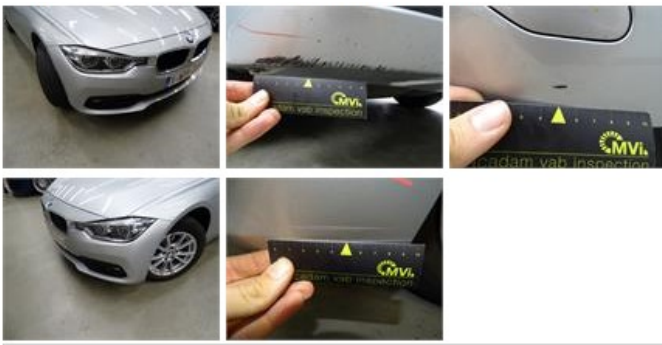
Bumper F, Scratch(es), LI - Repair and paint (complete)

211,80

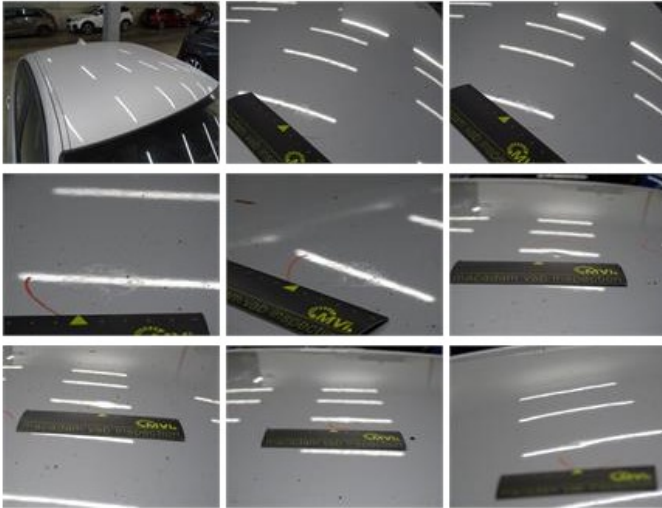
Roof, Chemical polution, LI - Repair and paint (complete) 529,50

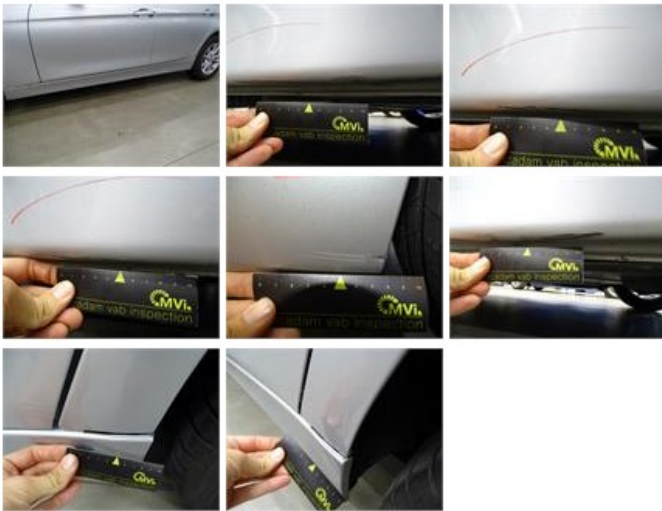
Sill outer L, Scratch(es), LI - Repair and paint (complete) 310,50
