**BMW 3 TOURING: 1LKJ953**

Vinnumber:	<b>WBA8J91010K424307</b>	Versionname:	<b>2.0 320D EFFICIENTDYN. (120KW) TOURING</b>
First Registrationdate:	<b>13/10/2015</b>	Fiscalpower:	
Expertise Mileage:	<b>167004</b>	Power Kw:	<b>120</b>
Bodytype:	<b>Break</b>	Body color:	<b>Silver</b>
Gearbox:	<b>MAN 6 VIT</b>	Paint type:	<b>Metalic</b>
Transmission:	<b>Back</b>	Rims summer:	<b>Aluminium</b>
Fueltype:	<b>Diesel</b>	Oil level:	<b>OK</b>
Battery functioning:	<b>Yes</b>	Parking lot:	<b>1508</b>
Number of doors:	<b>5</b>		
Number of seats:	<b>5</b>		
Number head rests:	<b>5</b>		
Rims summer:	<b>Aluminium</b>		
Category:	<b>Passenger Car</b>		
Oil level:	<b>OK</b>		
Registration Certificate Car (BE):	<b>Yes</b>

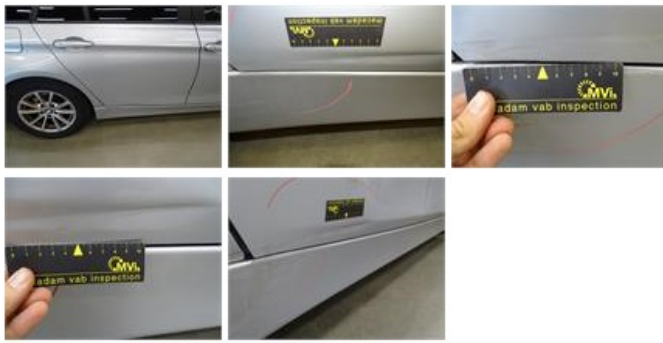
<b>Total cost ex VAT</b>	<b>2271,61</b>
<b>Door R R, Dent(s) and scratch(es), LI - Repair and paint (complete)</b>	<b>318,35</b>

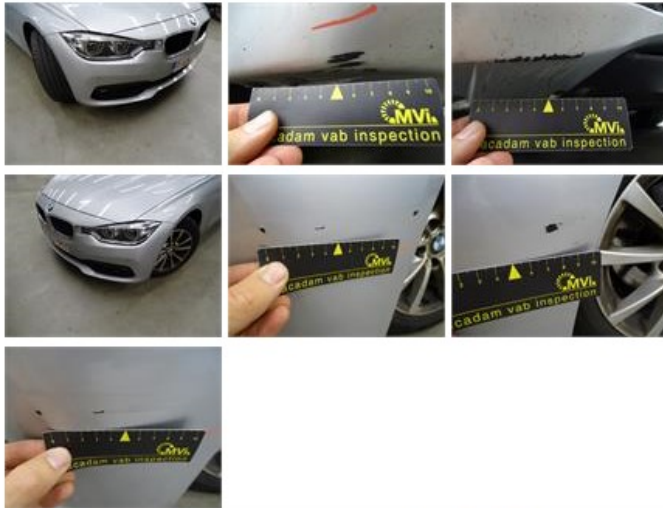
Bumper F, Scratch(es), LI - Repair and paint (complete) 211,80

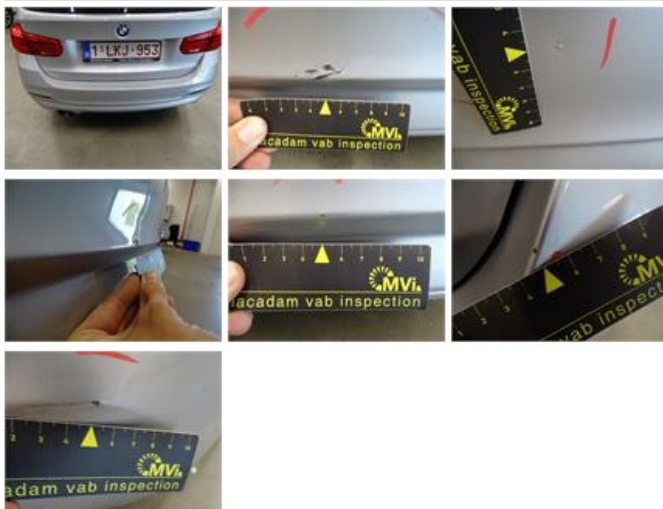
Bumper R, Dent(s) and scratch(es), LI - Repair and paint (complete) 211,80

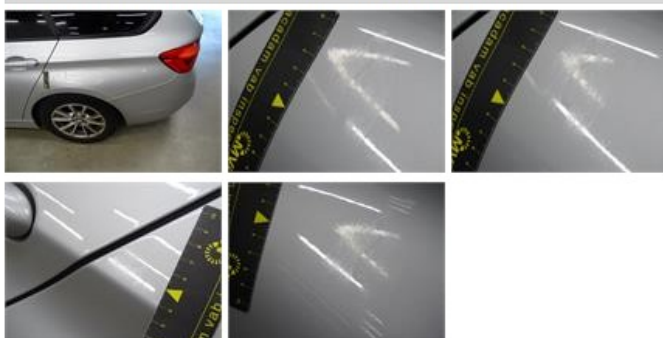
Wing R L, Chemical polution, LI - Repair and paint (complete) 308,20

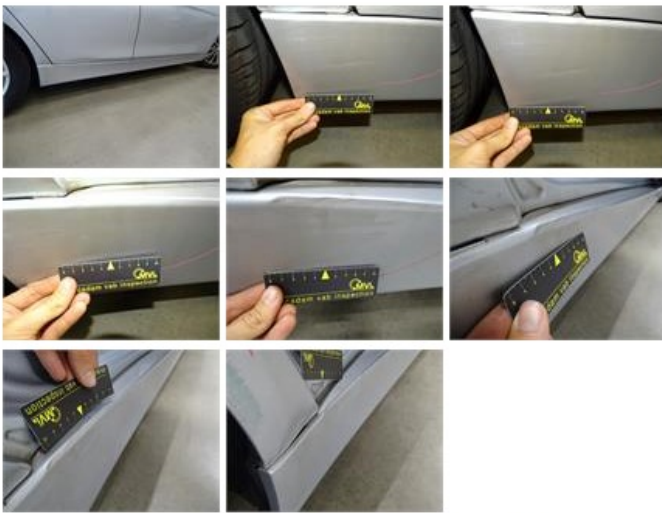
Sill outer R, Dent(s) and scratch(es), LI - Repair and paint (complete) 310,50

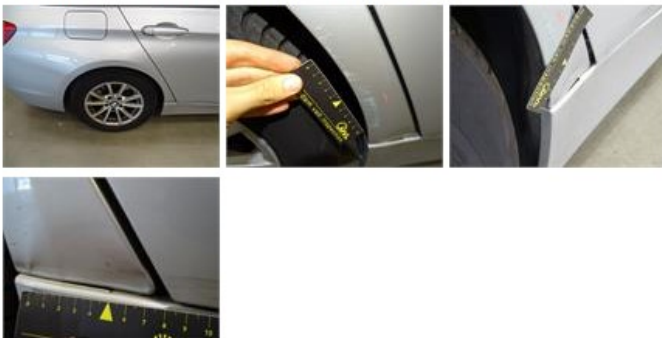
Wing R R, Dent(s) and scratch(es), LI - Repair and paint (complete) 308,20

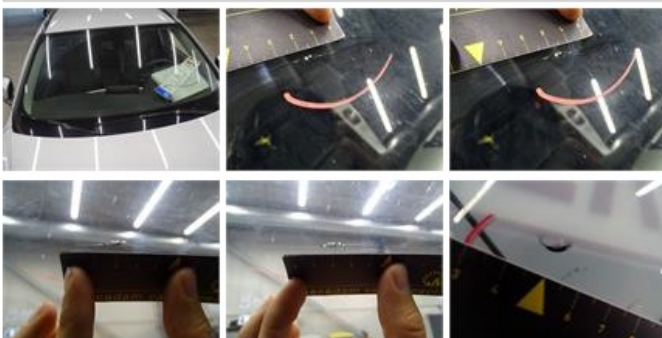
Windscreen, Stone chip(s), E - Replace 487,20
