AUDI A5: 1HFA200

Limited Technical Inspection

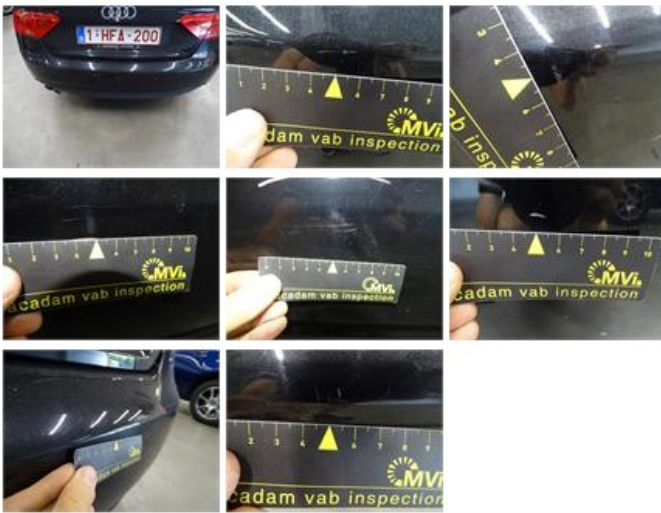
Bumper R, Scratch(es), LI - Repair and paint (complete) 254,16

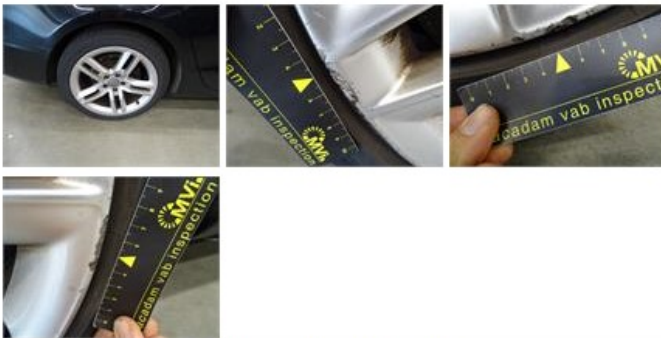
Alloy rim R R, Scratch(es), LI - Repair and paint (complete) 95,00

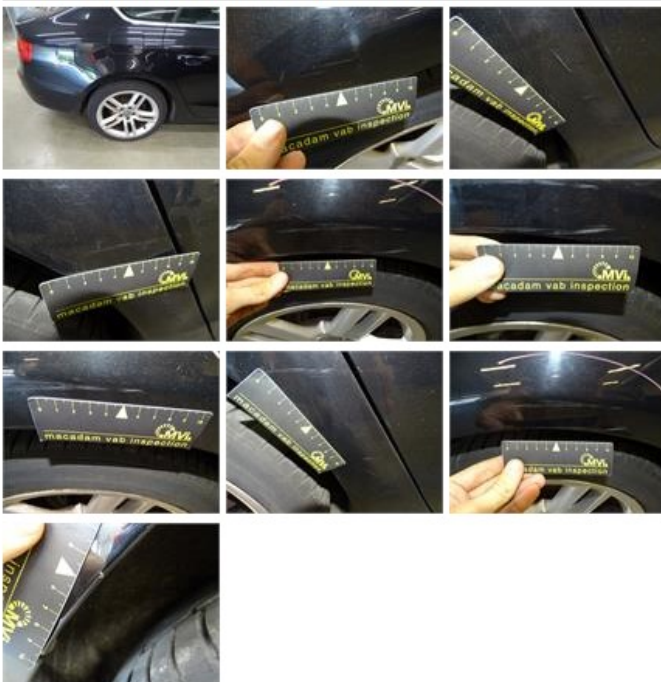
Wing R R, Scratch(es), LI - Repair and paint (complete) 369,84

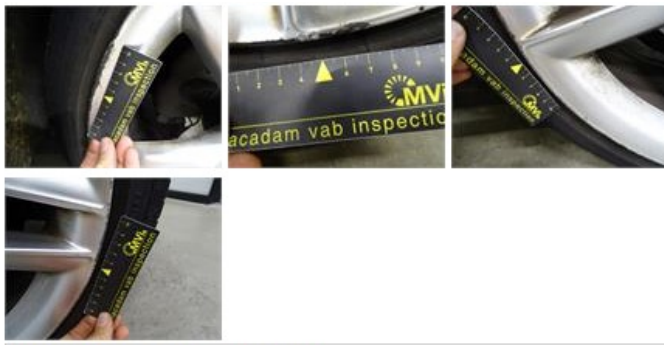
Alloy rim F R, Scratch(es), LI - Repair and paint (complete) 95,00

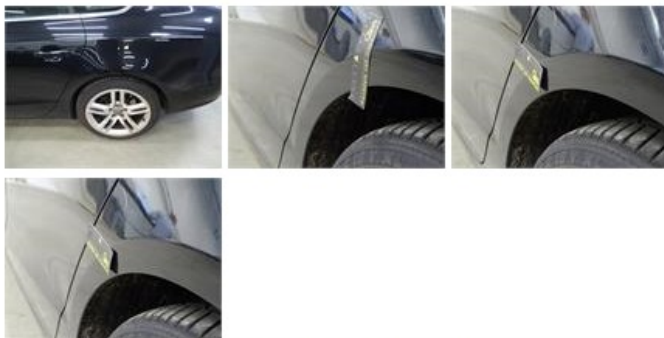
Wing R L, Dent(s), PDR - Paintless dent repair

63,00

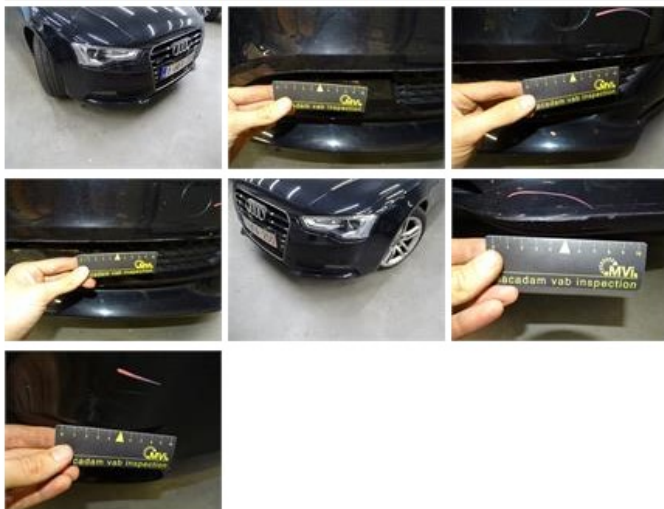
Bumper F, Scratch(es), LI - Repair and paint (complete)

254,16
