BMW 5 TOURING: 1KJF123

Limited Technical Inspection

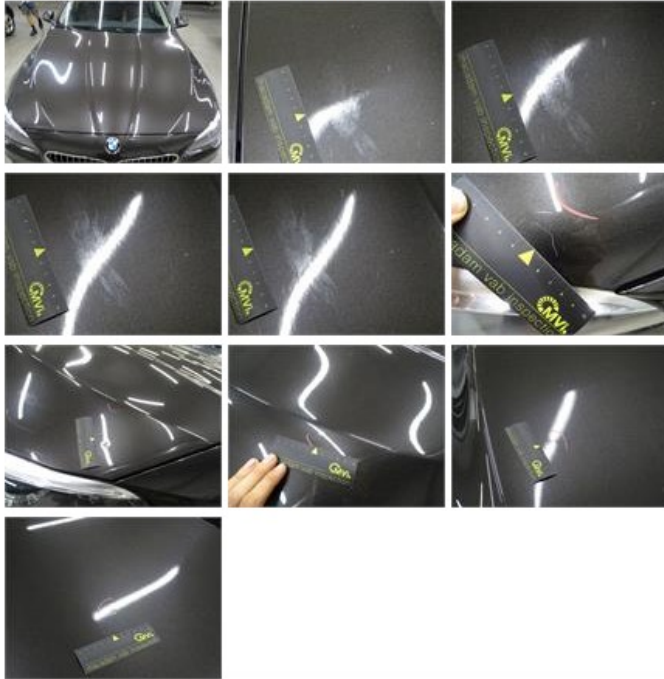
Door F L, Scratch(es), Acceptable	0,00
<i>No pictures to display</i>	
Wing R L, Dent(s), Acceptable	0,00
<i>No pictures to display</i>	
Wing F L, Scratch(es), Acceptable	0,00
<i>No pictures to display</i>	
Door R L, Dent(s) and scratch(es), Acceptable	0,00
<i>No pictures to display</i>	
Bonnet, Dent(s), PDR - Paintless dent repair	122,40

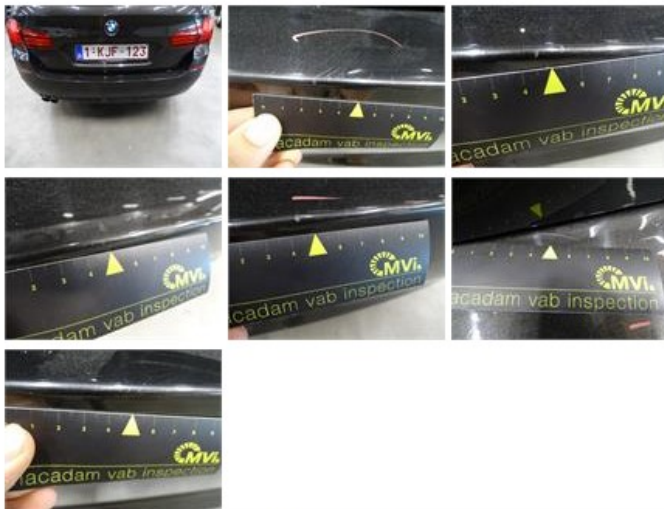
Door F R, Scratch(es), Acceptable	0,00
<i>No pictures to display</i>	
Bumper R, Scratch(es), LI - Repair and paint (complete)	254,16

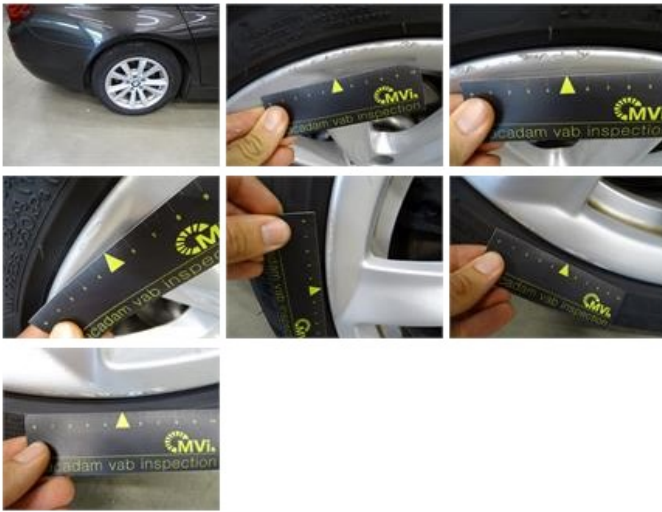
Alloy rim R R, Scratch(es), LI - Repair and paint (complete)

95,00

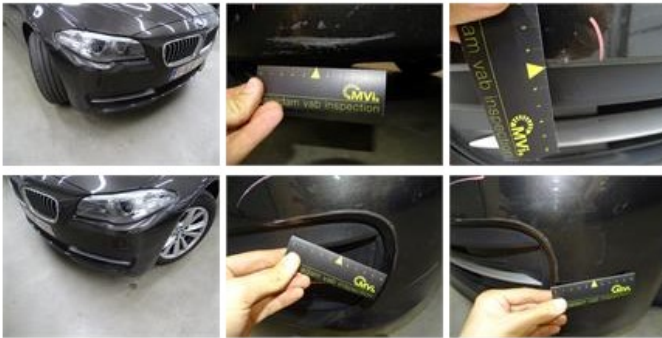
Bumper F, Scratch(es), LI - Repair and paint (complete)

254,16
