MERCEDES A: 1HCU444

Limited Technical Inspection

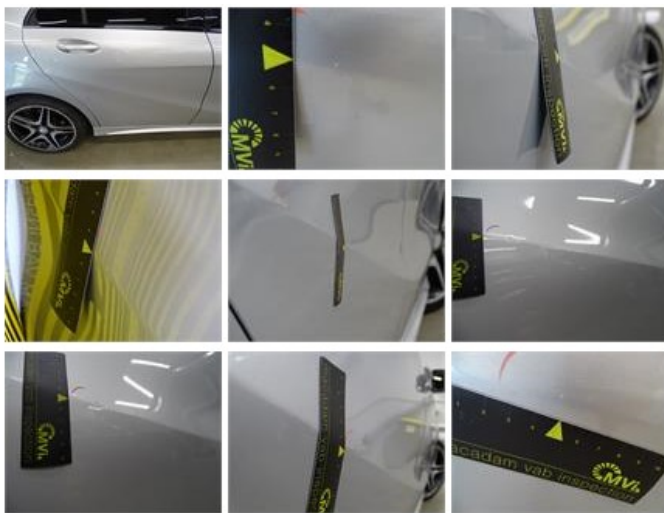
Total cost ex VAT	1925,83
Door R R, Dent(s) and scratch(es), LI - Repair and paint (complete)	318,35

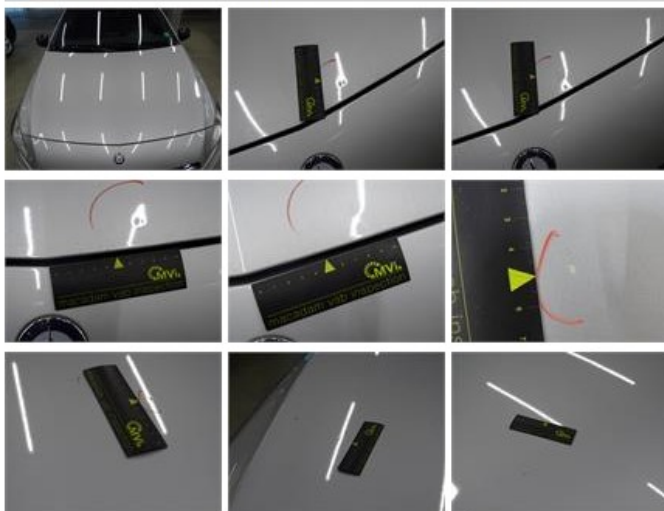
Bonnet, Dent(s) and scratch(es), LI - Repair and paint (complete)

290,08

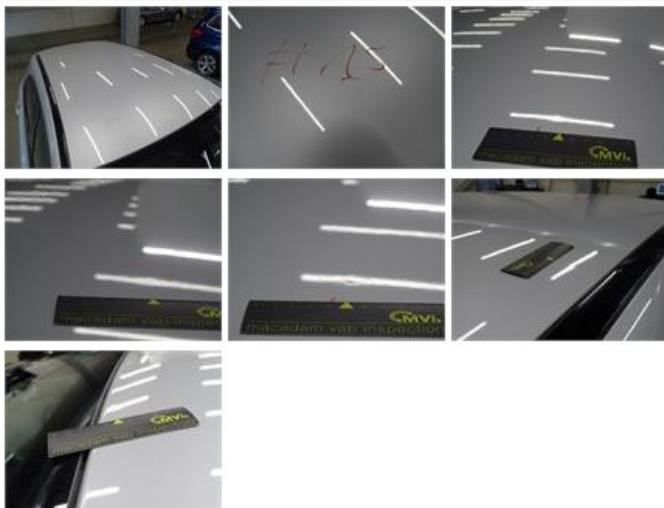
Roof, Dent(s), PDR - Paintless dent repair

300,60

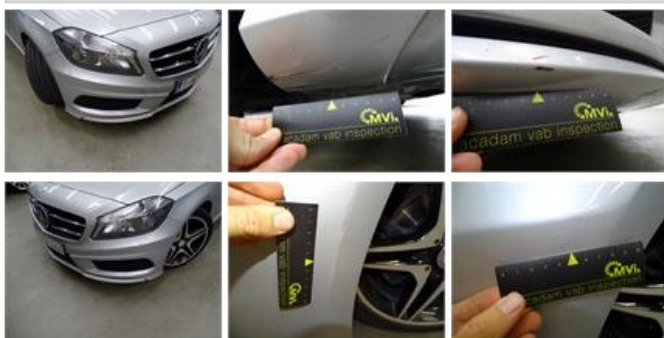
Bumper F, Scratch(es), LI - Repair and paint (complete)

211,80

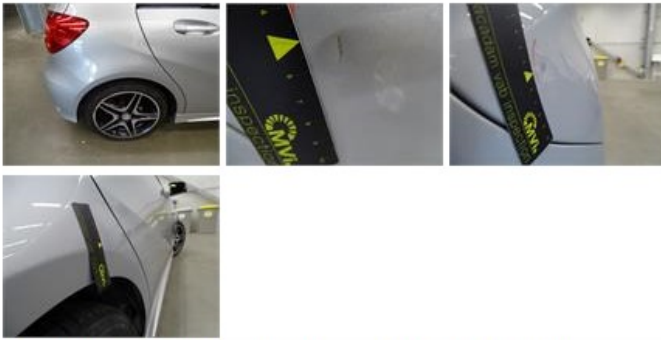
Wing R R, Dent(s) and scratch(es), LI - Repair and paint (complete) 308,20

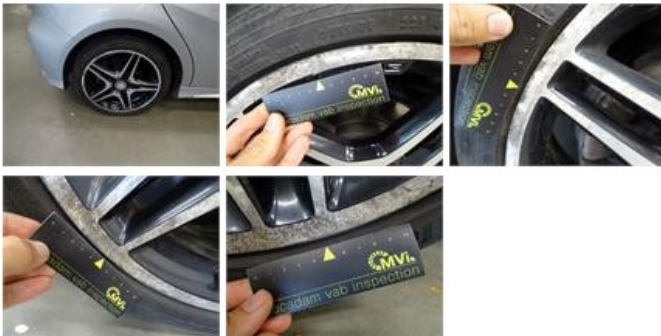
Alloy rim R R polished, Scratch(es), LI - Repair and paint (complete) 95,00

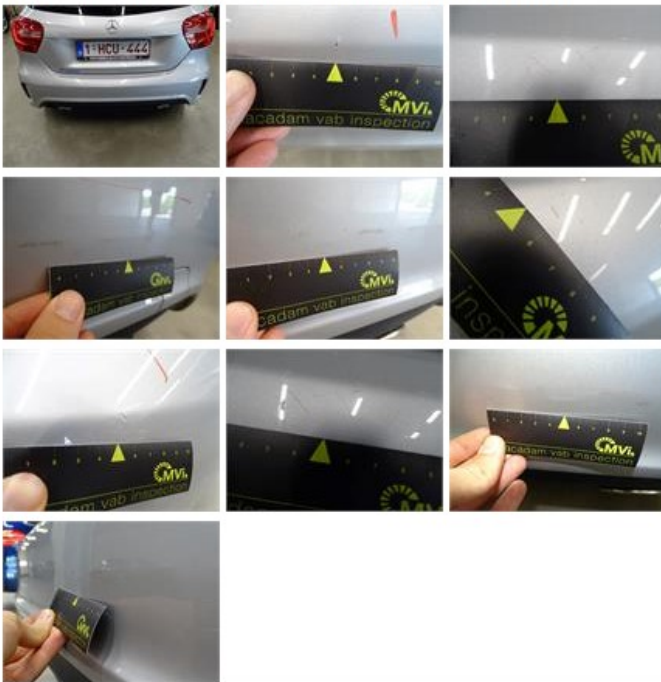
Bumper R, Dent(s) and scratch(es), LI - Repair and paint (complete) 211,80

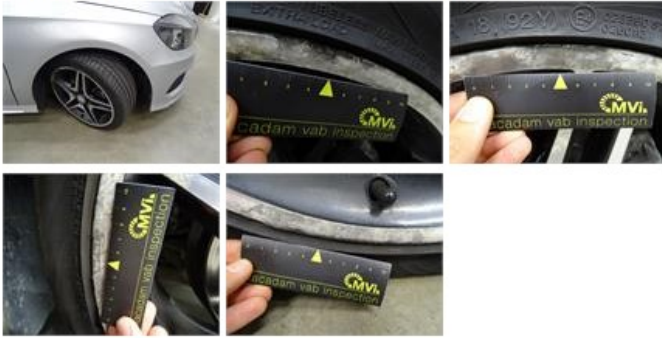
Alloy rim F R polished, Scratch(es), LI - Repair and paint (complete)	95,00
---	-------
