VOLKSWAGEN PASSAT VARIANT: 1VKM066

Limited Technical Inspection

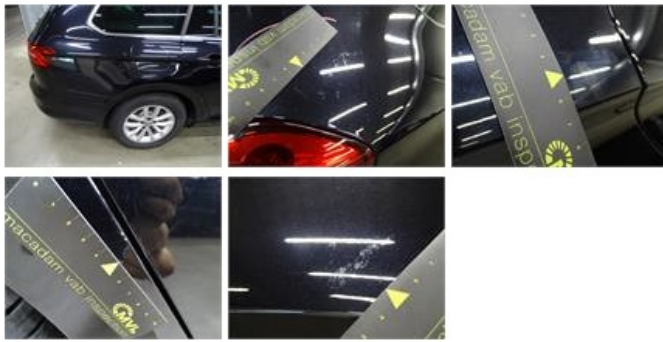
Wing R R, Chemical polution, LI - Repair and paint (complete)

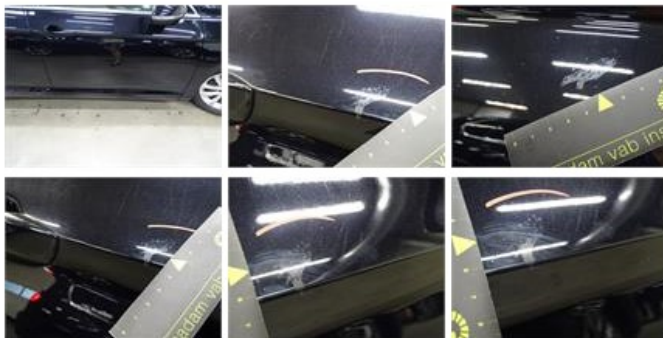
Door F R, Chemical polution, LI - Repair and paint (complete)

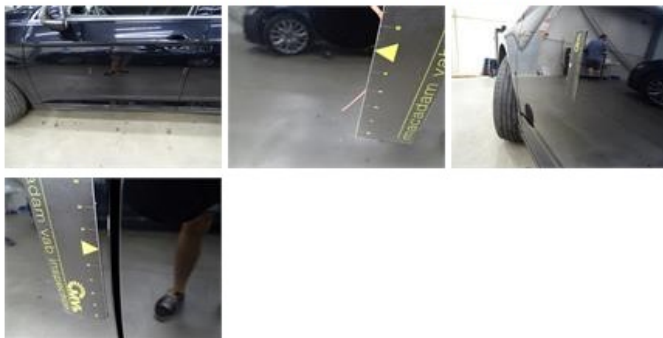
Door F L, Dent(s) and scratch(es), LI - Repair and paint (complete)

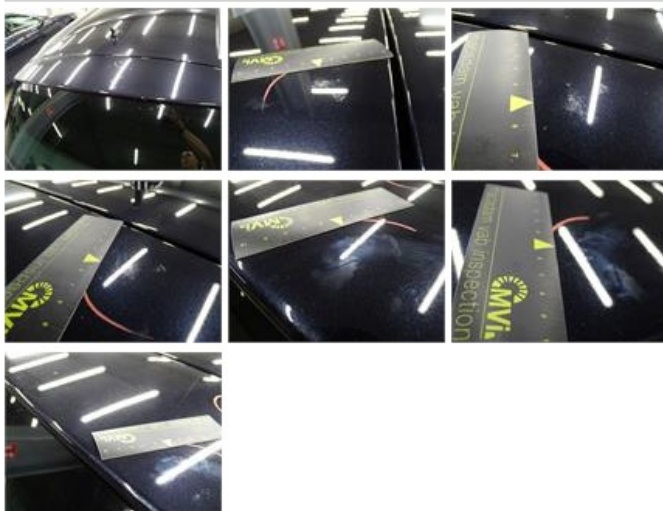
Rear spoiler, Chemical polution, LI - Repair and paint (complete)

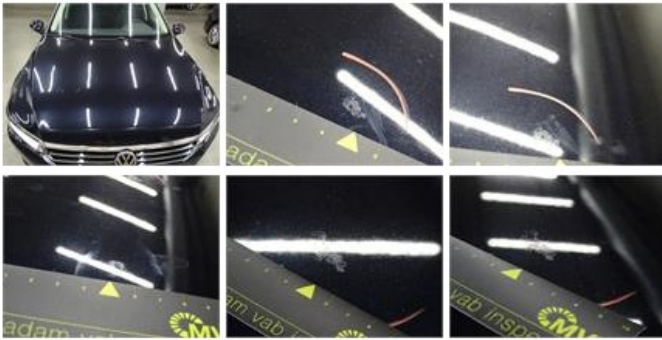
Bonnet, Chemical polution, LI - Repair and paint (complete)

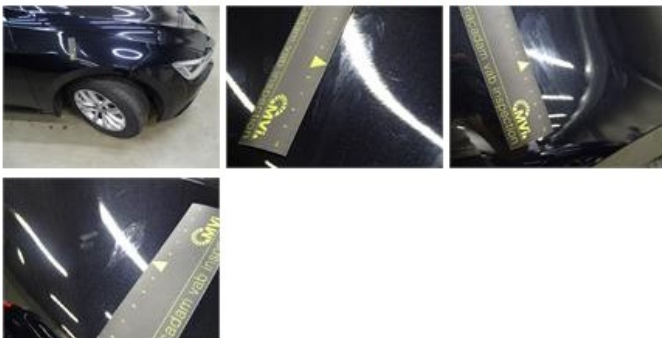
Wing F R, Chemical polution, LI - Repair and paint (complete)

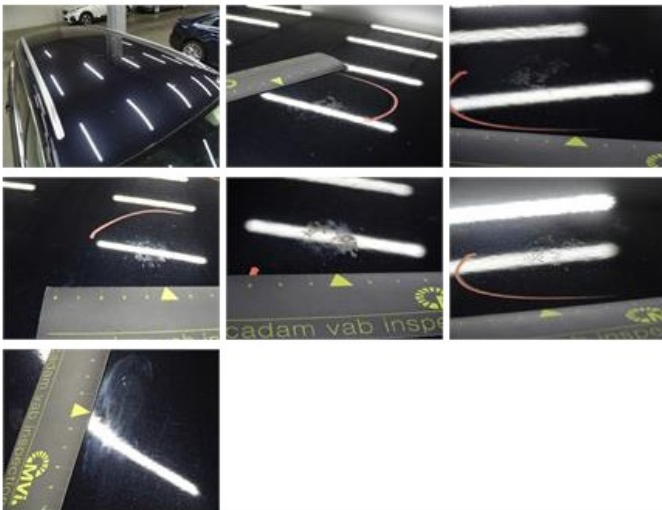
Roof, Chemical polution, LI - Repair and paint (complete)

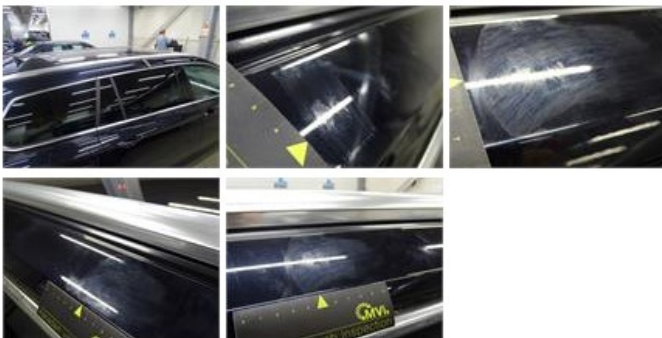
Roof pillar R, Chemical polution, LI - Repair and paint (complete)
