VOLKSWAGEN Crafter 35 MWB: 1ALM797			
Vinnumber:	WV1ZZZ2FZA7003975	Versionname:	CRAFTER 35 LB2C MWB 109PK
First Registrationdate:	3/02/2011	Fiscalpower:	
Expertise Mileage:	150044	Power Kw:	80
Bodytype:	Transporter	Body color:	White
Gearbox:	MAN 6 VIT	Paint type:	Opaque
Transmission:		Rims summer:	Steel
Fueltype:	Diesel	Oil level:	OK
Battery functioning:	Yes	Parking lot:	LCV06
Number of doors:	5		
Number of seats:	7		
Number head rests:	7		
Rims summer:	Steel		
Category:	Light Commercial Vehicle		
Oil level:	OK

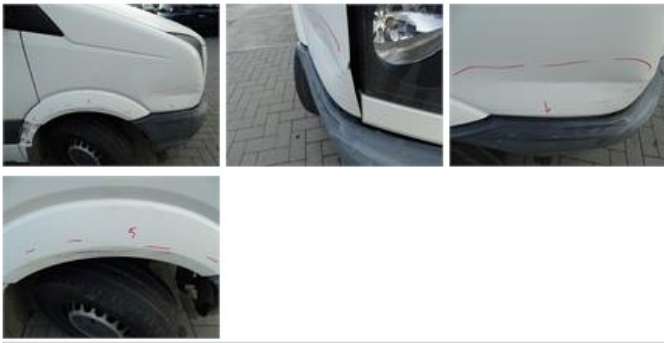
Wing F R, Deformed / Strained, Le - Replace and paint	427,51
---	---------------

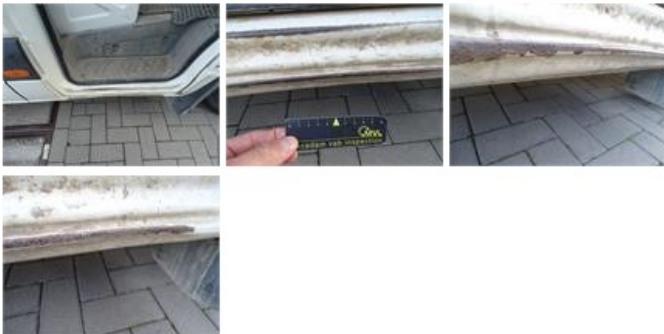
Sill outer R, Dent(s) and scratch(es), LI - Repair and paint (complete) 232,88

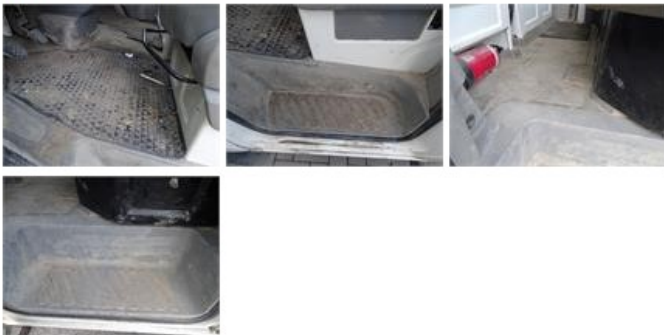
Interior, Dirty, Cleaning 50,00
