VOLKSWAGEN GOLF VARIANT: 1JSP586

Limited Technical Inspection

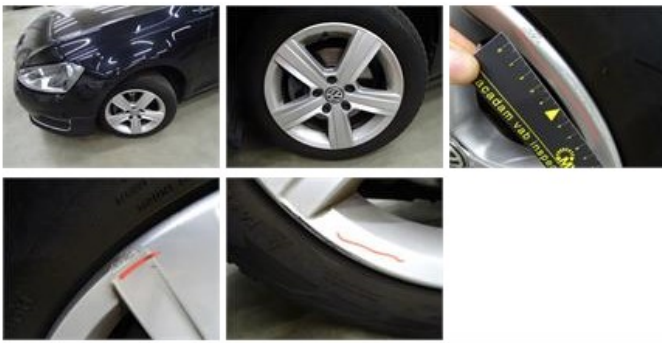
Total cost ex VAT	2124,85
Bonnet, Scratch(es), 67 - Polish	0,00
<i>No pictures to display</i>	
Alloy rim F L, Scratch(es), LI - Repair and paint (complete)	95,00

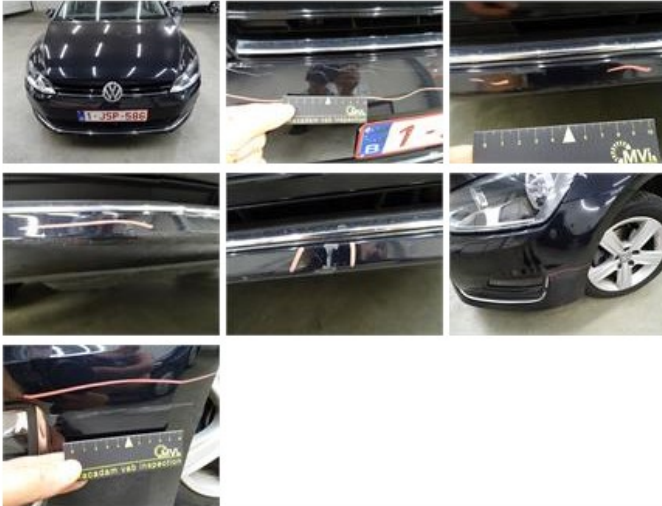
Bumper F, Scratch(es), LI - Repair and paint (complete) 211,80

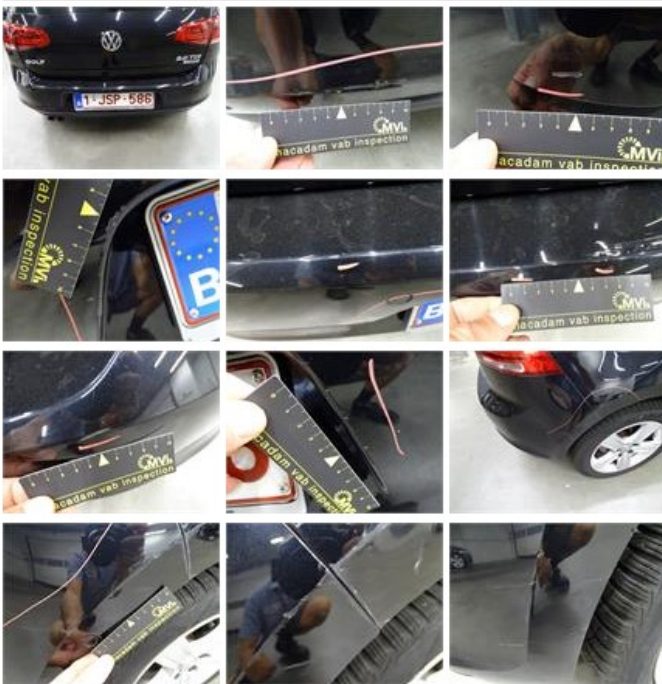
Bumper R, Scratch(es), LI - Repair and paint (complete) 211,80

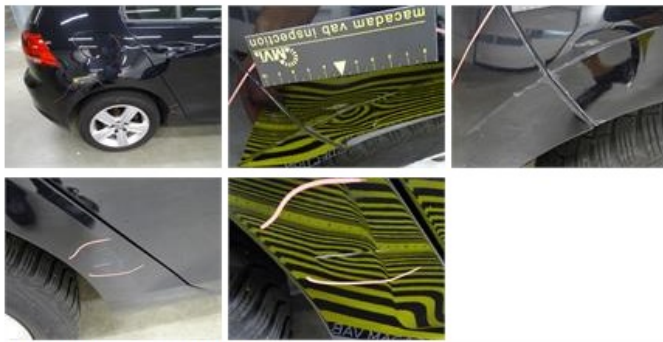
Wing R R, Dent(s) and scratch(es), LI - Repair and paint (complete) 308,20

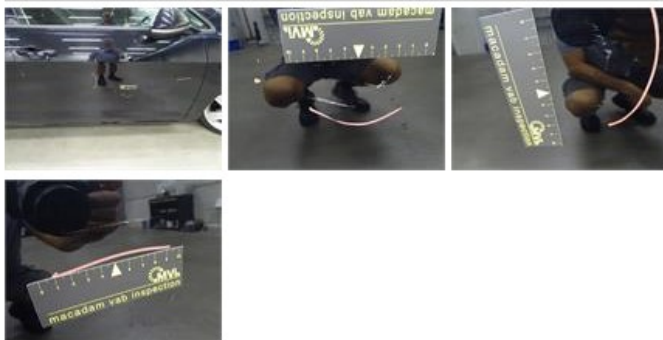
Door F R, Scratch(es), LI - Repair and paint (complete) 318,35

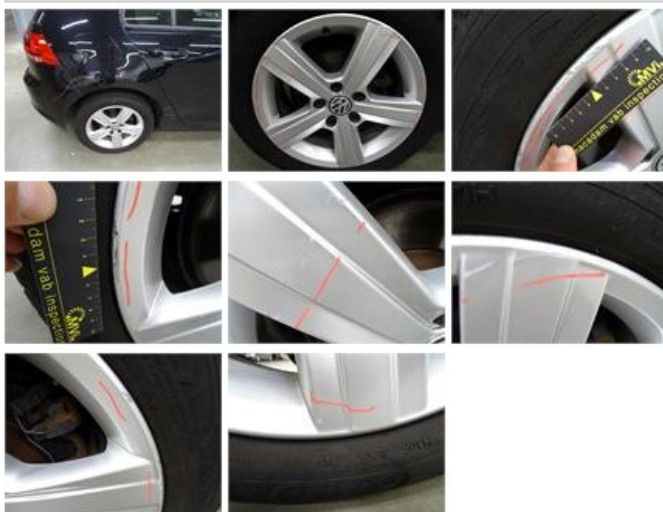
Alloy rim R R, Scratch(es), LI - Repair and paint (complete) 95,00
