**VOLKSWAGEN GOLF VII: 1KCV457**

**Limited Technical Inspection**

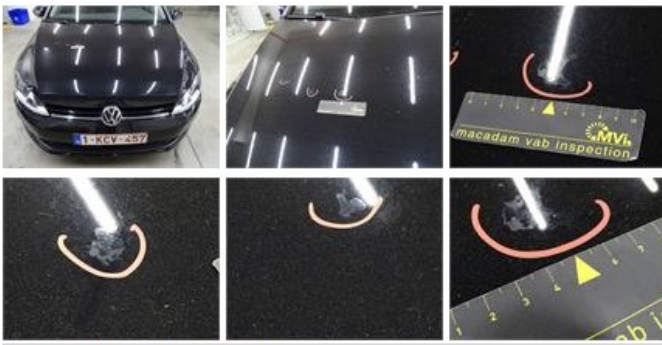
Total cost ex VAT	<b>290,08</b>
Bonnet, Chemical polution, LI - Repair and paint (complete)	<b>290,08</b>

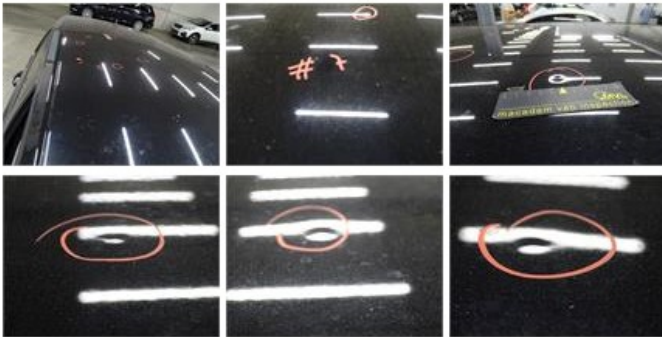
Roof, Hail damage, PDR - Hail 0,00
