VOLVO V70: 1HKL092

Limited Technical Inspection

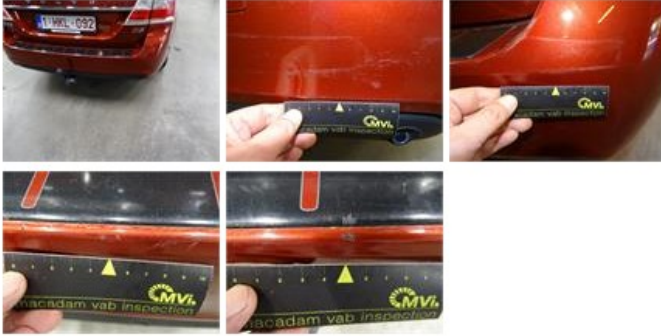
<i>No pictures to display</i>	
Tailgate, Scratch(es), Acceptable	0,00
<i>No pictures to display</i>	
Door F L, Scratch(es), Acceptable	0,00
<i>No pictures to display</i>	
Door F R, Scratch(es), Acceptable	0,00
<i>No pictures to display</i>	
Alloy rim R L, Scratch(es), Acceptable	0,00
<i>No pictures to display</i>	
Door R L, Dent(s) and scratch(es), Acceptable	0,00
<i>No pictures to display</i>	
Alloy rim F L, Scratch(es), Acceptable	0,00
<i>No pictures to display</i>	
Bumper R, Scratch(es), LI - Repair and paint (complete)	254,16
