SKODA Superb: 1VPQ916

Limited Technical Inspection

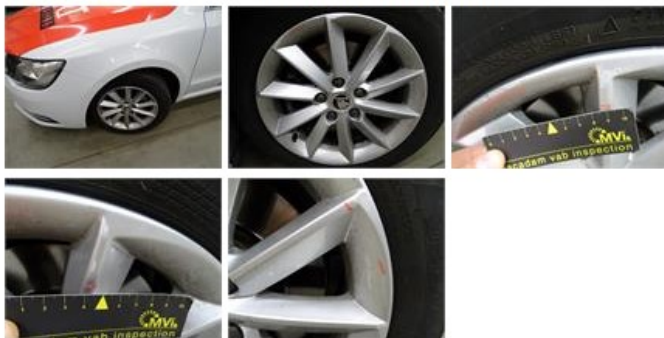
Alloy rim F L, Scratch(es), LI - Repair and paint (complete)

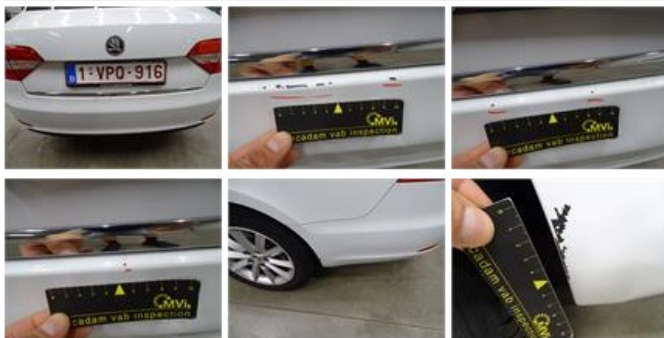
Bumper R, Scratch(es), LI - Repair and paint (complete)

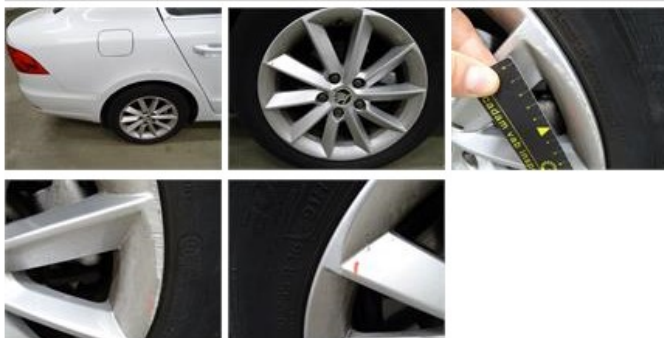
Alloy rim R R, Scratch(es), LI - Repair and paint (complete)

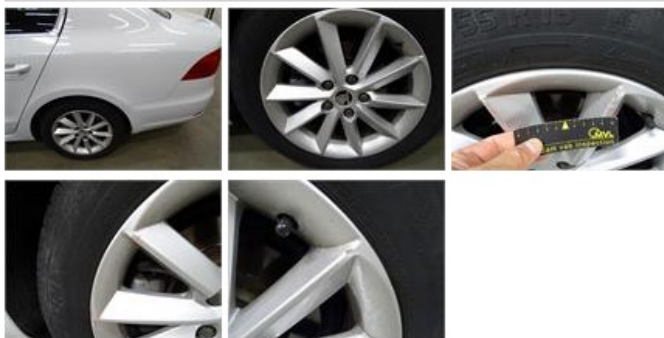
Alloy rim R L, Scratch(es), LI - Repair and paint (complete)

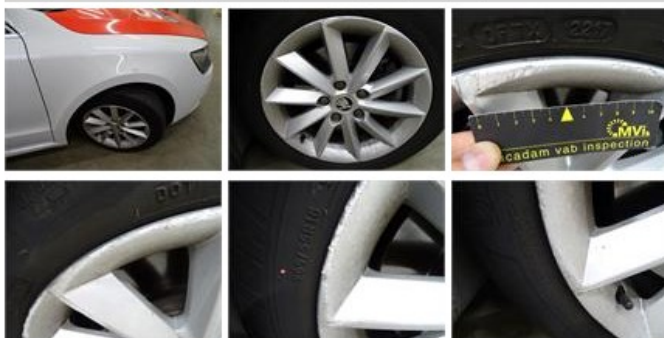
Alloy rim F R, Scratch(es), LI - Repair and paint (complete)
