OPEL INSIGNIA SPORTS TOURER: 1KXV458

Limited Technical Inspection

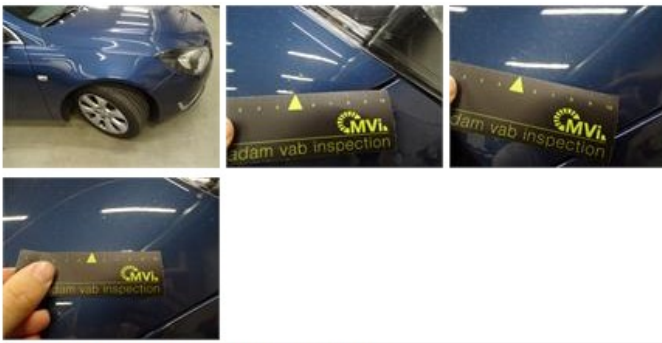
Total cost ex VAT	1703,90
Wing F R, Bad repair, Acceptable	0,00

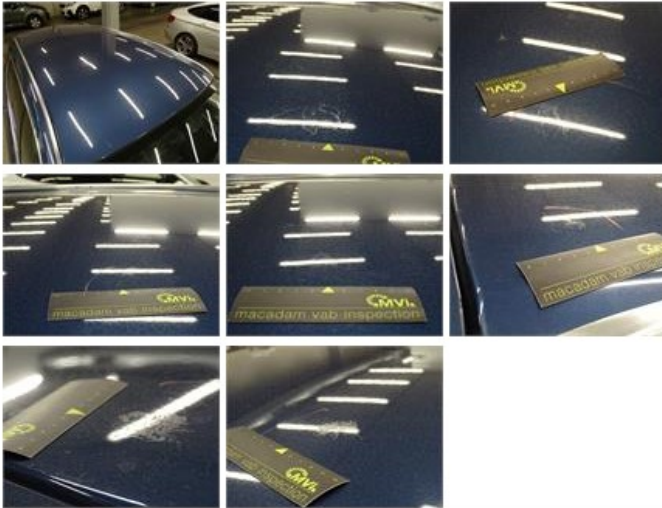
Roof, Chemical polution, LI - Repair and paint (complete) 481,50

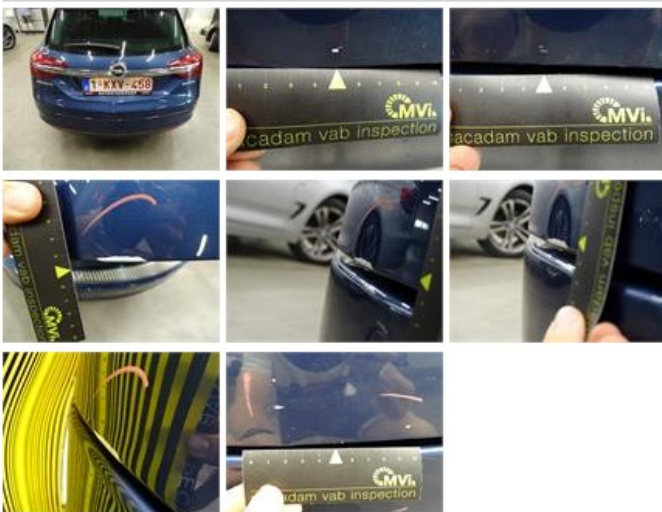
Tailgate, Dent(s) and scratch(es), LI - Repair and paint (complete) 301,68

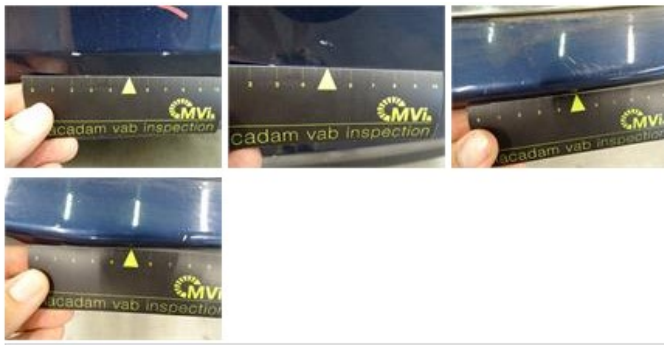
Bumper R, Scratch(es), LI - Repair and paint (complete) 211,80

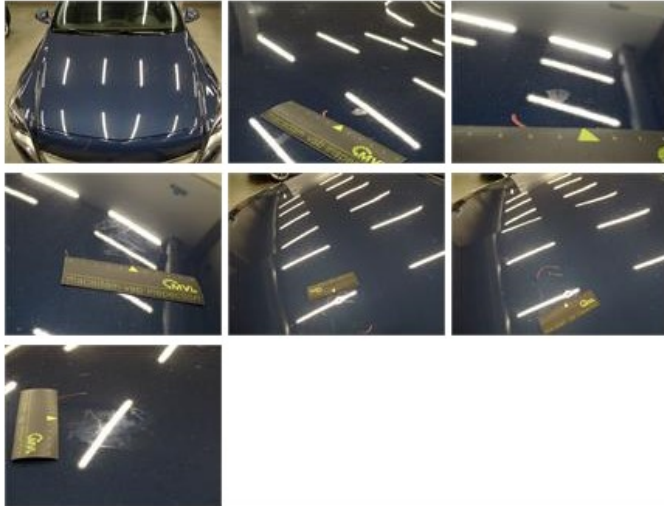
Bonnet, Chemical polution, LI - Repair and paint (complete)

290,08

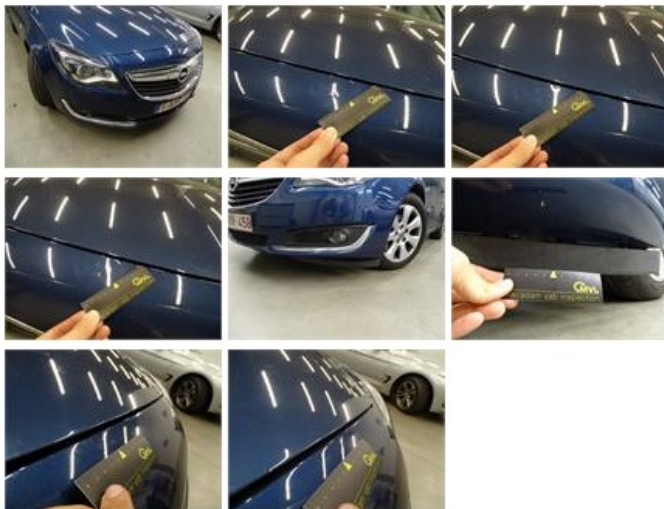
Bumper F, Bad repair, Acceptable

0,00

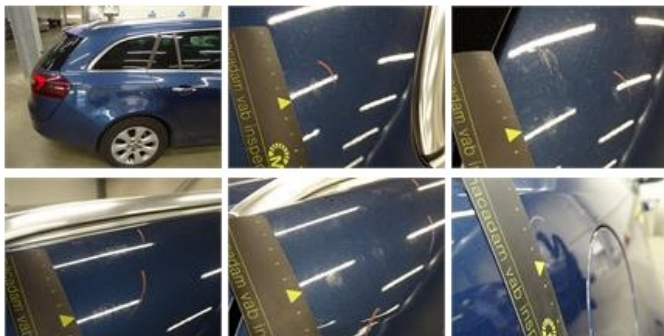
Wing R R, Chemical polution, LI - Repair and paint (complete)

308,20
