VOLVO XC60: 1LGK224

| Vinnumber: | VV1DZARC1G2837579 | Versionname: | 2.0 D3 2WD VOLVO OCEAN RACE |

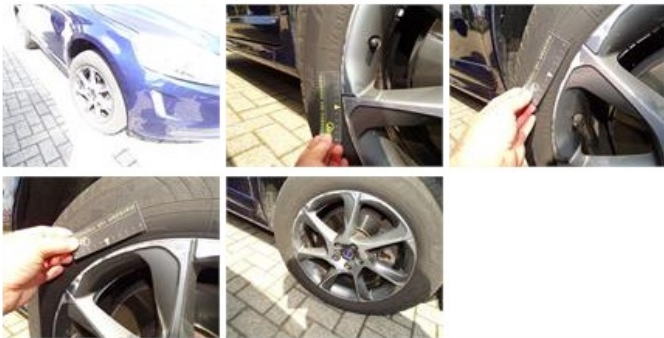
| Alloy rim F R polished, Scratch(es), LI - Repair and paint (complete) | | 95,00 |
