**RENAULT Laguna: 1HHZ094**

**Limited Technical Inspection**

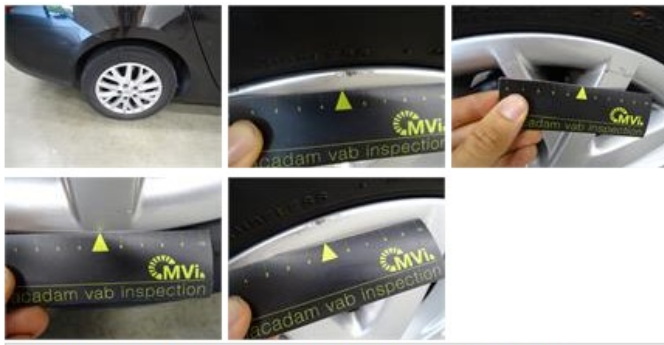
Total cost ex VAT	2892,12
Alloy rim R R, Scratch(es), LI - Repair and paint (complete)	95,00

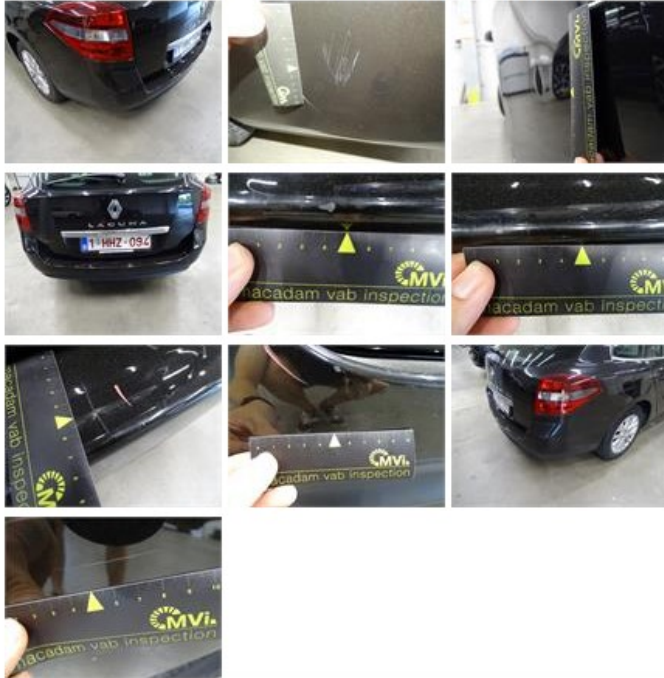
Bumper R, Dent(s) and scratch(es), LI - Repair and paint (complete)

211,80

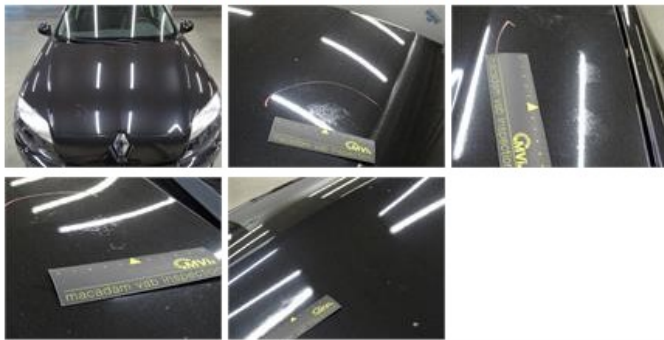
Bonnet, Chemical polution, LI - Repair and paint (complete)

290,08

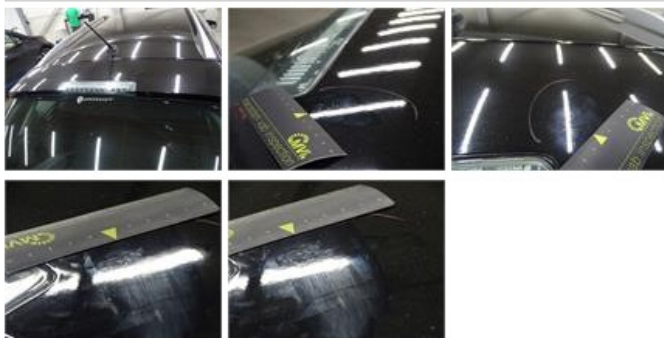
Rear spoiler, Chemical polution, LI - Repair and paint (complete)

115,56

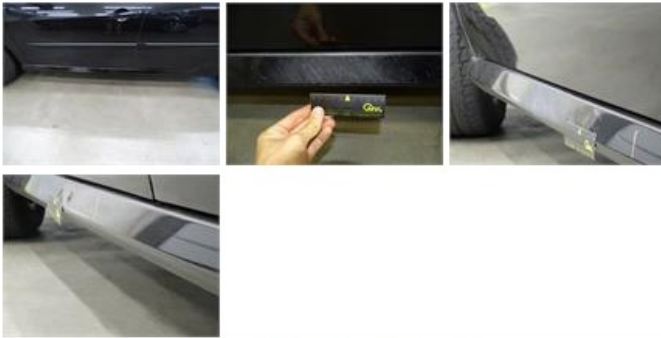
Sill outer L, Dent(s) and scratch(es), LI - Repair and paint (complete)

310,50

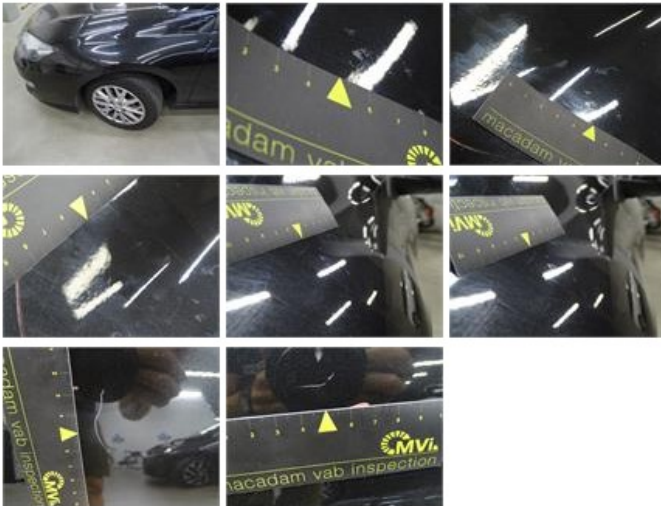
Wing F L, Chemical polution, LI - Repair and paint (complete)

220,18

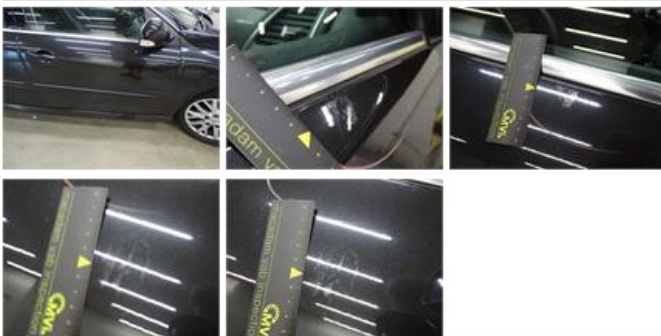
Door F R, Chemical polution, LI - Repair and paint (complete)

318,35

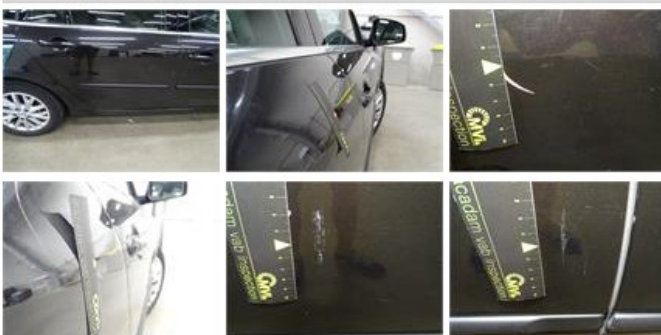
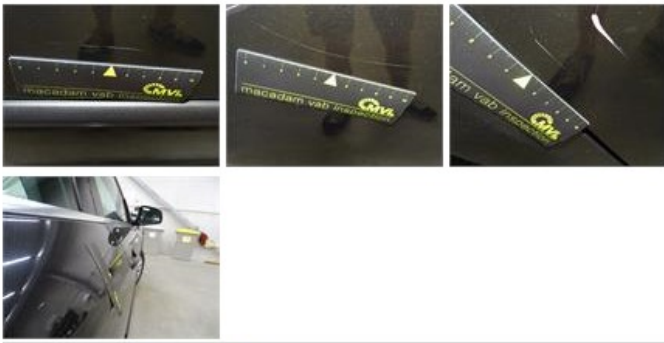
Door R R, Dent(s) and scratch(es), LI - Repair and paint (complete)

318,35

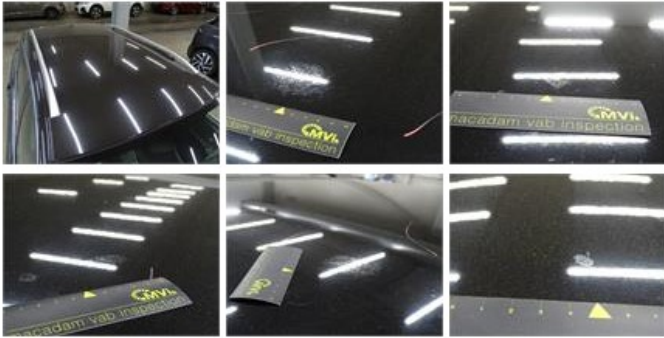
Roof, Chemical polution, LI - Repair and paint (complete) 481,50

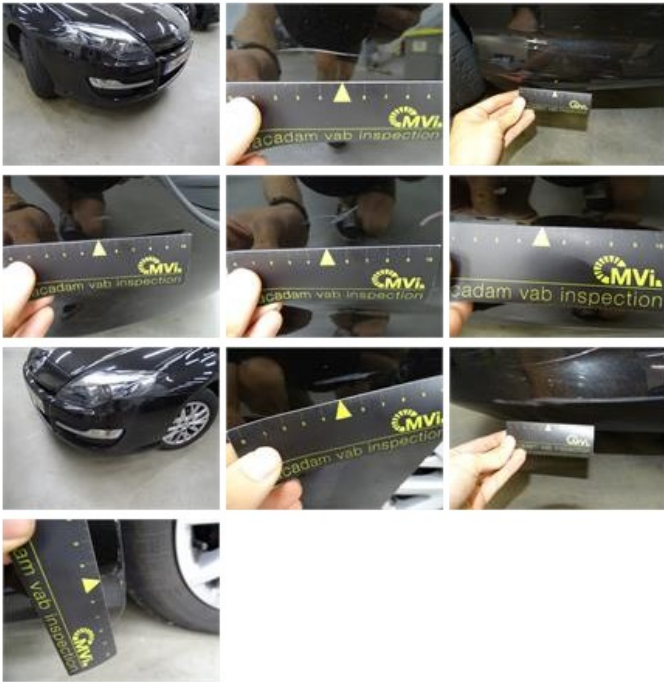
Bumper F, Scratch(es), LI - Repair and paint (complete) 211,80

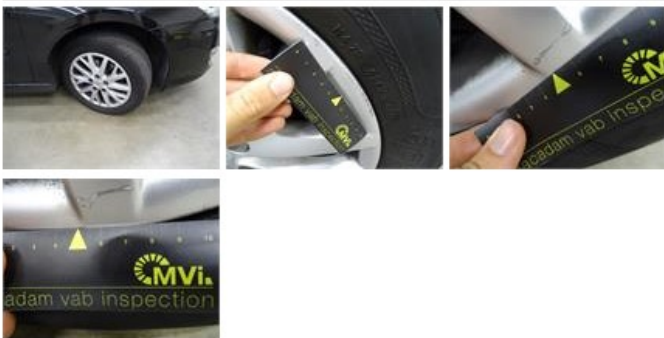
Alloy rim F R, Scratch(es), LI - Repair and paint (complete) 95,00
