VOLKSWAGEN Golf: 1HKD185

Limited Technical Inspection

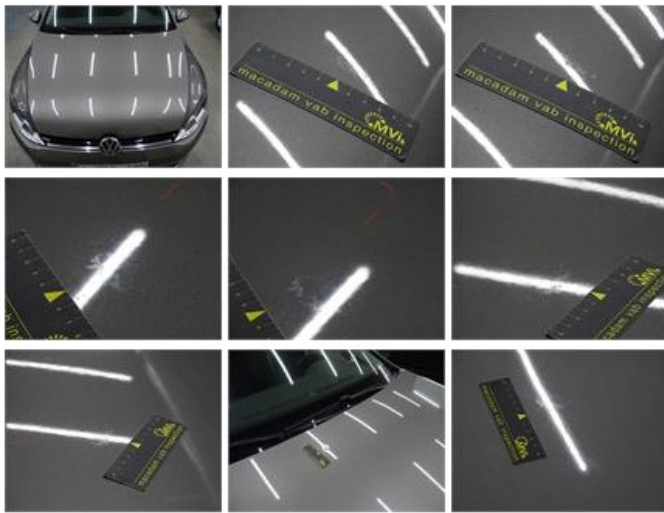
Total cost ex VAT	1675,45
Bonnet, Chemical polution, LI - Repair and paint (complete)	290,08

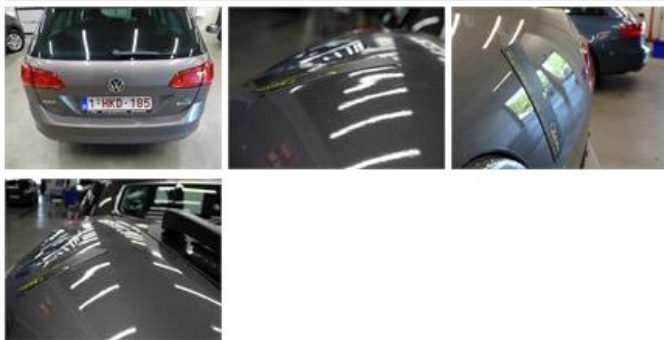
Tailgate, Dent(s), PDR - Paintless dent repair 63,00

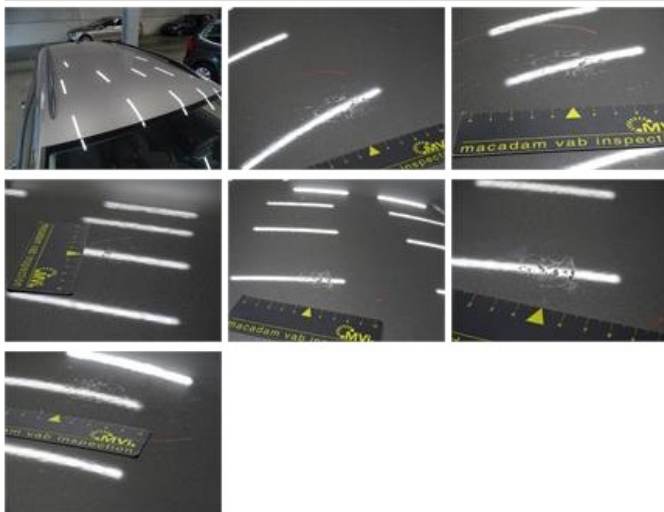
Roof, Chemical pollution, LI - Repair and paint (complete) 481,50
