VOLVO V60: 1FVU191

Limited Technical Inspection

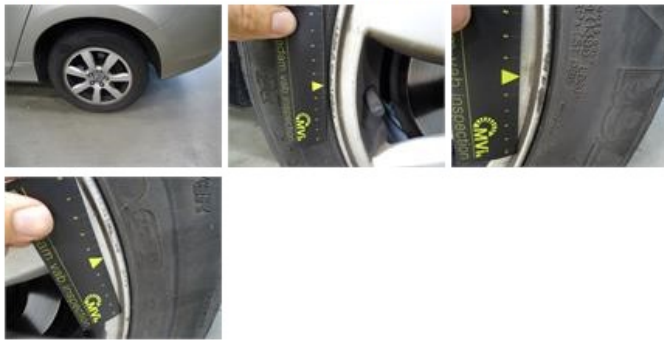
Alloy rim R L, Scratch(es), LI - Repair and paint (complete)

95,00

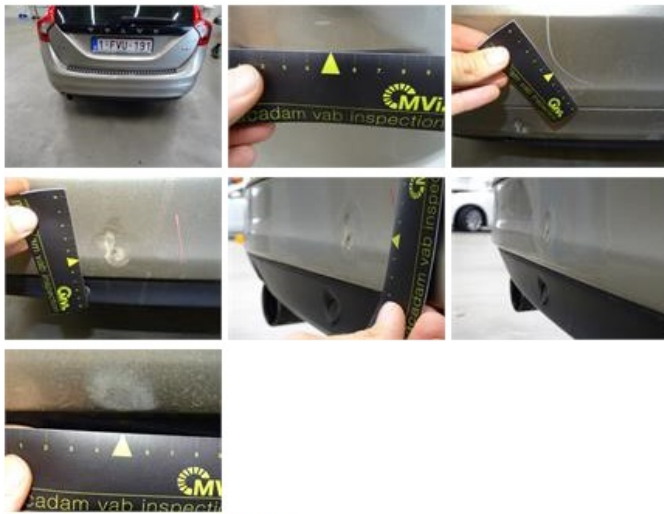
Bumper R, Dent(s) and scratch(es), LI - Repair and paint (complete)

211,80

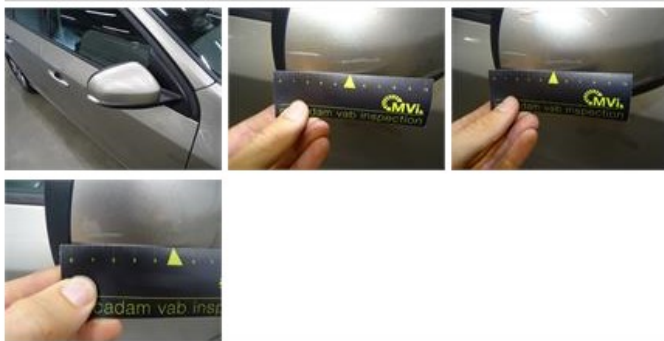
Rearview mirror housing R, Scratch(es), LI - Repair and paint (complete)

115,56

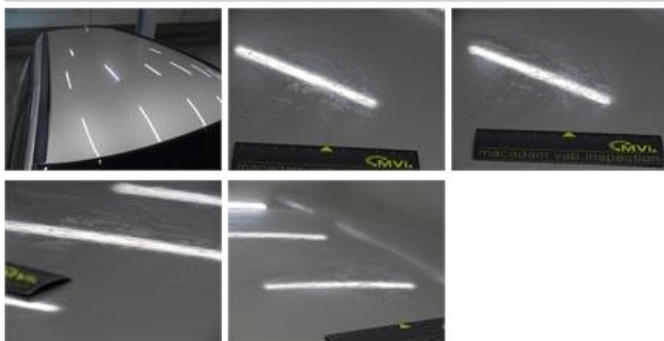
Roof, Chemical pollution, LI - Repair and paint (complete)

481,50

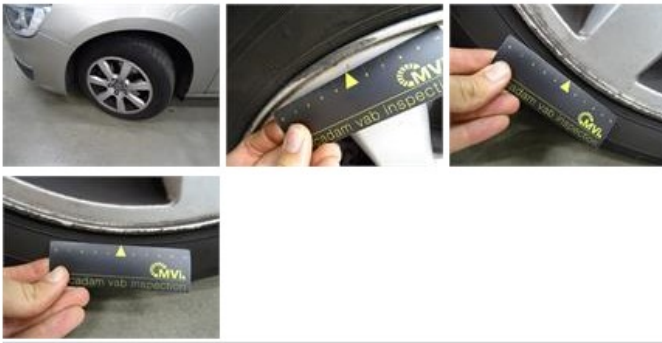
Alloy rim F L, Scratch(es), LI - Repair and paint (complete)

95,00

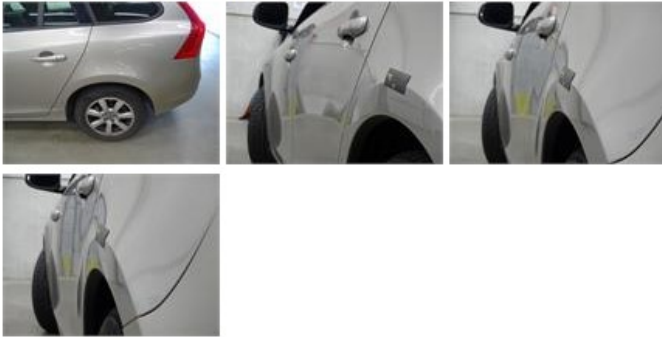
Wing R L, Bad repair, Acceptable 0,00

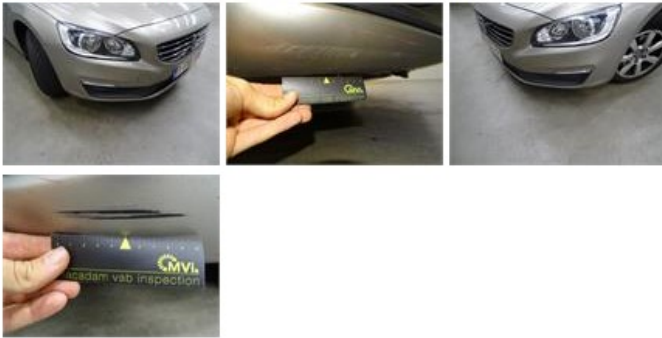
Bumper F, Scratch(es), LI - Repair and paint (complete) 211,80

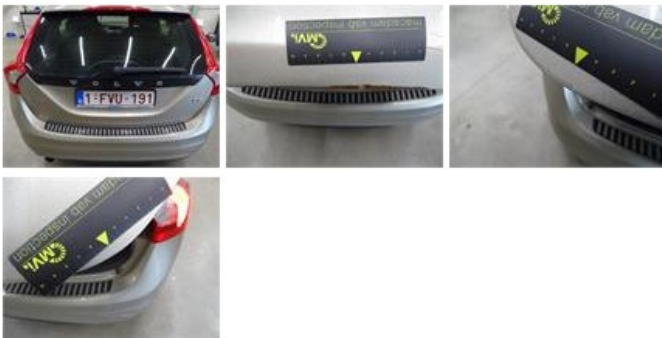
Tailgate, Bad repair, Acceptable 0,00
