AUDI A3 SPORTBACK: 1KXL474

Limited Technical Inspection

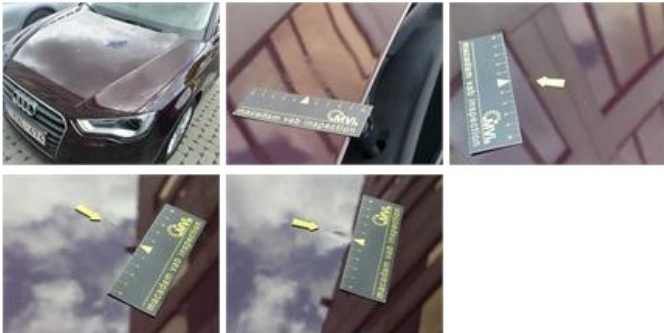
Bonnet, Chemical pollution, LI - Repair and paint (complete)	290,08

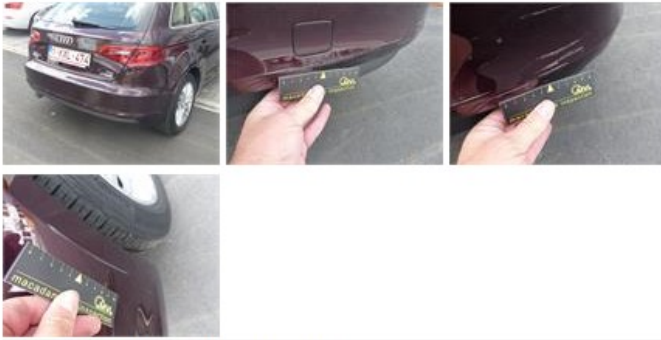
Bumper R, Scratch(es), LI - Repair and paint (complete)

211,80
