**BMW 2 ACTIVE TOURER: 1KUB620**

Vinnumber:	<b>WBA2C11000V519067</b>	Versionname:	<b>2.0 218D (100KW) ACTIVE TOURER</b>
First Registrationdate:	<b>3/07/2015</b>	Fiscalpower:	
Expertise Mileage:	<b>121735</b>	Power Kw:	<b>100</b>
Bodytype:		Body color:	<b>Black</b>
Gearbox:	<b>MAN 6 VIT</b>	Paint type:	<b>Metalic</b>
Transmission:	<b>Front</b>	Rims summer:	<b>Aluminium</b>
Fueltype:	<b>Diesel</b>	Oil level:	<b>OK</b>
Battery functioning:	<b>Yes</b>	Parking lot:	<b>3832</b>
Number of doors:	<b>5</b>		
Number of seats:	<b>5</b>		
Number head rests:	<b>5</b>		
Rims summer:	<b>Aluminium</b>		
Category:	<b>Passenger Car</b>		
Oil level:	<b>OK</b>		
Registration Certificate Car (BE):	<b>Yes</b>

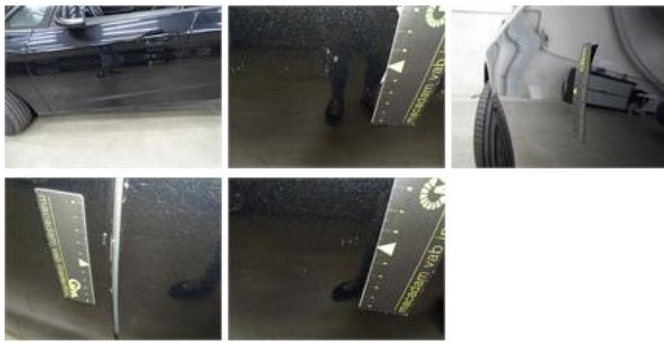
<b>Total cost ex VAT</b>	<b>1059,35</b>
<b>Door F L, Dent(s) and scratch(es), LI - Repair and paint (complete)</b>	<b>318,35</b>

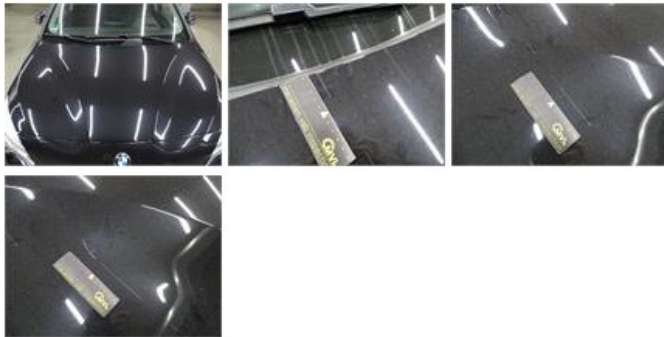
Bonnet, Scratch(es), 67 - Polish 0,00

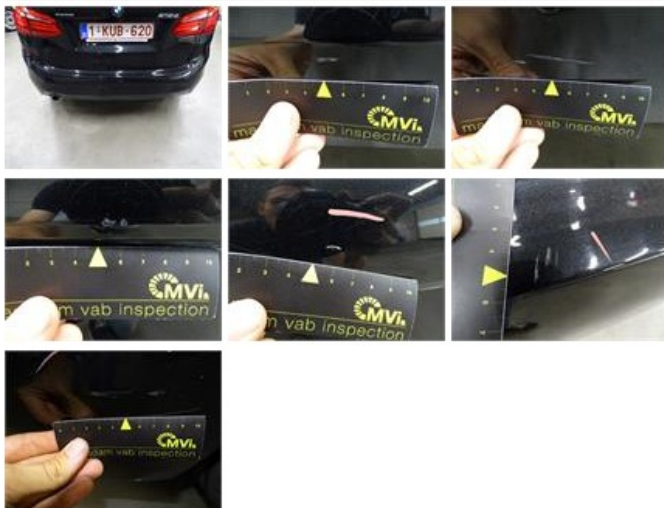
Bumper R, Scratch(es), LI - Repair and paint (complete) 211,80
