**AUDI Q5: 1KXV418**

**Limited Technical Inspection**

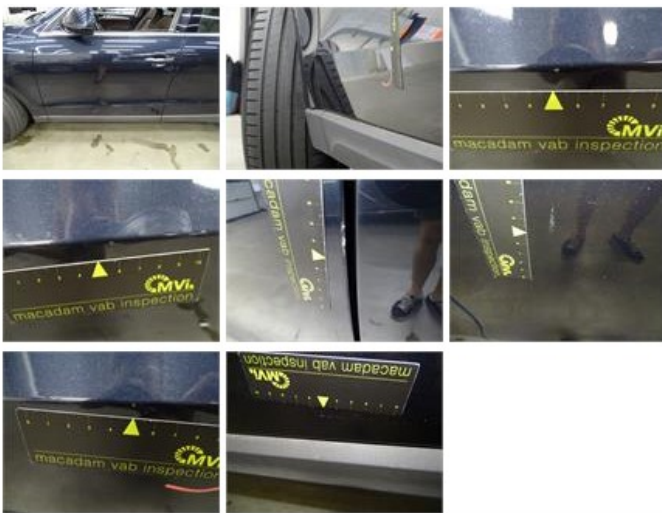
Total cost ex VAT	1744,62
Bumper F, Scratch(es), Acceptable	0,00
<i>No pictures to display</i>	
Door F L, Dent(s) and scratch(es), LI - Repair and paint (complete)	382,02

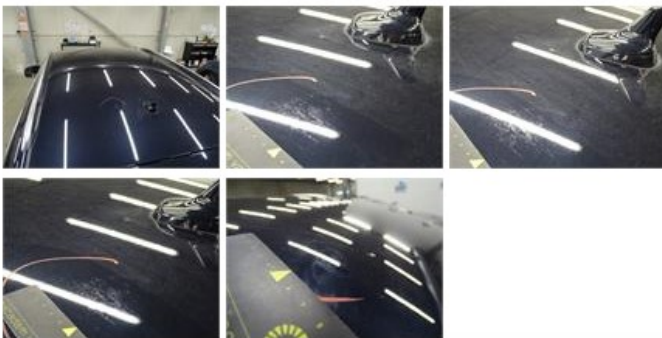
Roof, Chemical polution, LI - Repair and paint (complete) 577,80

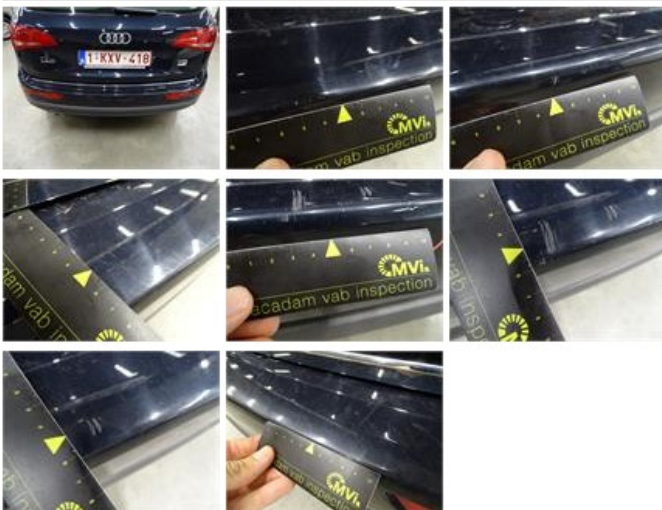
Bumper R, Scratch(es), LI - Repair and paint (complete) 254,16

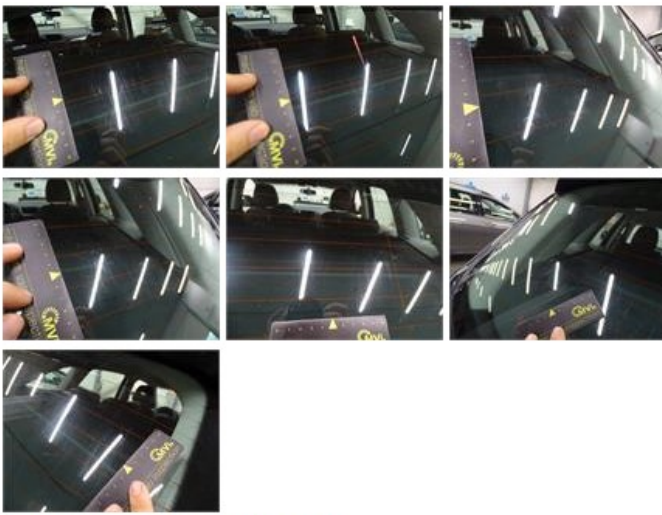
Rear window, Scratch(es), E - Replace 420,00
