BMW 1 HATCH: 1SYJ314

Vinnumber:	WBA1V710605A66312	Versionname:	116d (85 kW)
First Registrationdate:	18/08/2017	Fiscalpower:	
Expertise Mileage:	65143	Power Kw:	85
Bodytype:		Body color:	Grey
Gearbox:	MAN 6 VIT	Paint type:	Metalic
Transmission:	Back	Rims summer:	Aluminium
Fueltype:	Diesel	Oil level:	OK
Battery functioning:	Yes	Parking lot:	3620
Number of doors:	5		
Number of seats:	5		
Number head rests:	5		
Rims summer:	Aluminium		
Category:	Passenger Car		
Oil level:	OK		
Registration Certificate Car (BE):	Yes

Limited Technical Inspection

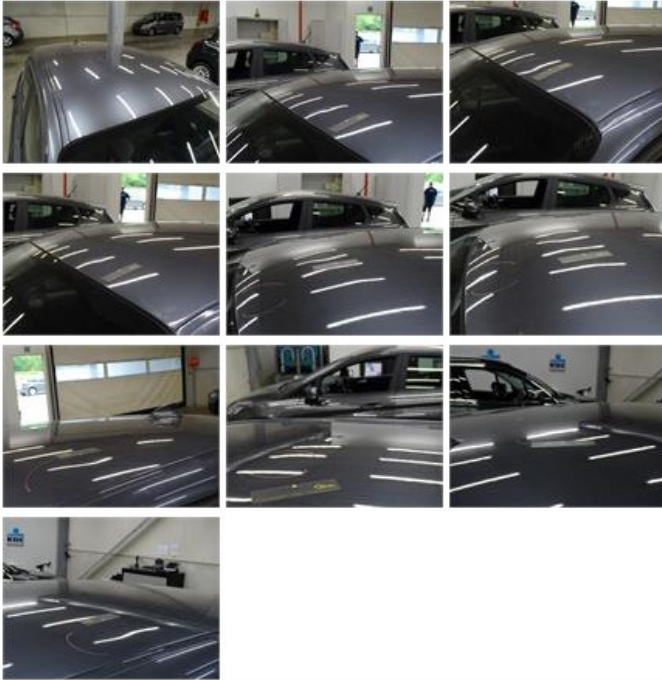
Roof, Deformed / Strained, LI - Repair and paint (complete) 553,50

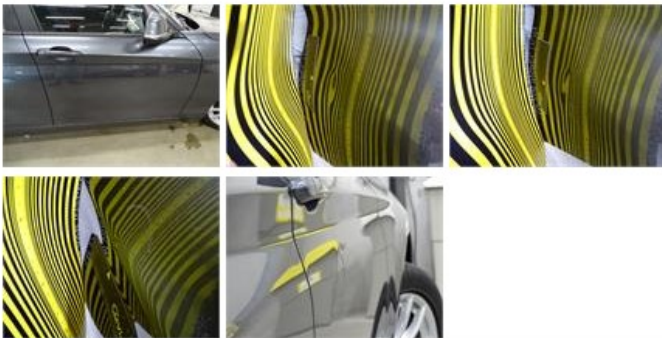
Door F R, Dent(s), LI - Repair and paint (complete) 318,35

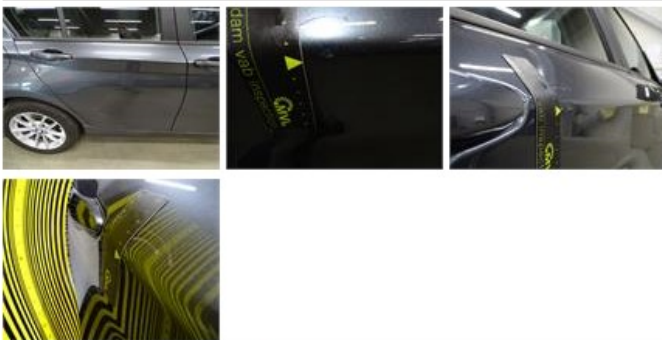
Door R R, Dent(s) and scratch(es), LI - Repair and paint (complete) 318,35

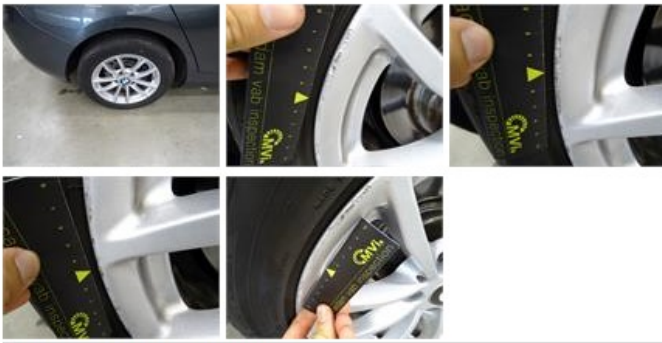
Alloy rim R R, Scratch(es), LI - Repair and paint (complete) 95,00

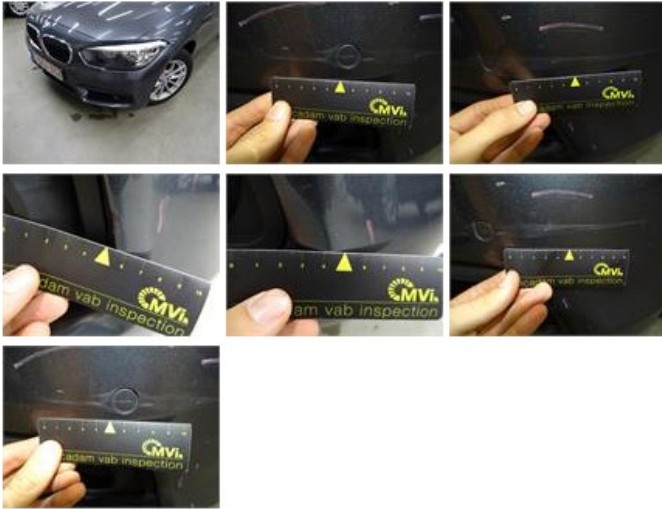
Bumper F, Scratch(es), LI - Repair and paint (complete) 211,80
