BMW 1: 1JAJ619			
Vinnumber:	WBA1C91060P873867	Versionname:	1 HATCH 116d Eff.Dyn.Ed. 116PK
First Registrationdate:	17/11/2014	Fiscalpower:	
Expertise Mileage:	96229	Power Kw:	85
Bodytype:	Hatchback	Body color:	Grey
Gearbox:	MAN 6 VIT	Paint type:	Metalic
Transmission:	Back	Rims summer:	Aluminium
Fueltype:	Diesel	Oil level:	OK
Battery functioning:	Yes	Parking lot:	2629
Number of doors:	5		
Number of seats:	5		
Number head rests:	5		
Rims summer:	Aluminium		
Category:	Passenger Car		
Oil level:	OK		
Registration Certificate Car (BE):	Yes

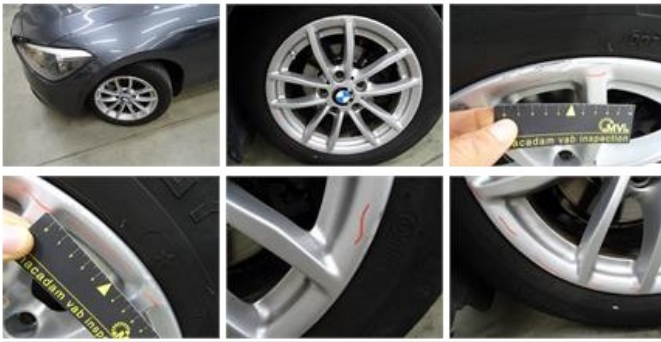
Alloy rim F L, Scratch(es), LI - Repair and paint (complete)

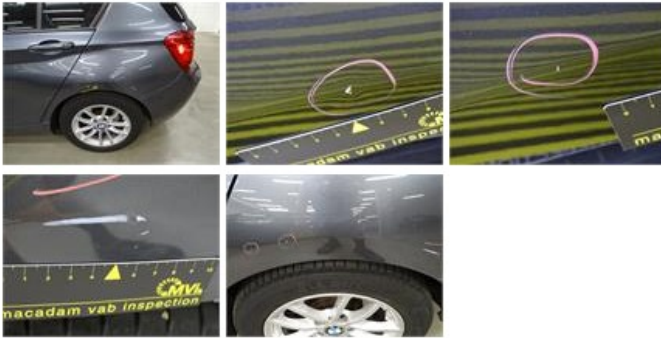
Wing R L, Dent(s) and scratch(es), LI - Repair and paint (complete)

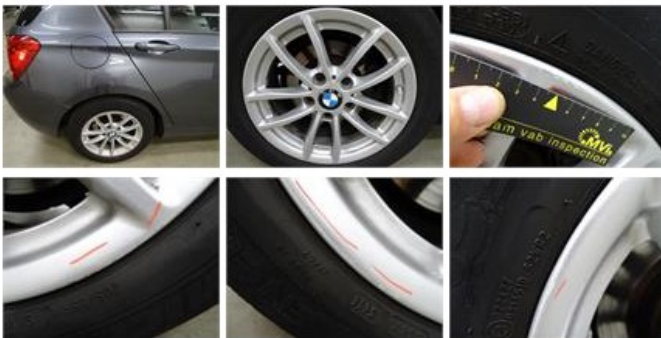
Alloy rim R R, Scratch(es), I - Repair

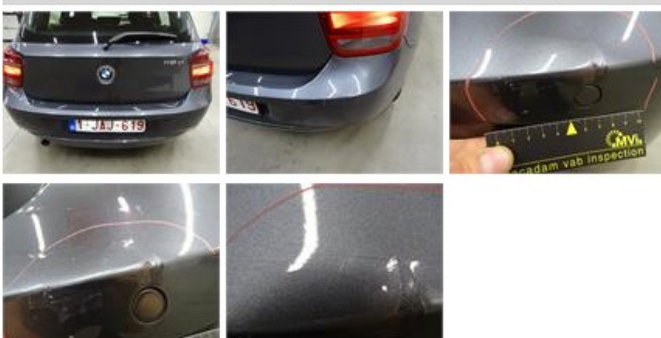
Bumper R, Dent(s) and scratch(es), LI - Repair and paint (complete)

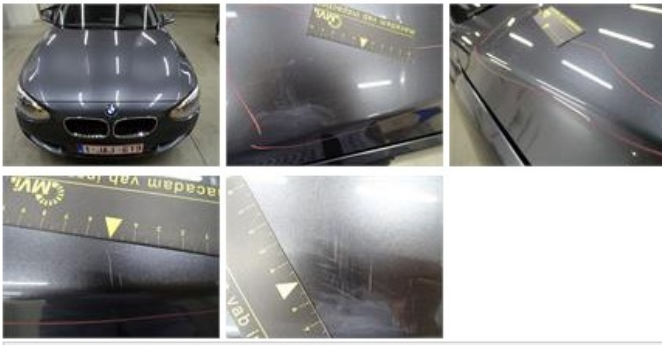
Bonnet, Scratch(es), LI - Repair and paint (complete)
