**BMW 1 HATCH: ES4928**

**Limited Technical Inspection**

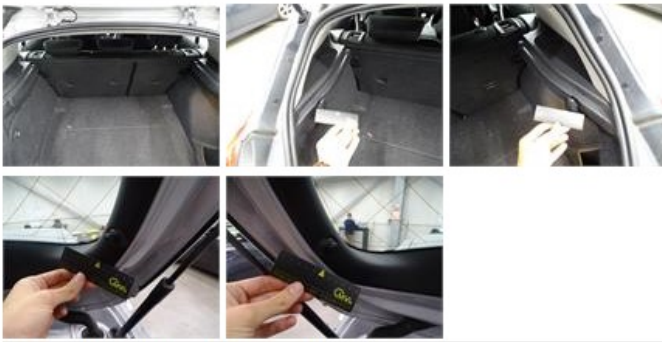
Doors open, Missing F, Damaged 0,00

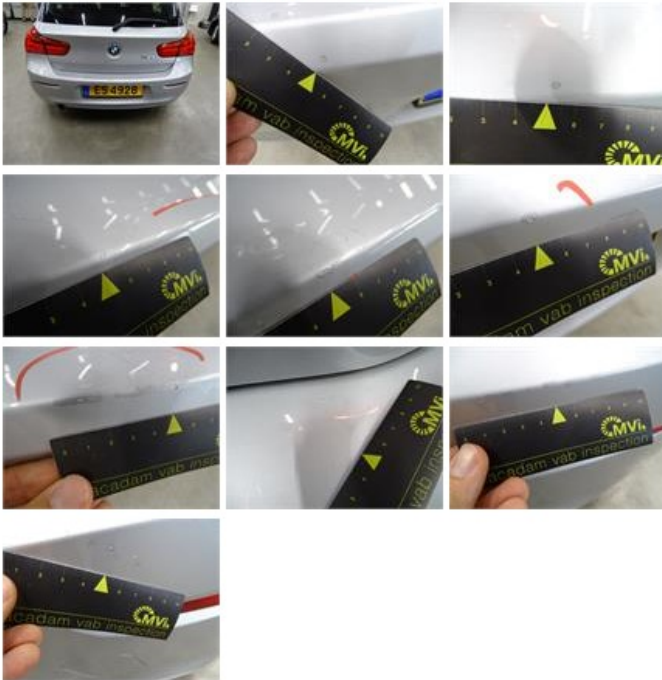
Bumper R, Scratch(es), LI - Repair and paint (complete)

211,80

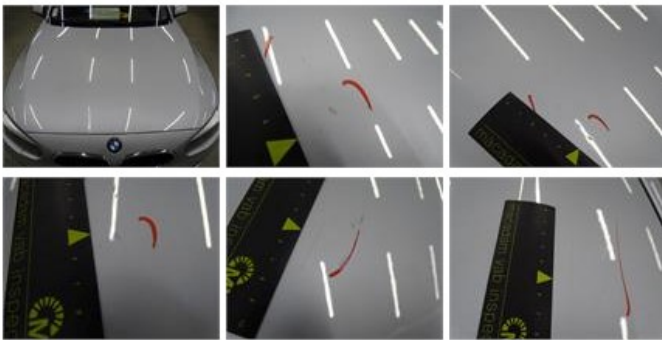
Bonnet, Dent(s) and scratch(es), LI - Repair and paint (complete)

290,08

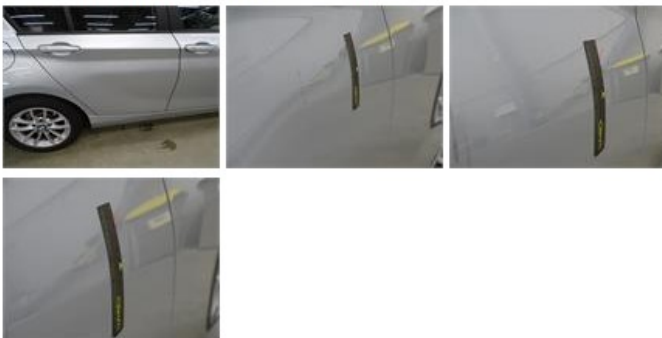
Door R R, Dent(s), PDR - Paintless dent repair

63,00

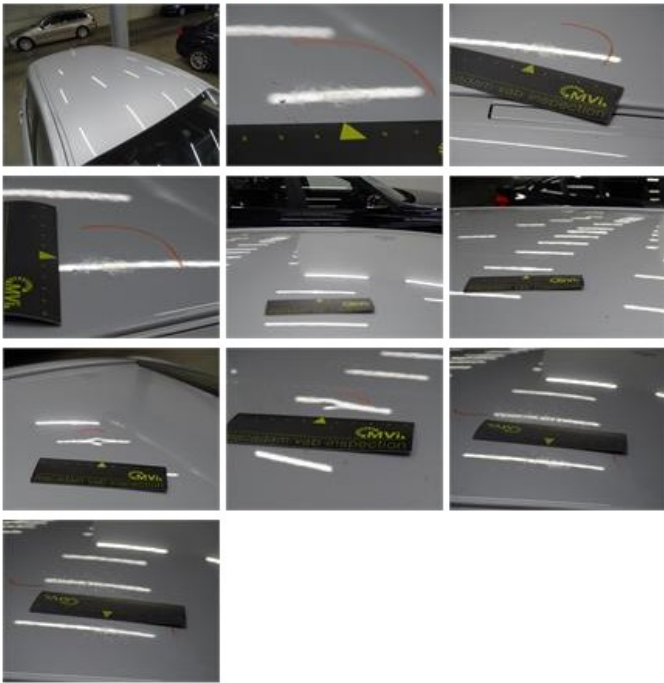
Roof, Chemical polution, LI - Repair and paint (complete)

577,50
