BMW 2 ACTIVE TOURER: 1LBL748

| Vinnumber: | WBA2B31040V543760 | Versionname: | 1.5 216D ACTIVE TOURER |

Limited Technical Inspection

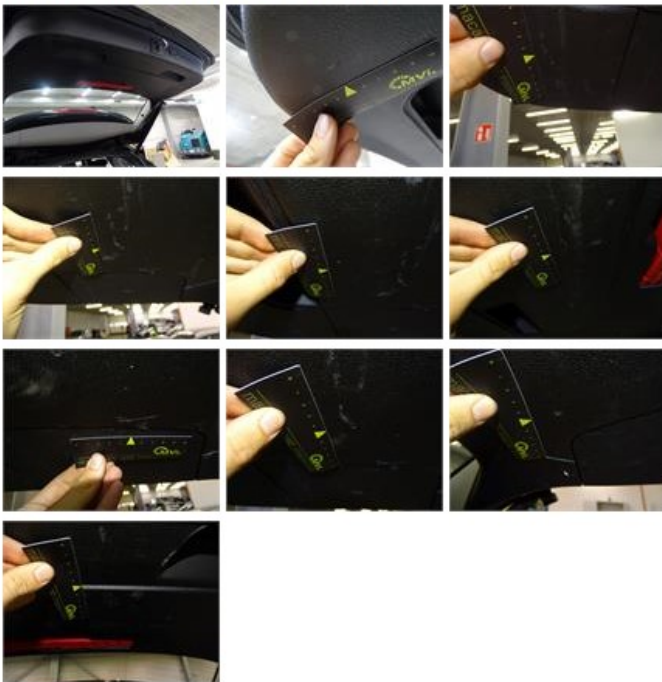
Trunk lid covering R, Scratch(es), Smart repair

110,64

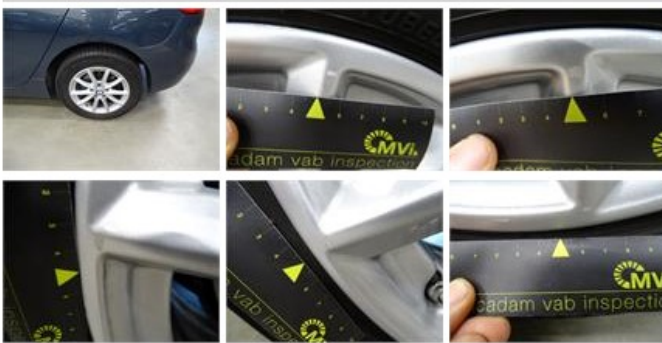
Alloy rim R L, Scratch(es), Acceptable

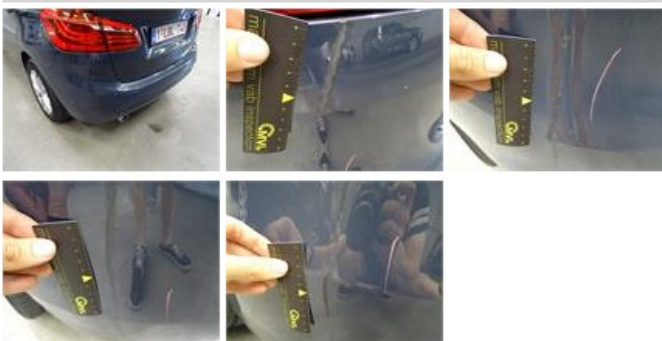
Bumper R, Scratch(es), LI - Repair and paint (complete)

211,80

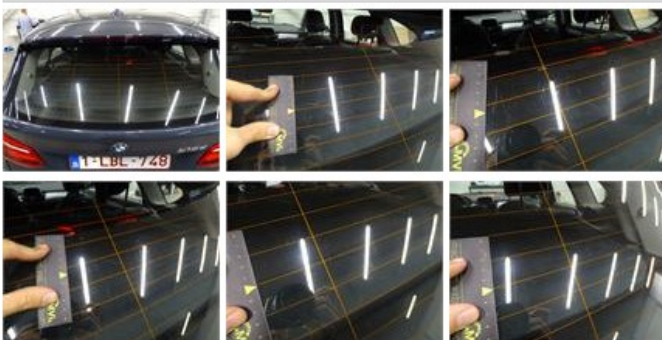
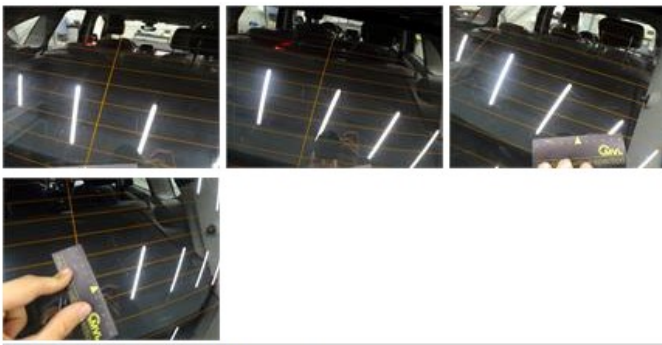
Rear window, Scratch(es), E - Replace

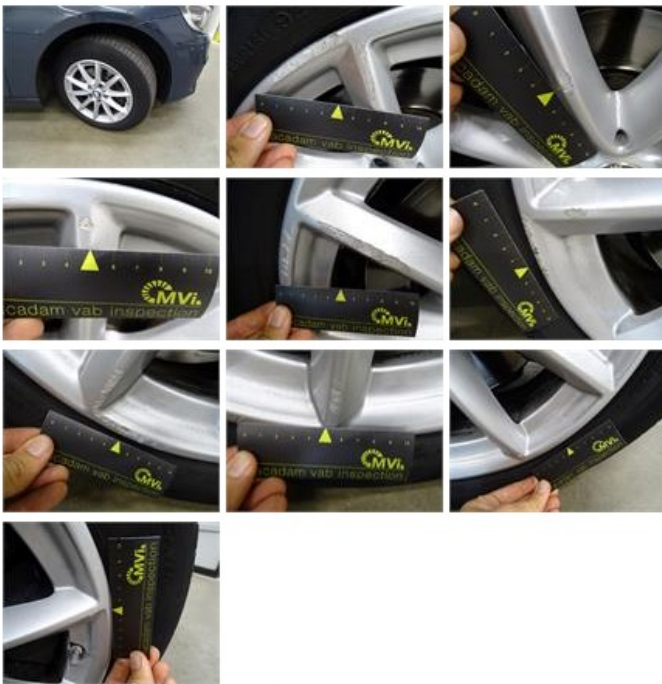
Alloy rim F R, Scratch(es), LI - Repair and paint (complete) 95,00

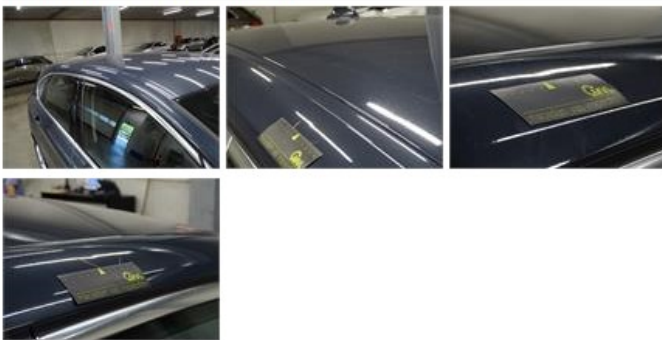
Roof pillar R, Dent(s), It - Spot repair 115,56

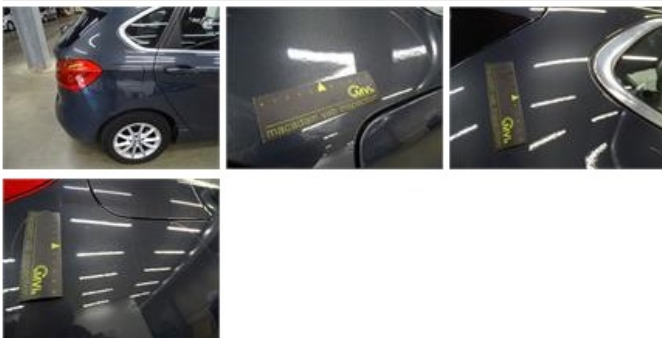
Wing R R, Bad repair, Acceptable 0,00

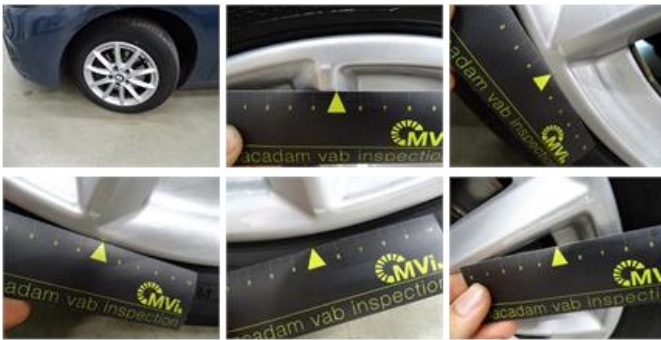
Alloy rim F L, Scratch(es), Acceptable
