BMW 2 ACTIVE TOURER: 1KGK415

Limited Technical Inspection

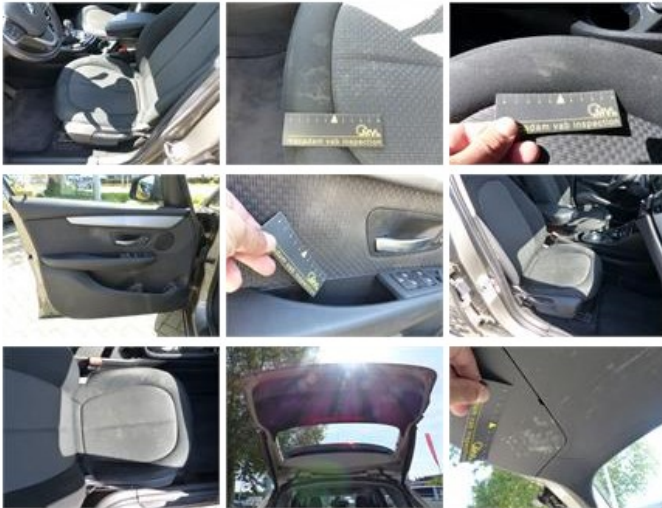
Interior, Dirty, Cleaning 25,00

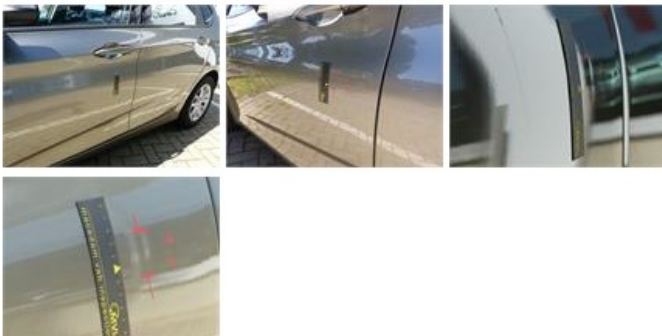
Door F L, Dent(s), PDR - Paintless dent repair 63,00
