BMW 3 TOURING: 1KNL894

Limited Technical Inspection

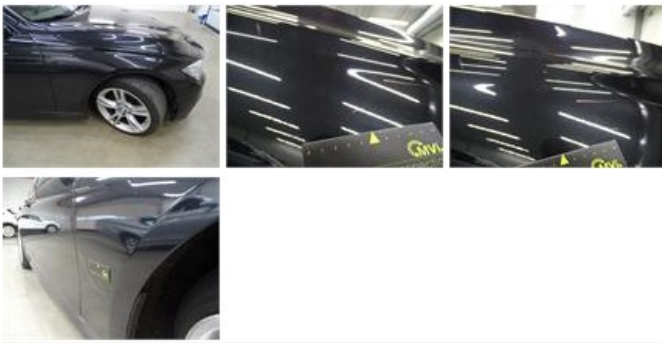
Total cost ex VAT	1025,60
Wing F R, Bad repair, Acceptable	0,00

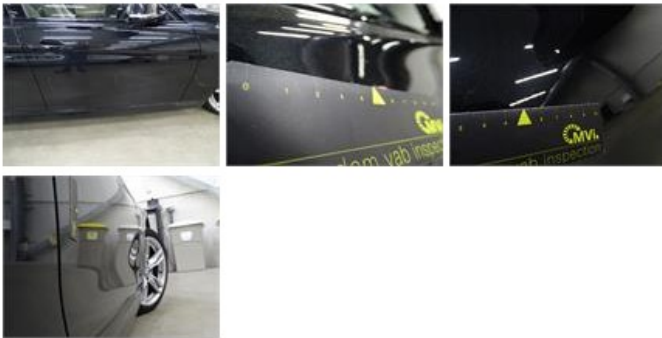
Door F R, Bad repair, Acceptable 0,00

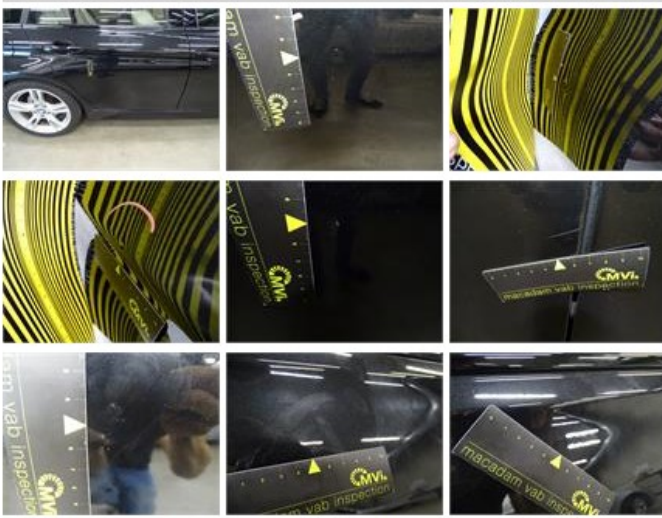
Door R R, Dent(s) and scratch(es), LI - Repair and paint (complete) 0,00

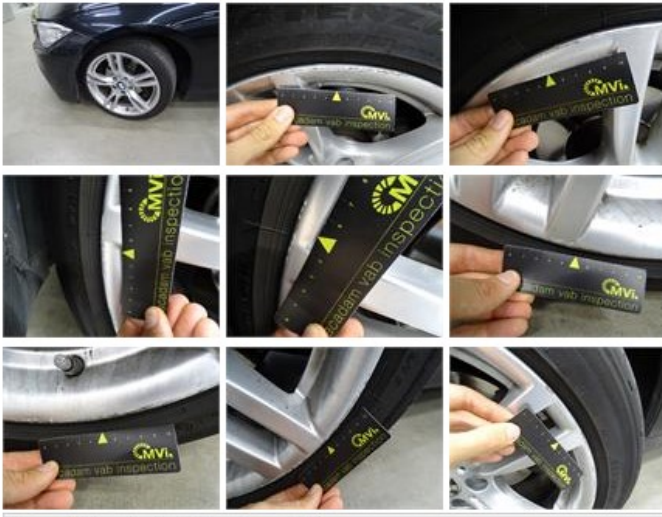
Alloy rim F L, Scratch(es), LI - Repair and paint (complete) 95,00

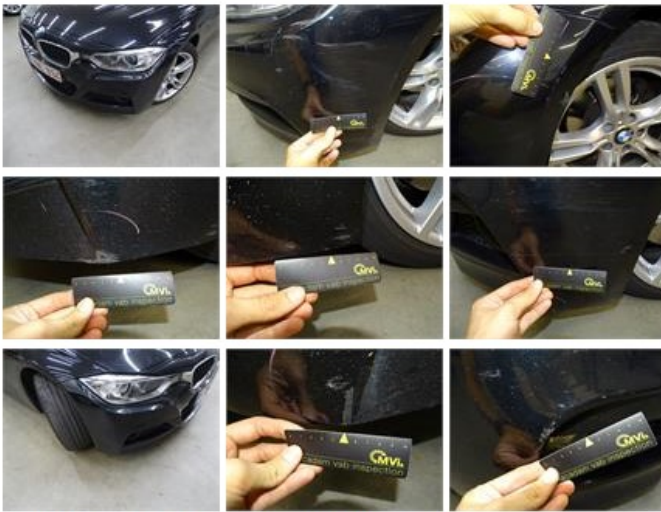
Bumper F, Scratch(es), LI - Repair and paint (complete)

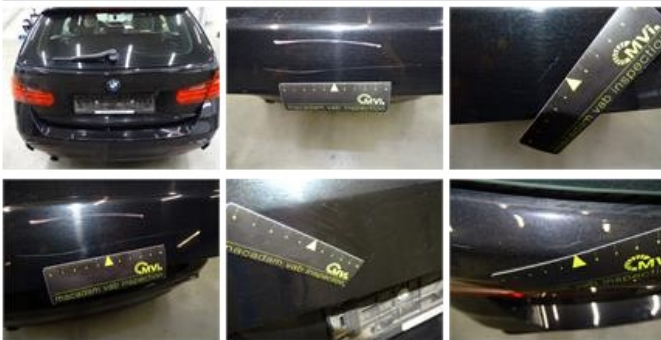
Tailgate, Scratch(es), LI - Repair and paint (complete)

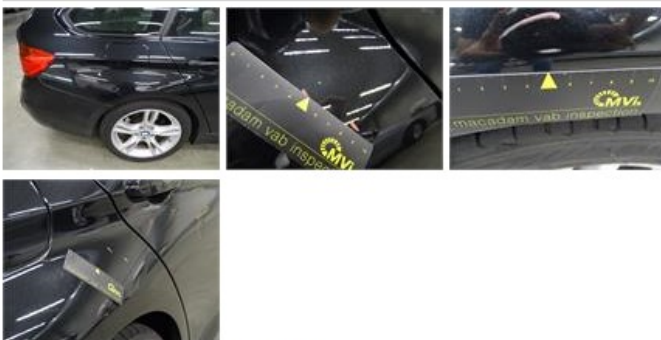
Wing R R, Bad repair, Acceptable

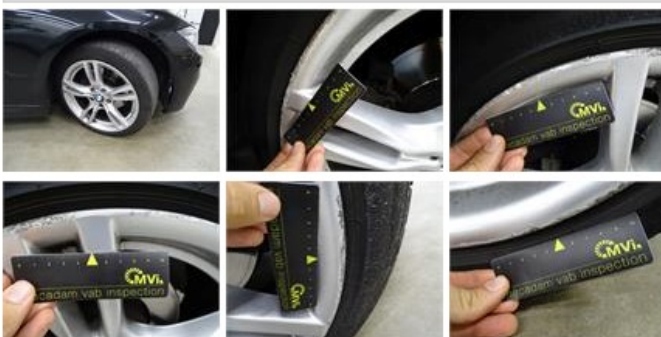
Alloy rim F R, Scratch(es), LI - Repair and paint (complete)

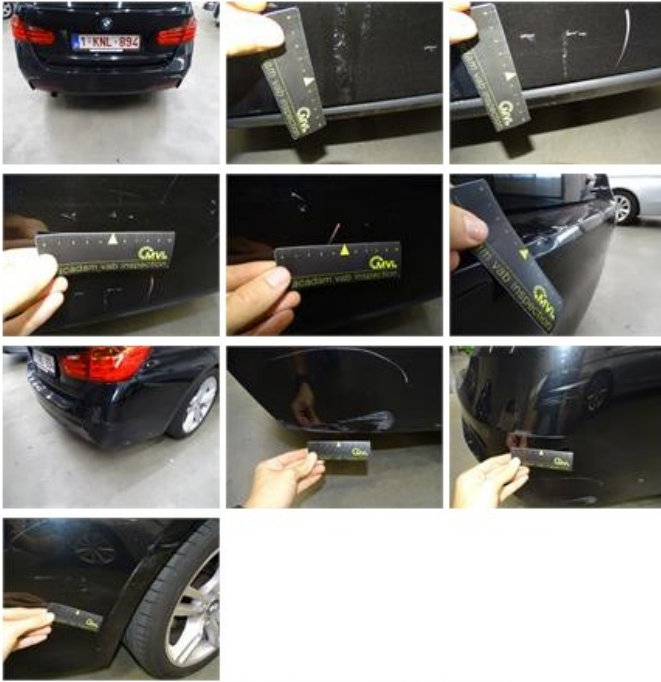
Bumper R, Dent(s) and scratch(es), LI - Repair and paint (complete)

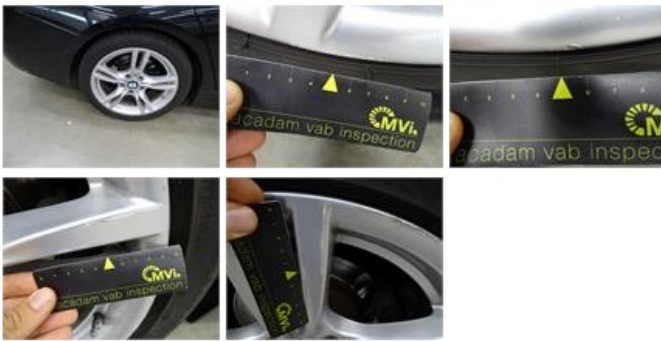
Alloy rim R R, Scratch(es), LI - Repair and paint (complete)

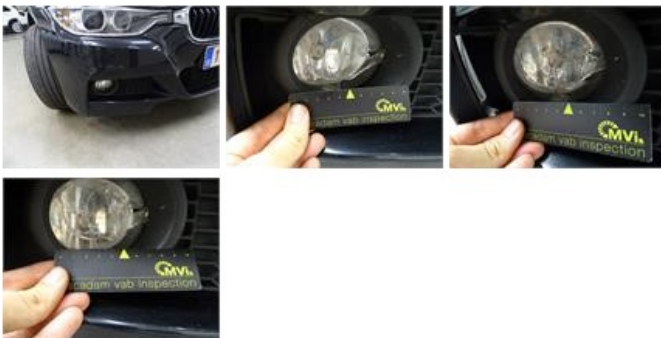
Foglight R, Broken, E - Replace
