**BMW 3 BERLINE: 1KTA994**

**Limited Technical Inspection**

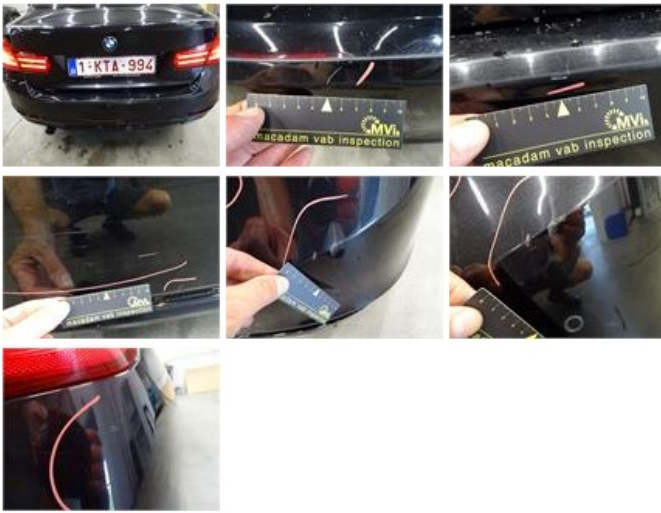
Bumper R, Scratch(es), LI - Repair and paint (complete)

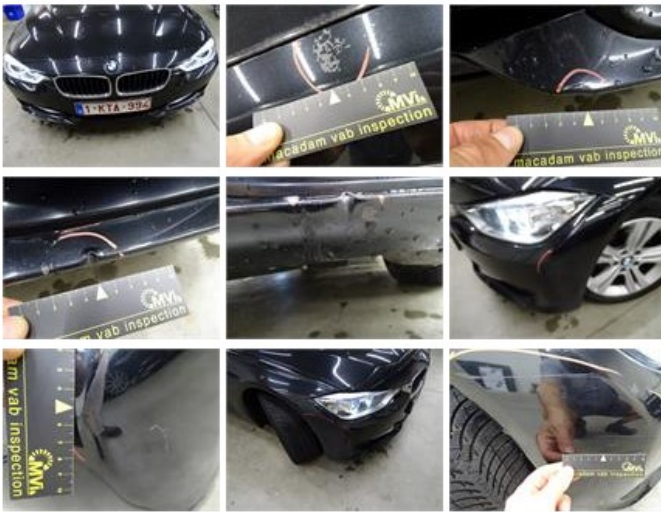
Bumper F, Dent(s) and scratch(es), LI - Repair and paint (complete)

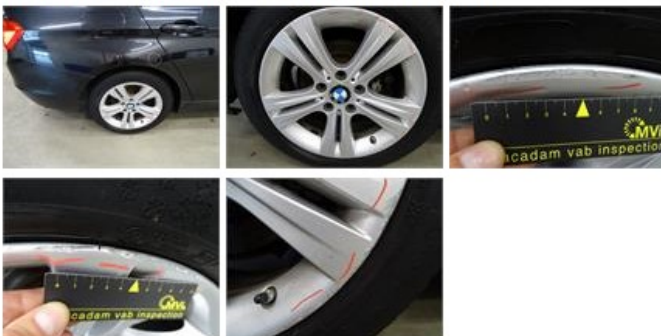
Alloy rim R R, Scratch(es), LI - Repair and paint (complete)

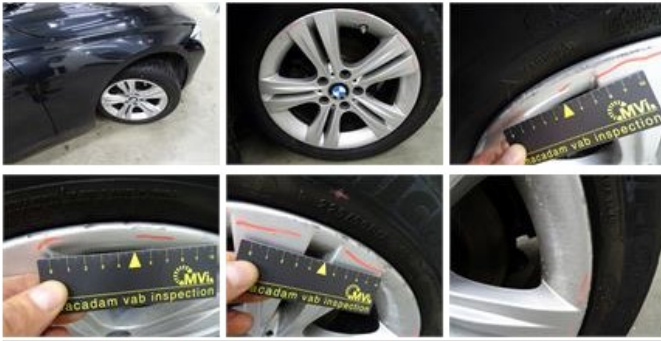
Alloy rim F R, Scratch(es), LI - Repair and paint (complete)

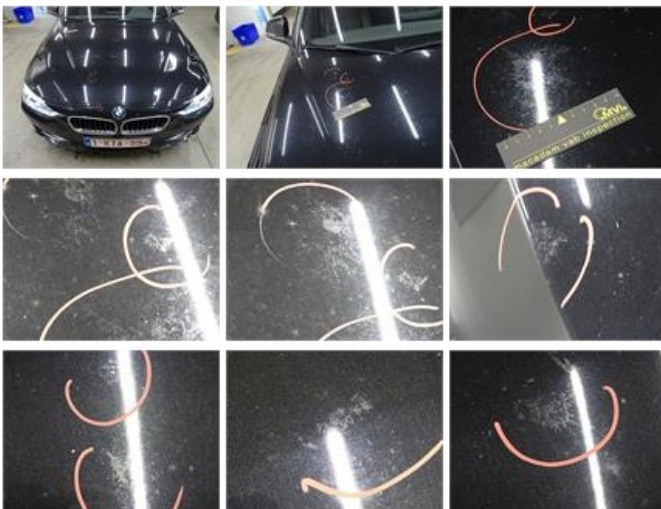
Bonnet, Chemical polution, LI - Repair and paint (complete)
