<b>BMW X4: YH5620</b>			
Vinnumber:	<b>WBAXX110400L98518</b>	Versionname:	<b>2.0 XDRIVE20D (140KW) 4WD</b>
First Registrationdate:	<b>3/07/2015</b>	Fiscalpower:	
Expertise Mileage:	<b>139890</b>	Power Kw:	<b>140</b>
Bodytype:	<b>SUV</b>	Body color:	<b>Black</b>
Gearbox:	<b>Automatic</b>	Paint type:	<b>Metalic</b>
Transmission:		Rims summer:	<b>Aluminium</b>
Fueltype:	<b>Diesel</b>	Oil level:	<b>OK</b>
Battery functioning:	<b>Yes</b>	Parking lot:	<b>2630</b>
Number of doors:	<b>5</b>		
Number of seats:	<b>5</b>		
Number head rests:	<b>5</b>		
Rims summer:	<b>Aluminium</b>		
Category:	<b>Passenger Car</b>		
Oil level:	<b>OK</b>

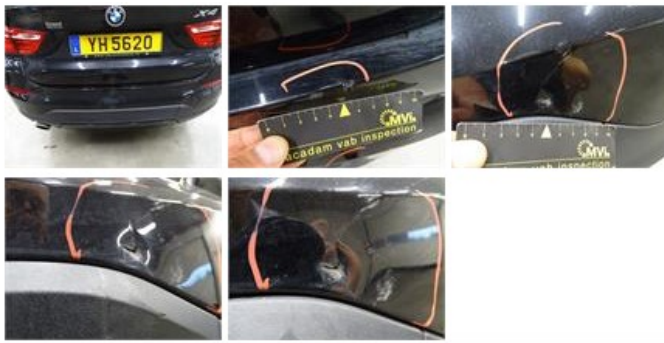
<b>Assistance equipment</b>			
Repair kit	<b>Yes</b>	Compressor	<b>Yes</b>
Total cost ex VAT			<b>2246,68</b>
Wing R L, Scratch(es), Acceptable			<b>0,00</b>
<i>No pictures to display</i>			
Bumper R, Dent(s) and scratch(es), LI - Repair and paint (complete)			<b>254,16</b>

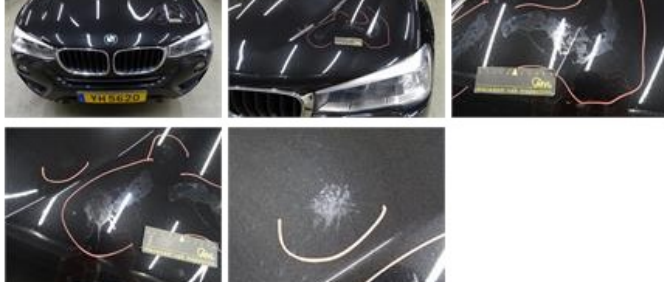
Bonnet, Chemical polution, LI - Repair and paint (complete) 348,09

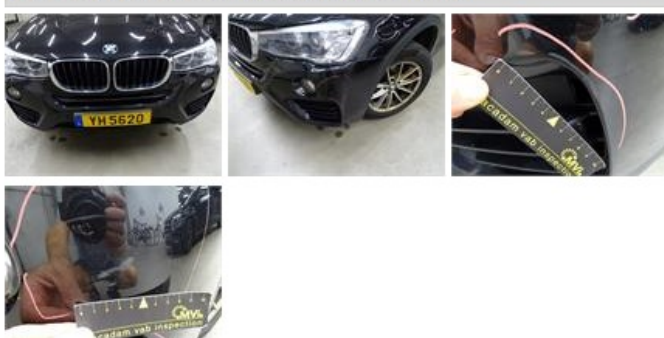
Bumper F, Scratch(es), LI - Repair and paint (complete) 254,16

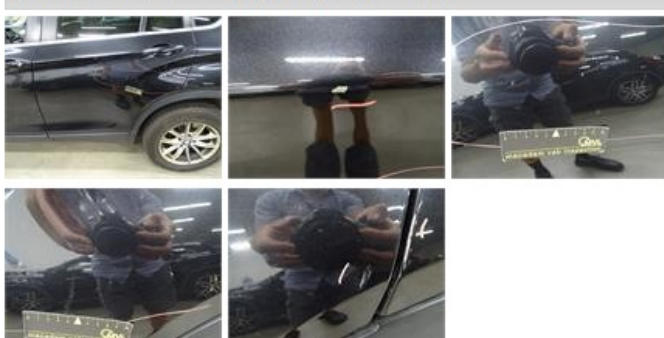
Door R L, Scratch(es), LI - Repair and paint (complete) 382,02
