IVECO DAILY: 1KPU239

Limited Technical Inspection

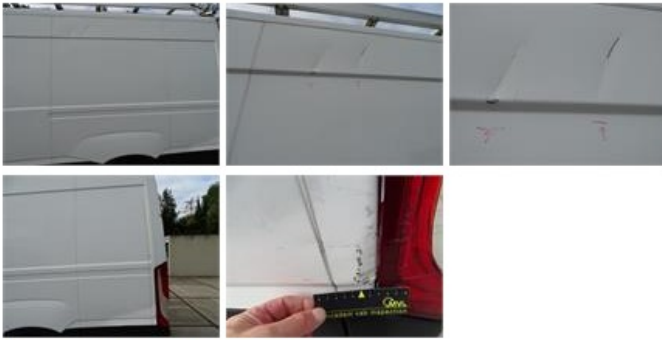
Wing R L, Dent(s) and scratch(es), LI - Repair and paint (complete) 231,15

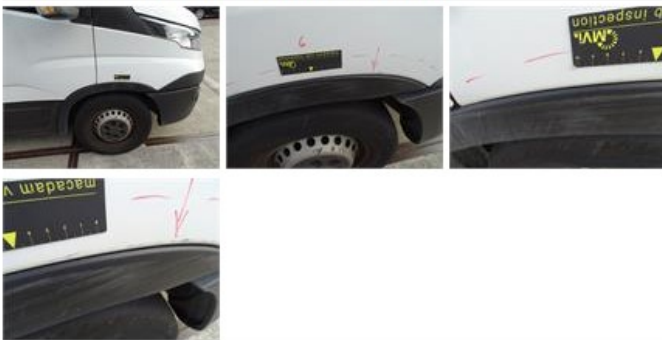
Wing F R, Scratch(es), LI - Repair and paint (complete) 165,13

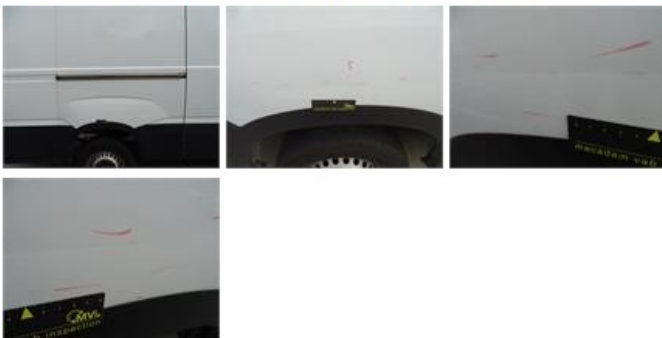
Wing R R, Dent(s) and scratch(es), LI - Repair and paint (complete)
