**FIAT 500: 1NVH486**

Vinnumber:	<b>ZFA3120000J585604</b>	Versionname:	<b>0.9 TURBO TWINAIR 85BHP POP STAR</b>
First Registrationdate:	<b>4/05/2016</b>	Fiscalpower:	
Expertise Mileage:	<b>99787</b>	Power Kw:	<b>63</b>
Bodytype:	<b>Hatchback</b>	Body color:	<b>White</b>
Gearbox:	<b>MAN 5 VIT</b>	Paint type:	<b>Metalic</b>
Transmission:		Rims summer:	<b>Aluminium</b>
Fueltype:	<b>Petrol</b>	Oil level:	<b>OK</b>
Battery functioning:	<b>Yes</b>	Parking lot:	<b>2703</b>
Number of doors:	<b>3</b>		
Number of seats:	<b>4</b>		
Number head rests:	<b>2</b>		
Rims summer:	<b>Aluminium</b>		
Category:	<b>Passenger Car</b>		
Oil level:	<b>OK</b>		
Registration Certificate Car (BE):	<b>Yes</b>

**Limited Technical Inspection**

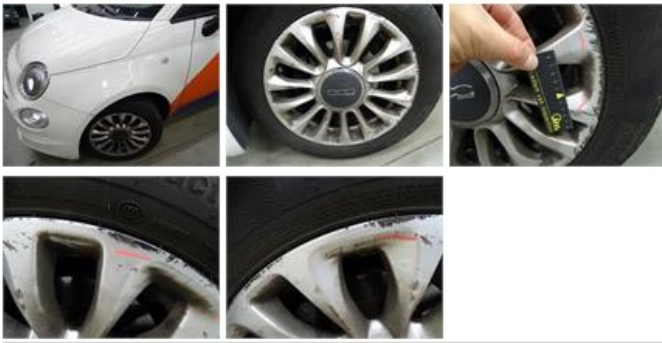
Alloy rim F L, Scratch(es), LI - Repair and paint (complete)	95,00
--	-------
