BMW 5: 1HCL606

Vinnumber:	WBA5J51070D582974	Versionname:	5 TOURING 520dXA 184PK Aut.
First Registrationdate:	18/06/2014	Fiscalpower:	
Expertise Mileage:	102710	Power Kw:	135
Bodytype:	Break	Body color:	White
Gearbox:	Automatic	Paint type:	Opaque
Transmission:	Back	Rims summer:	Aluminium
Fueltype:	Diesel	Oil level:	OK
Battery functioning:	Yes	Parking lot:	2228
Number of doors:	5		
Number of seats:	5		
Number head rests:	5		
Rims summer:	Aluminium		
Category:	Passenger Car		
Oil level:	OK		
Registration Certificate Car (BE):	Yes

Limited Technical Inspection

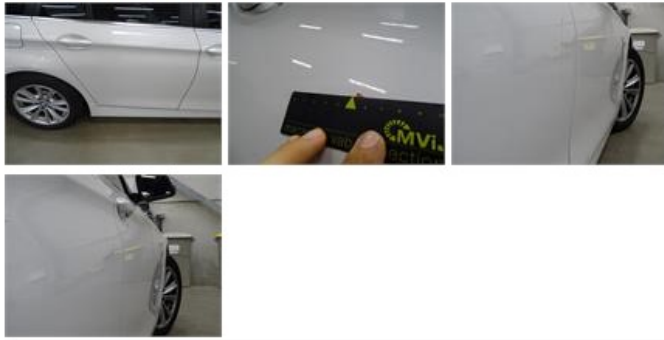
Door R R, Bad repair, Acceptable

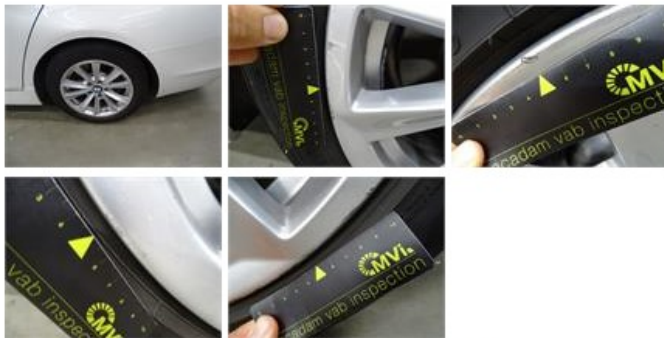
Alloy rim R L, Scratch(es), LI - Repair and paint (complete)

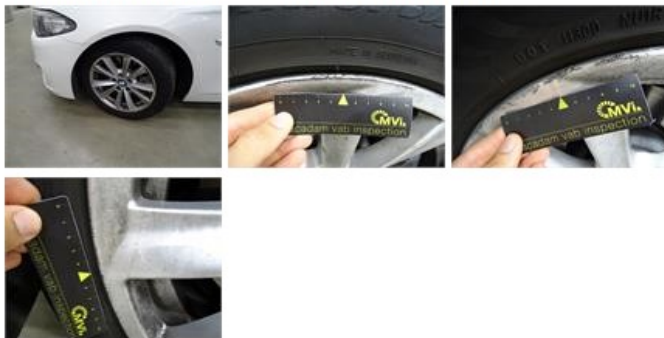
Alloy rim F L, Scratch(es), LI - Repair and paint (complete)

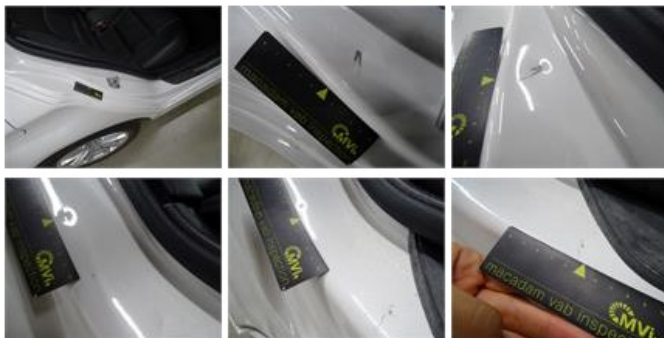
Rocker panel inner R R, Dent(s), LI - Repair and paint (complete)

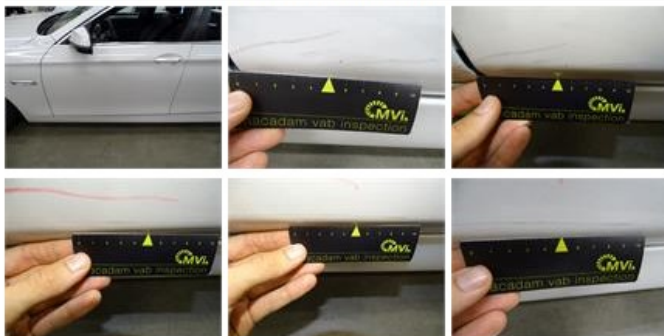
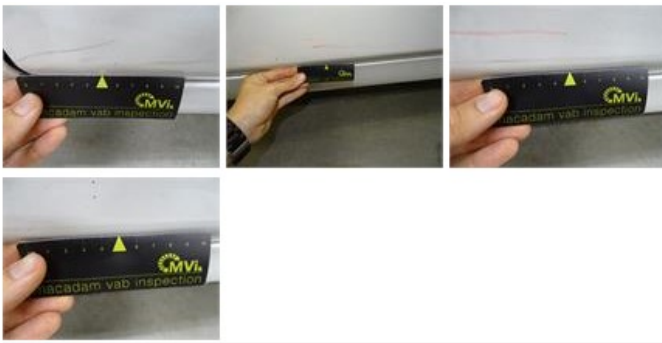
Door F L, Scratch(es), LI - Repair and paint (complete)

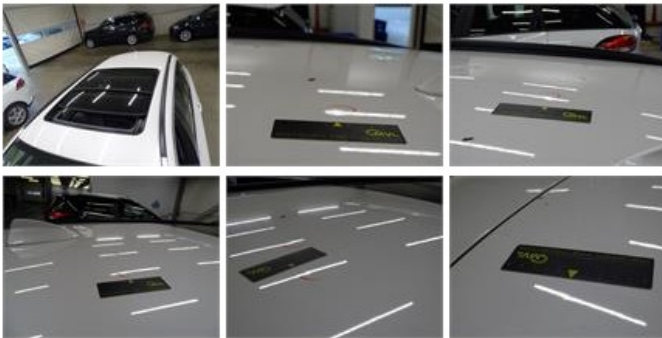
Roof, Dent(s), PDR - Paintless dent repair 122,40

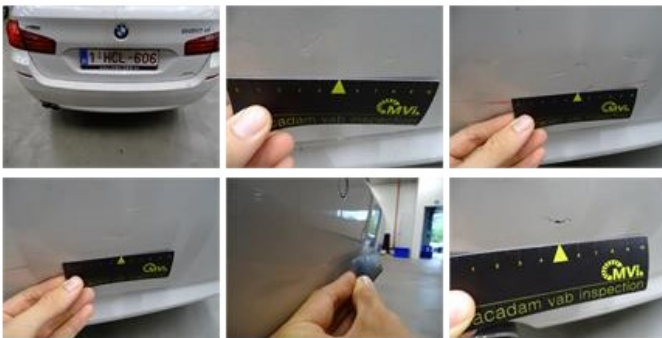
Bumper R, Dent(s) and scratch(es), LI - Repair and paint (complete) 254,16

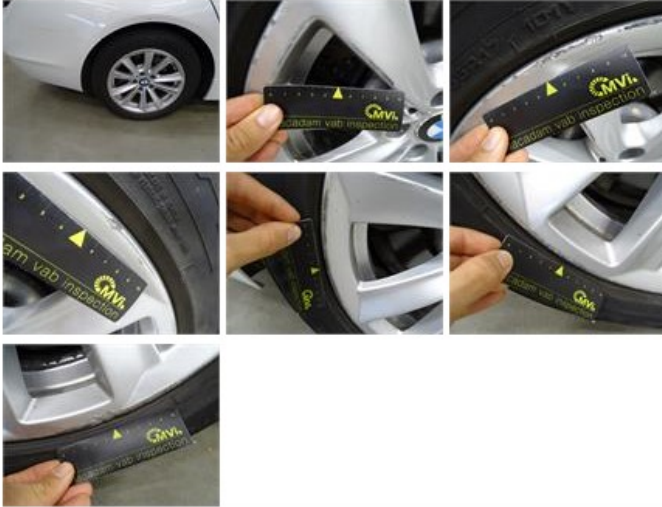
Alloy rim R R, Scratch(es), LI - Repair and paint (complete) 95,00

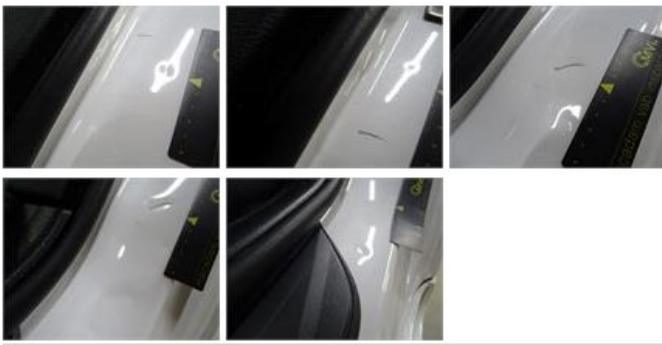
Rocker panel inner R L, Dent(s), LI - Repair and paint (complete) 115,56

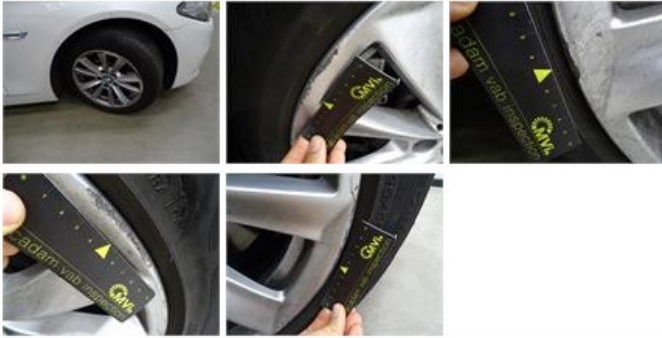
Alloy rim F R, Scratch(es), LI - Repair and paint (complete) 95,00

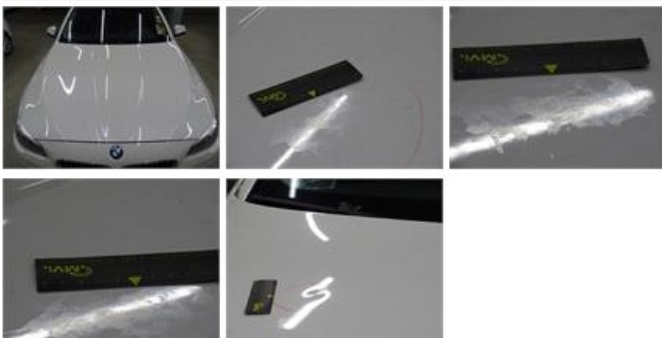
Bonnet, Chemical pollution, LI - Repair and paint (complete) 348,09

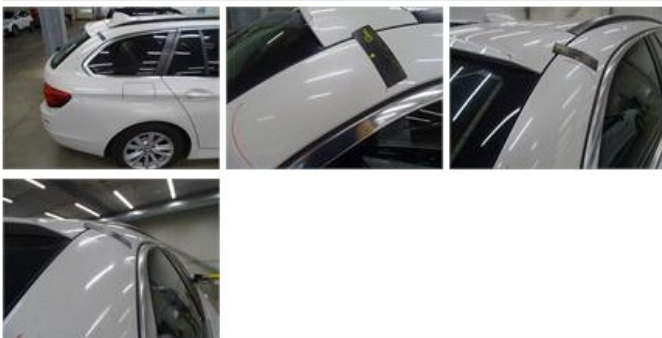
Wing R R, Bad repair, Acceptable 0,00

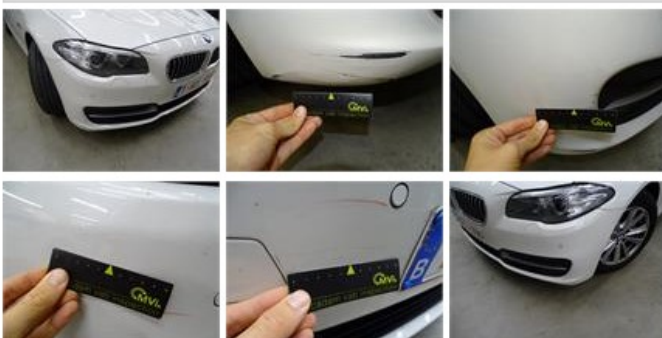
Bumper F, Scratch(es), LI - Repair and paint (complete) 254,16
