MERCEDES B: 1FGH156

Limited Technical Inspection

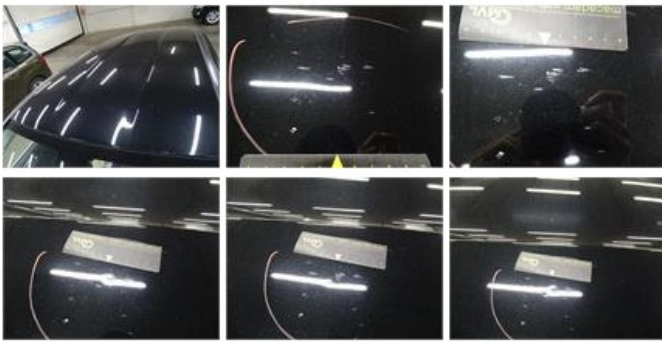
Roof, Dent(s) and scratch(es), LI - Repair and paint (complete) 481,50

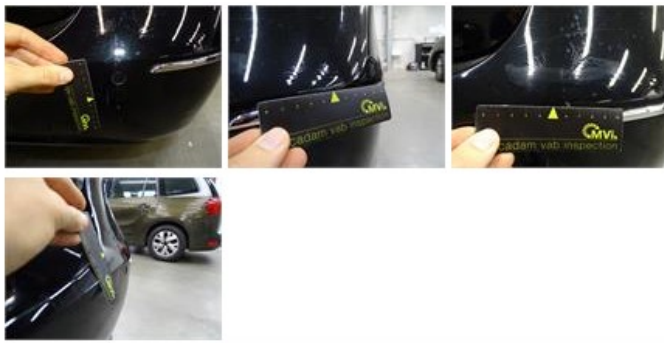
Bumper R, Dent(s) and scratch(es), LI - Repair and paint (complete) 211,80

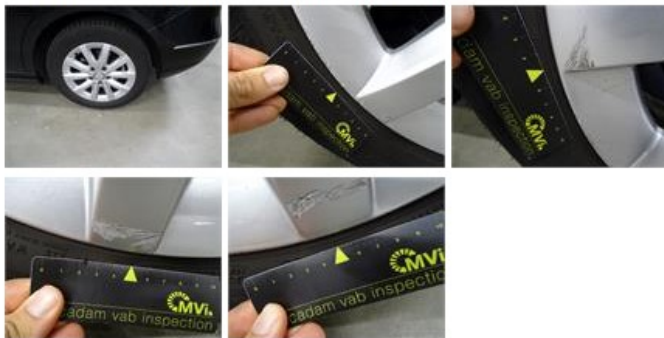
Alloy rim R L, Scratch(es), LI - Repair and paint (complete) 95,00

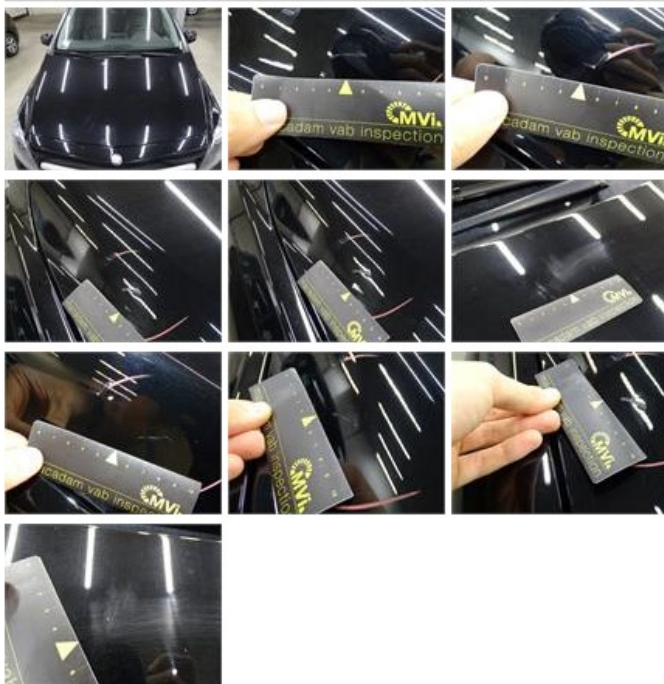
Bonnet, Dent(s) and scratch(es), LI - Repair and paint (complete) 290,08

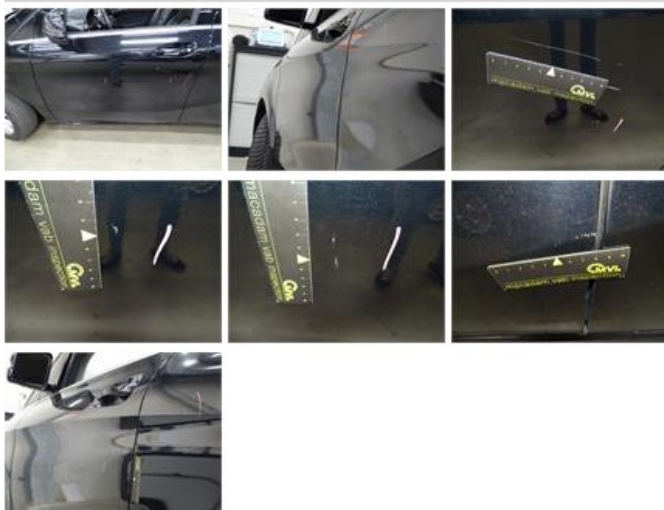
Door F L, Dent(s) and scratch(es), LI - Repair and paint (complete) 318,35

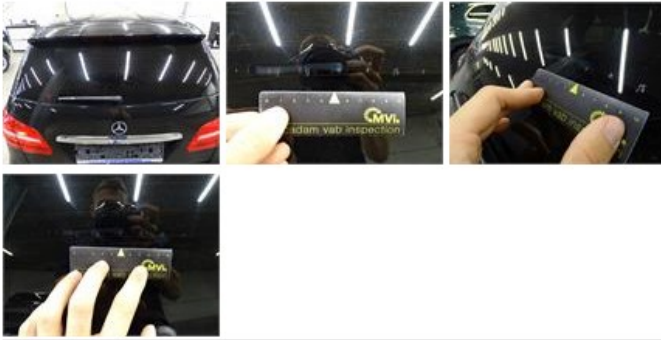
Rear window, Scratch(es), E - Replace

370,00

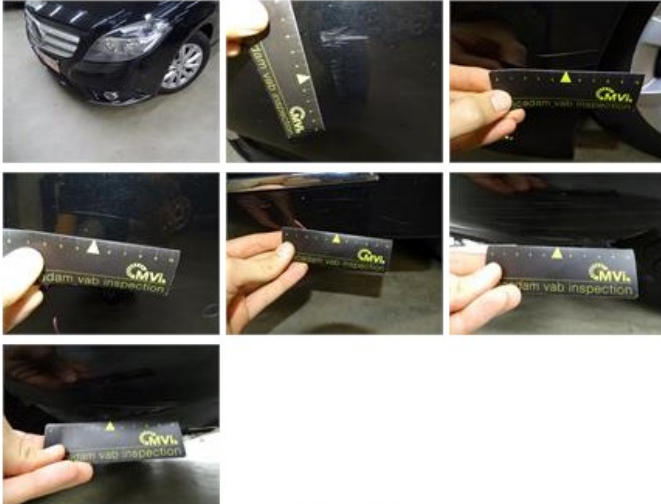
Bumper F, Scratch(es), LI - Repair and paint (complete)

211,80
