MERCEDES B: 1KGK471

Limited Technical Inspection

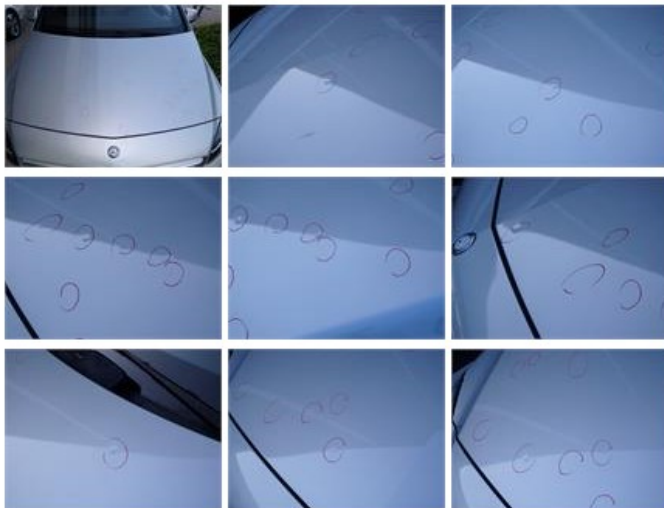
Bonnet, Hail damage, LI - Repair and paint (complete) 482,08

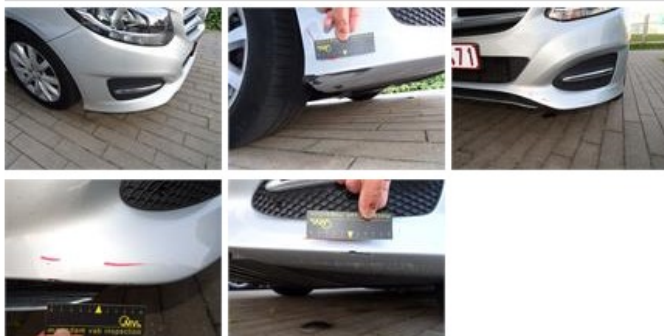
Bumper F, Scratch(es), LI - Repair and paint (complete) 211,80

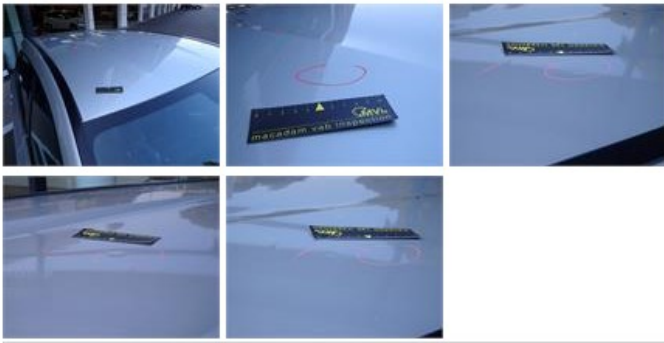
Roof, Hail damage, PDR - Hail 200,00
