CITROEN C4 Picasso: 1HJS015

Limited Technical Inspection

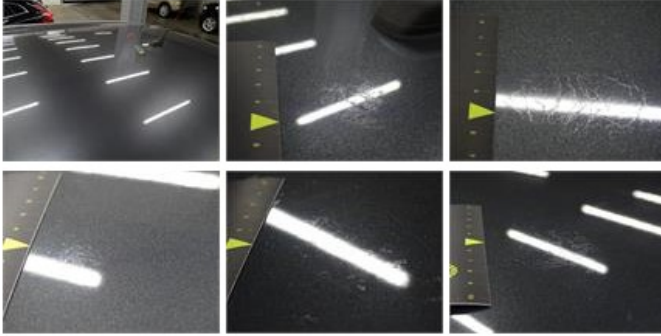
Roof, Chemical pollution, LI - Repair and paint (complete) 481,50
