**OPEL ZAFIRA TOURER: 1LBK930**

**Limited Technical Inspection**

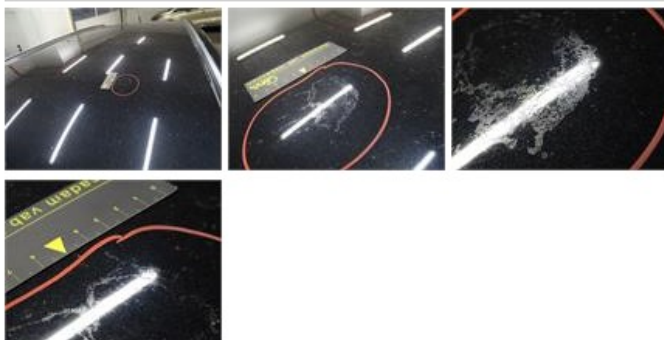
Roof, Chemical pollution, LI - Repair and paint (complete) 481,50
