**OPEL Vivaro 2900: 1GPP767**

**Limited Technical Inspection**

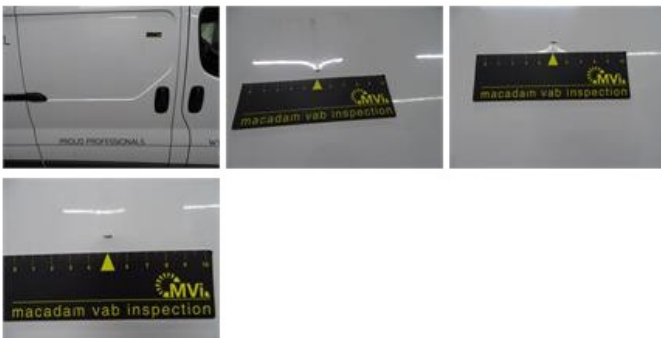
Door R R, Dent(s) and scratch(es), LI - Repair and paint (complete)

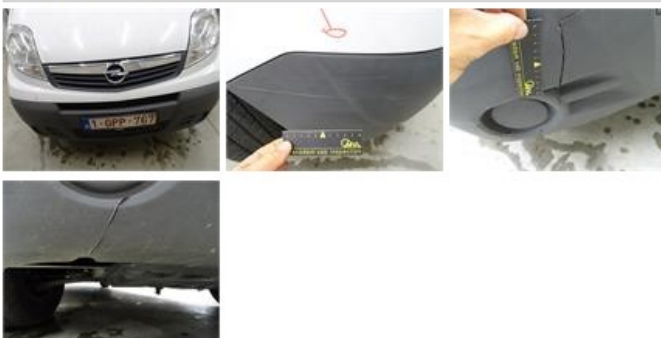
Bumper F, Crack, E - Replace

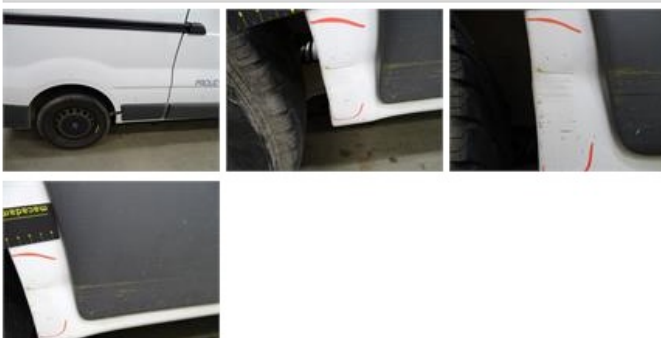
Wing R R, Dent(s) and scratch(es), LI - Repair and paint (complete)

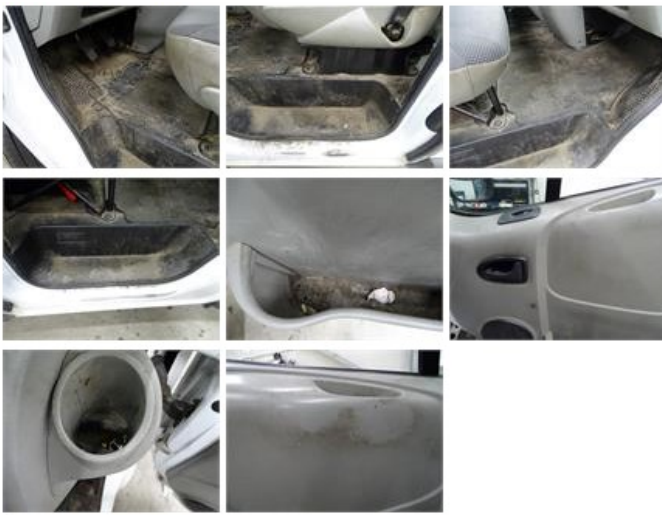
Interior, Dirty, Cleaning

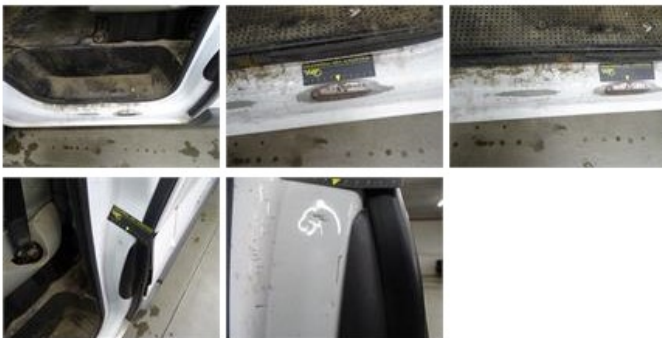
Rocker panel inner F L, Dent(s), LI - Repair and paint (complete) 115,56

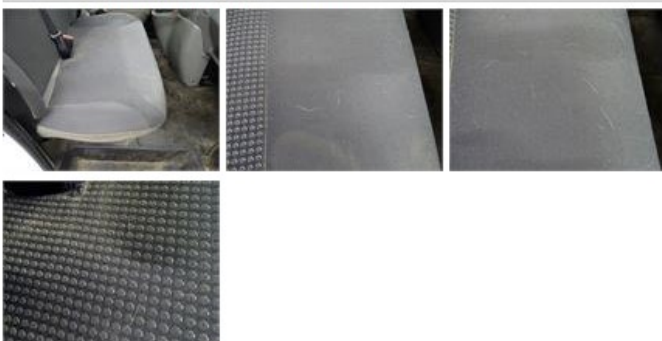
Seat cover F R, Dirty, Chemical cleaning 150,00

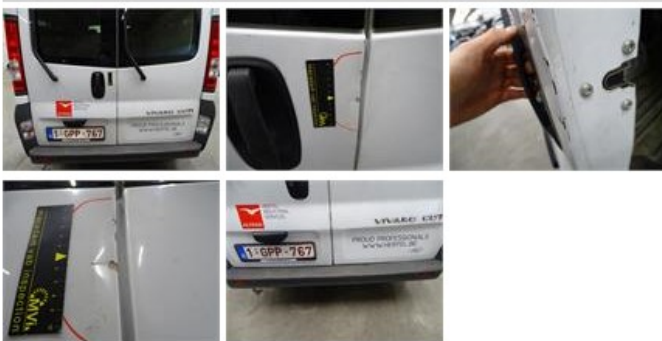
Trunk door R L, Dent(s) and scratch(es), It - Spot repair 115,56
