BMW 1: 1HNZ729

Limited Technical Inspection

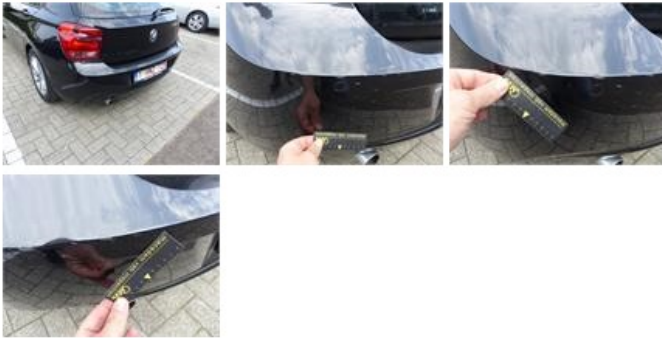
Bumper R, Scratch(es), LI - Repair and paint (complete) 211,80
