**RENAULT ESPACE: 1KXV370**

**Limited Technical Inspection**

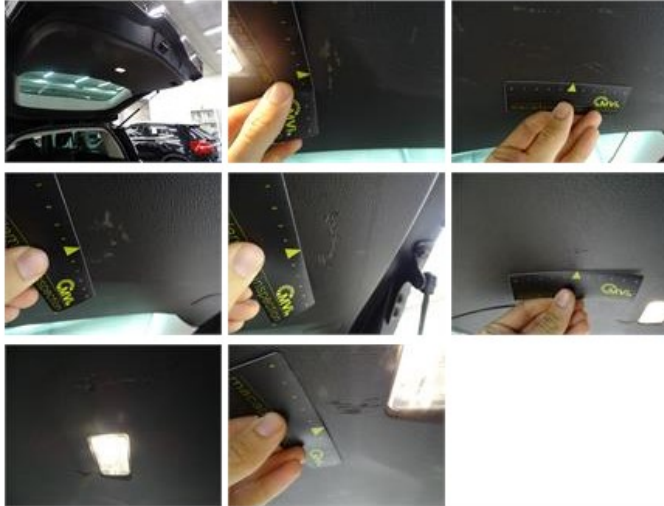
Trunk lid covering R, Scratch(es), Smart repair 110,64

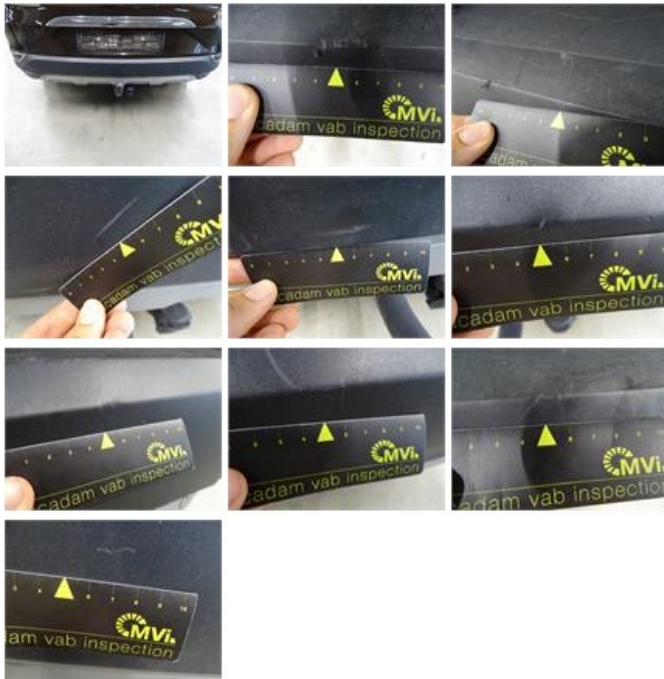
Bumper R, Scratch(es), Smart repair 110,64

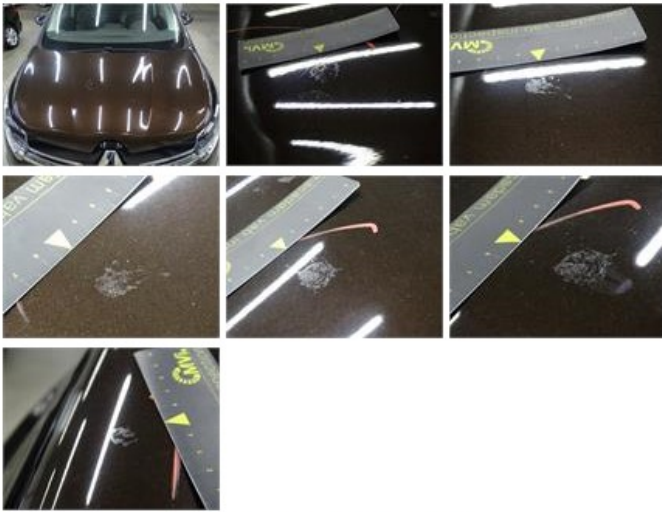
Bonnet, Chemical polution, LI - Repair and paint (complete)

348,09

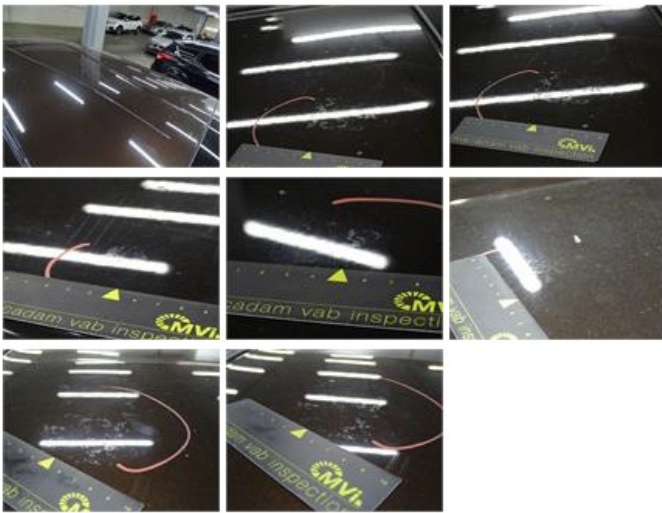
Roof, Chemical polution, LI - Repair and paint (complete)

577,80
