**SKODA Octavia: 1HCR738**

**Limited Technical Inspection**

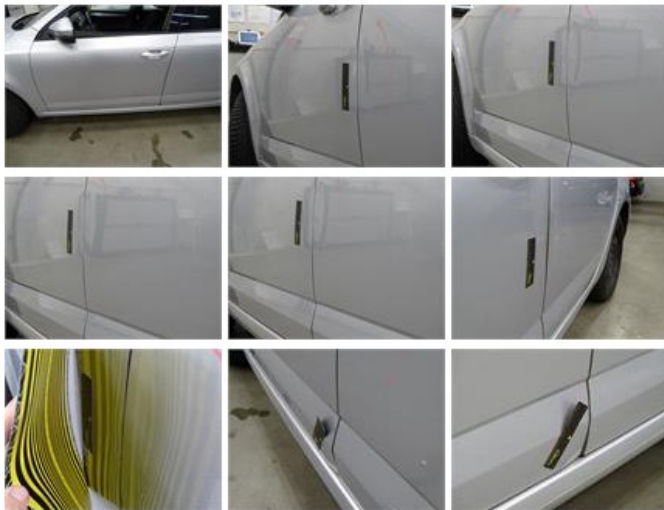
Door seal F L, Deformed / Strained, E - Replace

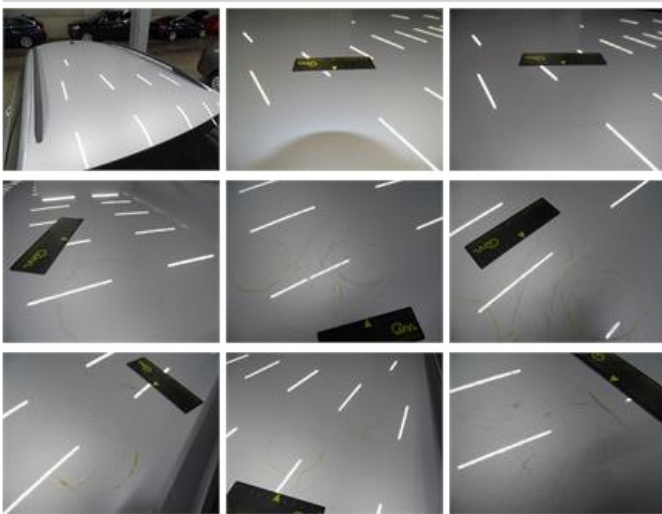
Roof, Scratch(es), LI - Repair and paint (complete) 481,50

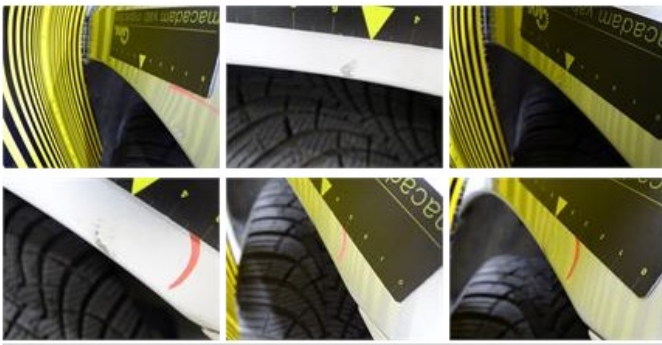
Wing F R, Dent(s) and scratch(es), LI - Repair and paint (complete) 220,18
